VICTORIA HARBOUR DOCKLANDS

CONSERVATION MANAGEMENT PLAN

Places Victoria &
City of Melbourne

June 2012

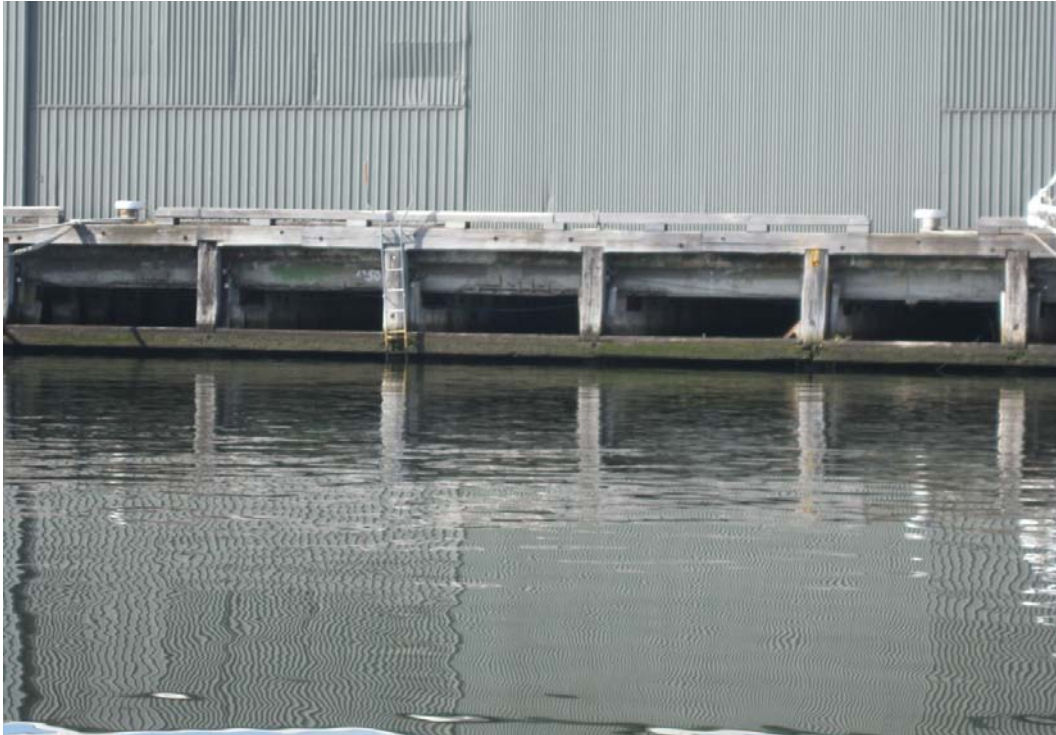
Figure 23 Wharf face, berth 3, showing exposed reinforcement of wharf beam.

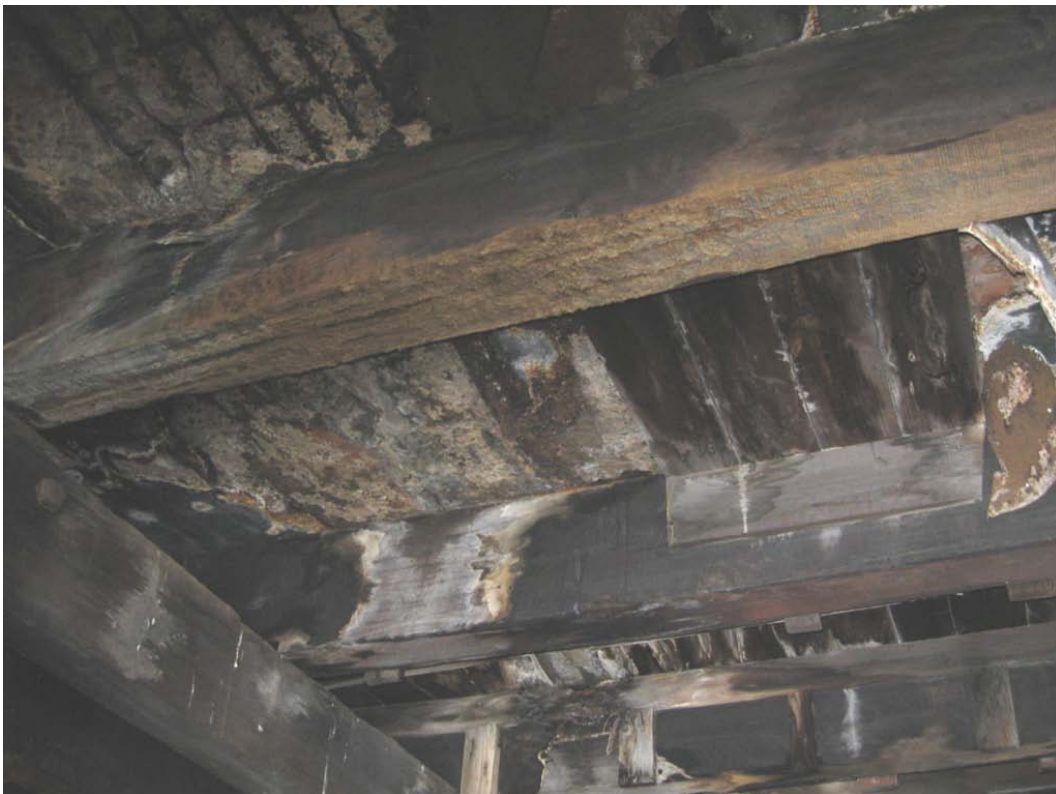
Berths 9 to 14 do not have visible diagonal bracing – refer to Figure 27, Figure 28 and Figure 24. It is expected that these berths relied on the large number of piles to share the mooring and berthing forces. These forces may also have been limited by the slow pace of the berthing vessels, with the surrounding land reducing the wind velocity on vessels at berth, as well as reducing wave creation.

Figure 24 Underside of concrete slab deck, berth 10, showing corroded metal formwork, corroded reinforcement, and impacts of water penetration to timber structure level from deck.

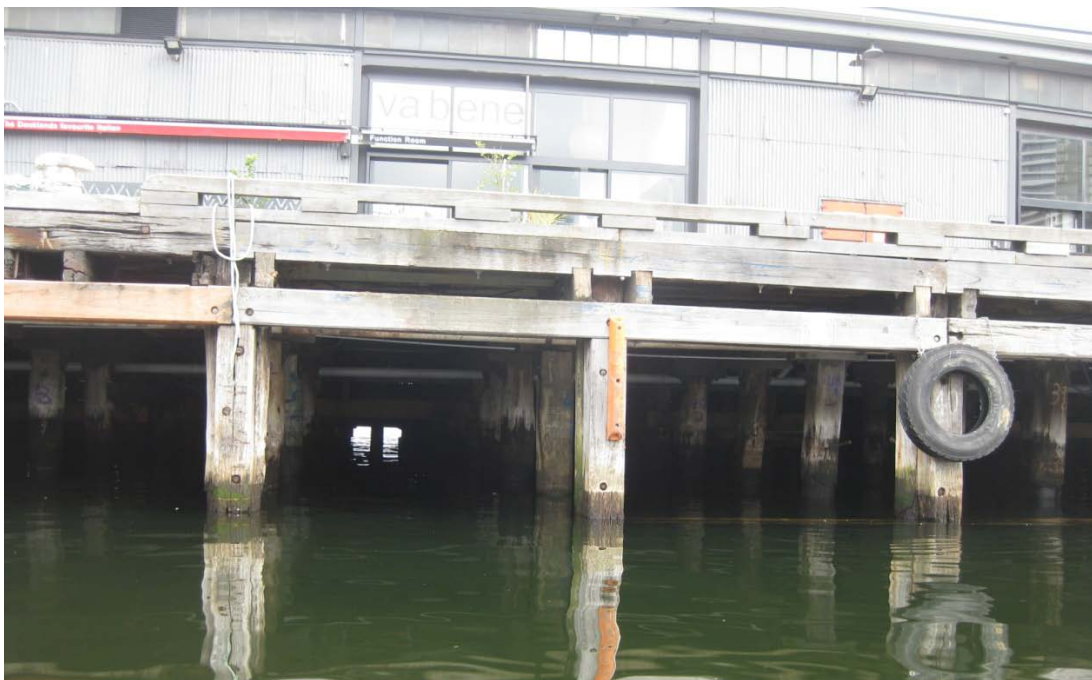
Figure 28 View to north, berth 10. Note deterioration of piles at water level and end grain decay in beams.

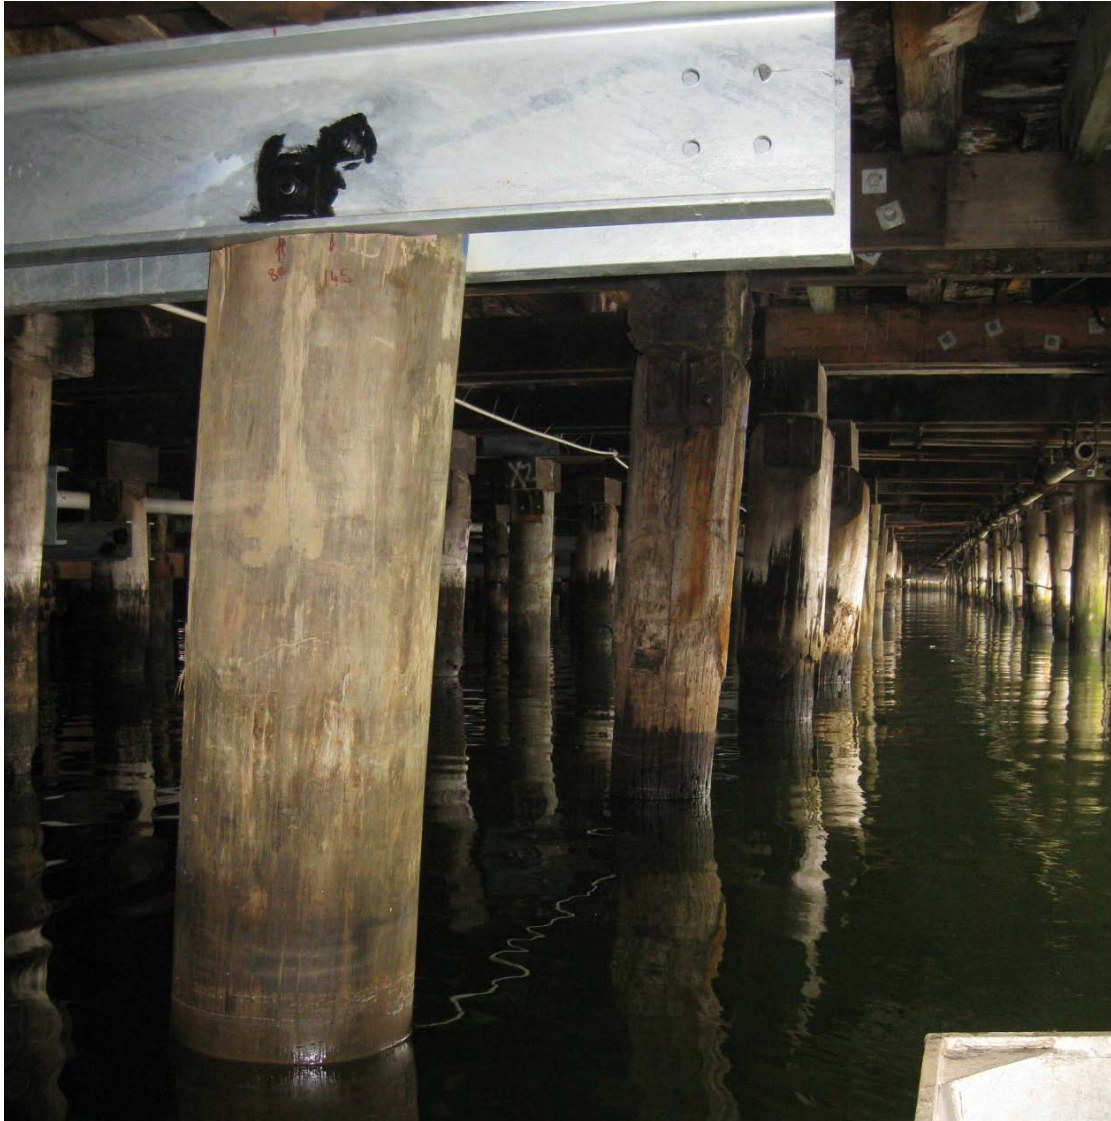
Figure 29 Under deck view to east, berth 10. Note new piles and galvanised channel beams (transfer beams) in foreground; and new timber beams with galvanised bolts in upper middle ground.

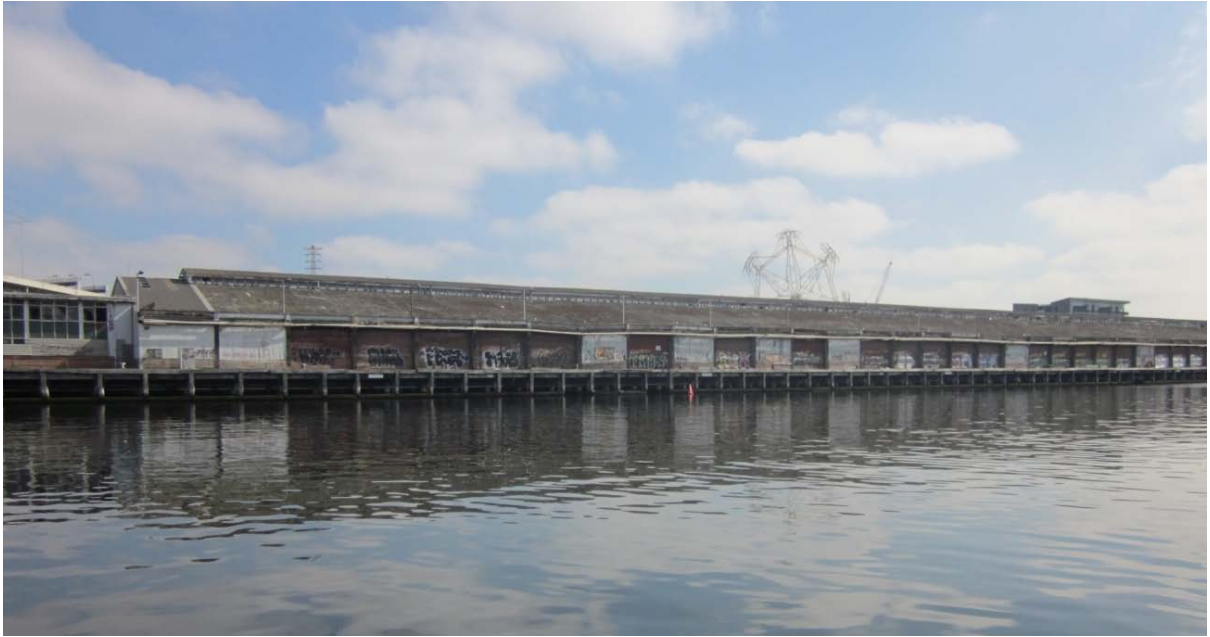
Figure 44 Berth 20 and 21 shed, showing the south elevation, from Victoria Harbour. The 1968 amenities block is visible at the left side. Note the altered pattern of openings and some of the impacts of deterioration and vandalism.

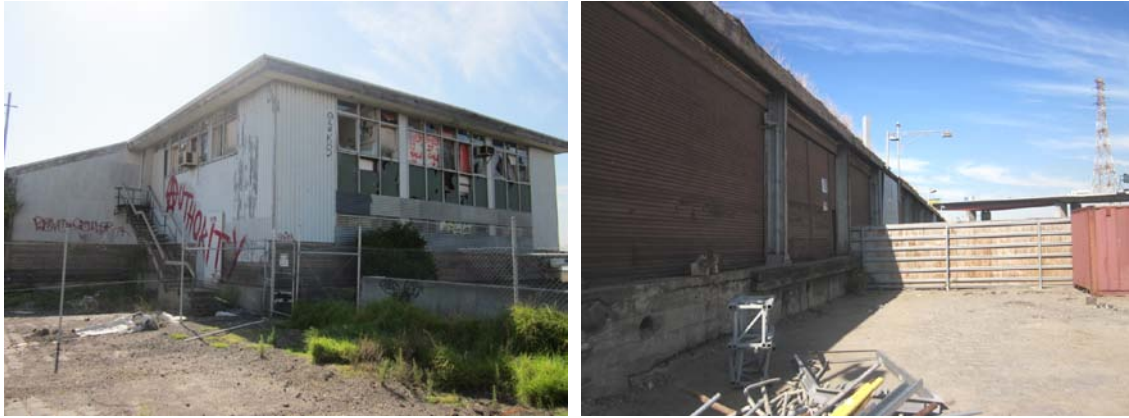
Figure 46 From left: Amenities bay constructed in 1968, to the west end of berth 21 shed; berth 20 shed, looking west. Note the deteriorated wharf structure and missing timber buffer rail at left.

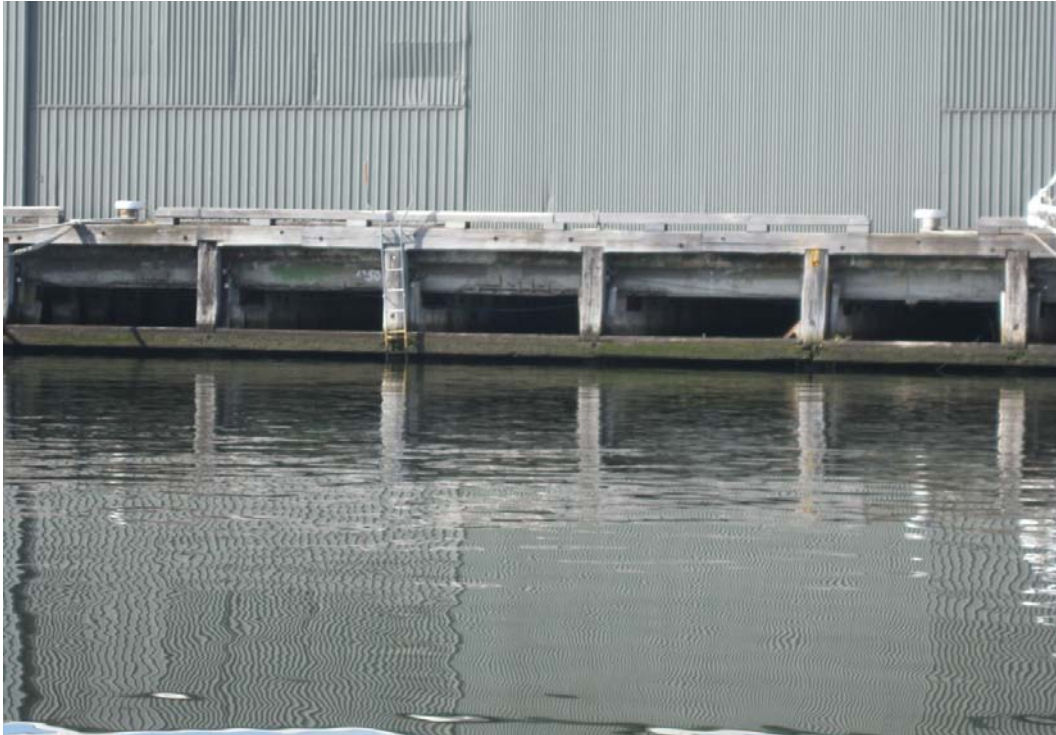
Figure 23 Wharf face, berth 3, showing exposed reinforcement of wharf beam.

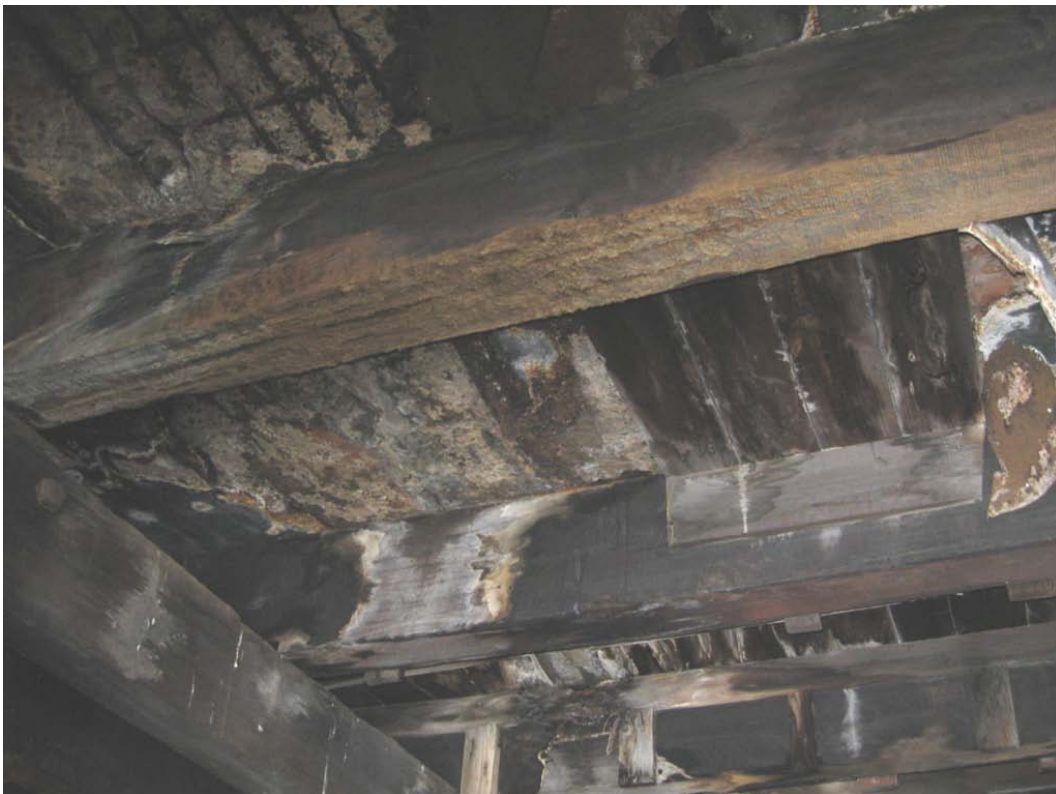
Figure 24 Underside of concrete slab deck, berth 10, showing corroded metal formwork, corroded reinforcement, and impacts of water penetration to timber structure level from deck.

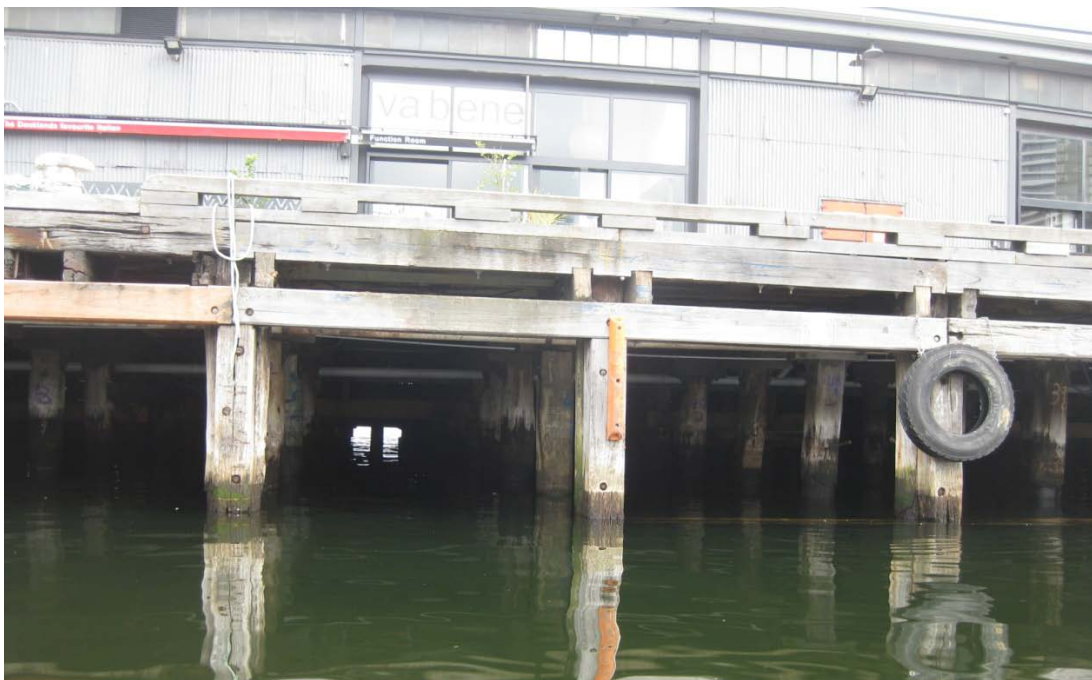
Figure 28 View to north, berth 10. Note deterioration of piles at water level and end grain decay in beams.

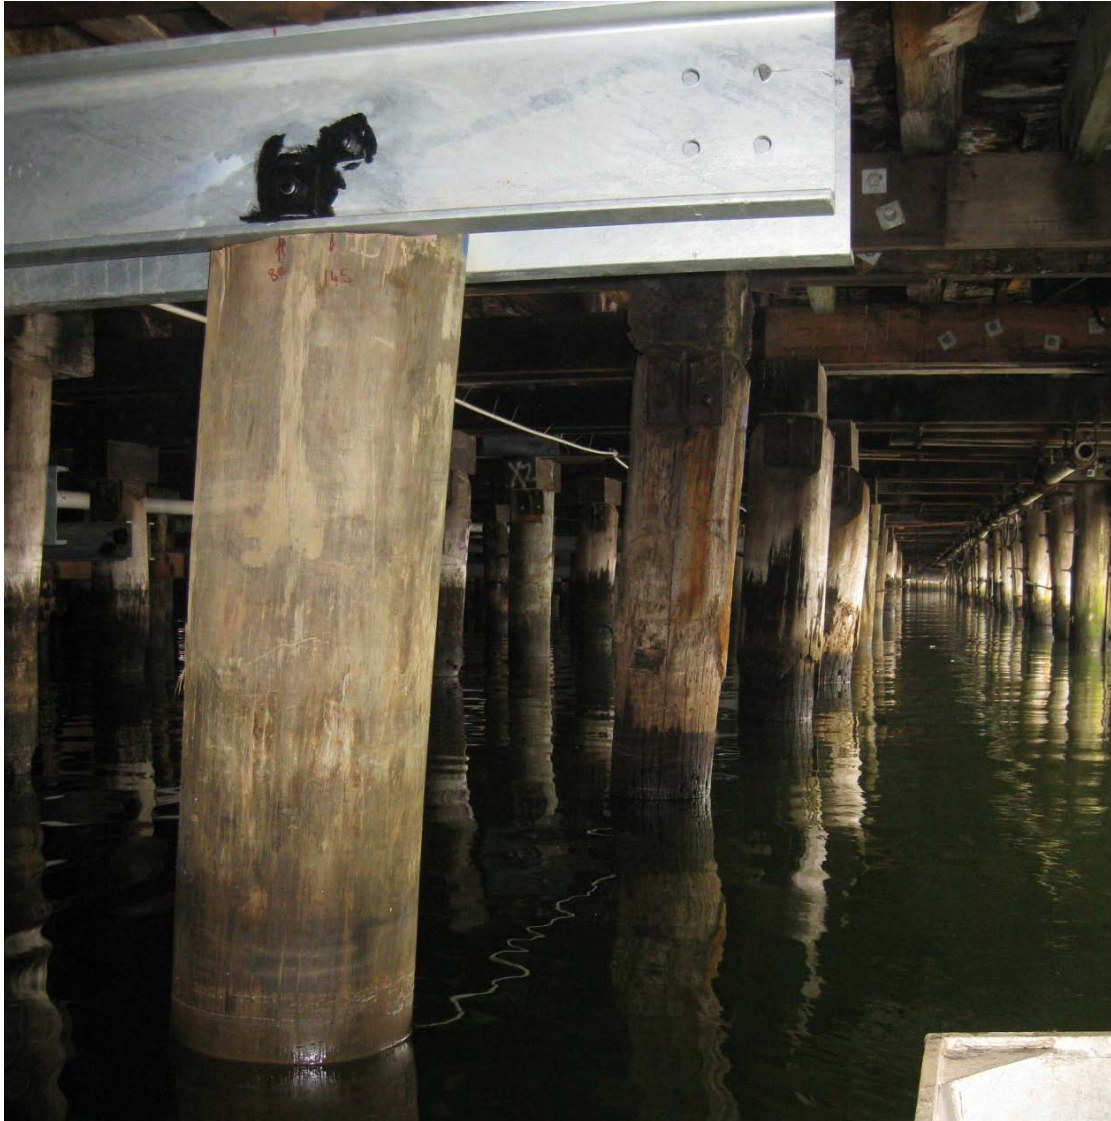
Figure 29 Under deck view to east, berth 10. Note new piles and galvanised channel beams (transfer beams) in foreground; and new timber beams with galvanised bolts in upper middle ground.

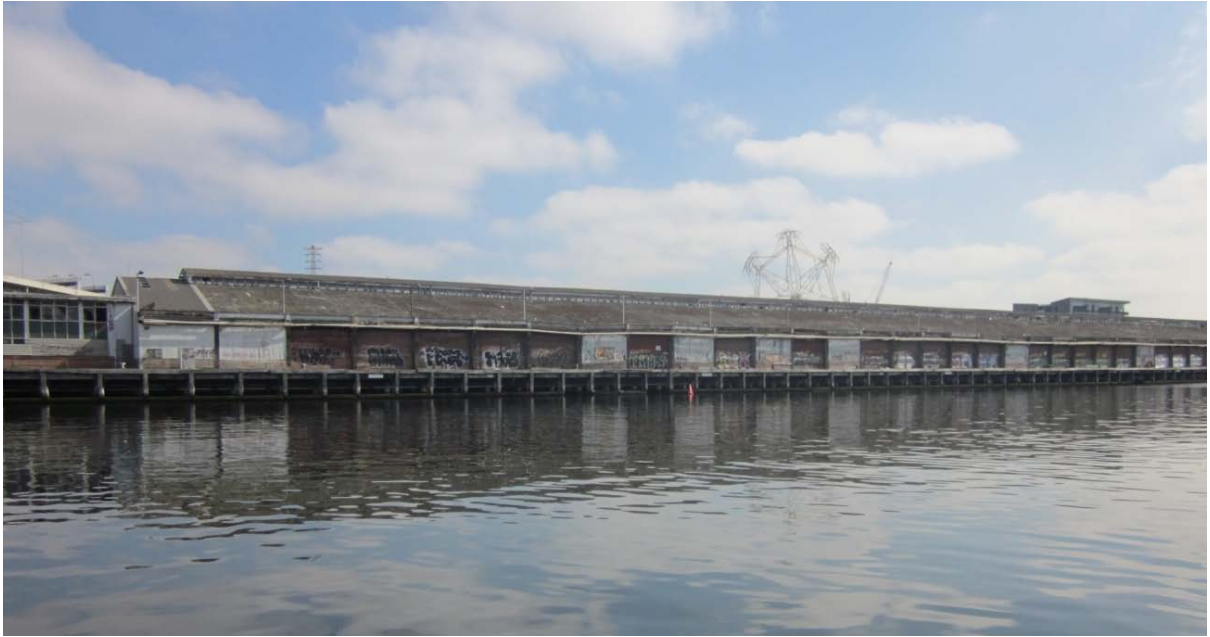
Figure 44 Berth 20 and 21 shed, showing the south elevation, from Victoria Harbour. The 1968 amenities block is visible at the left side. Note the altered pattern of openings and some of the impacts of deterioration and vandalism.

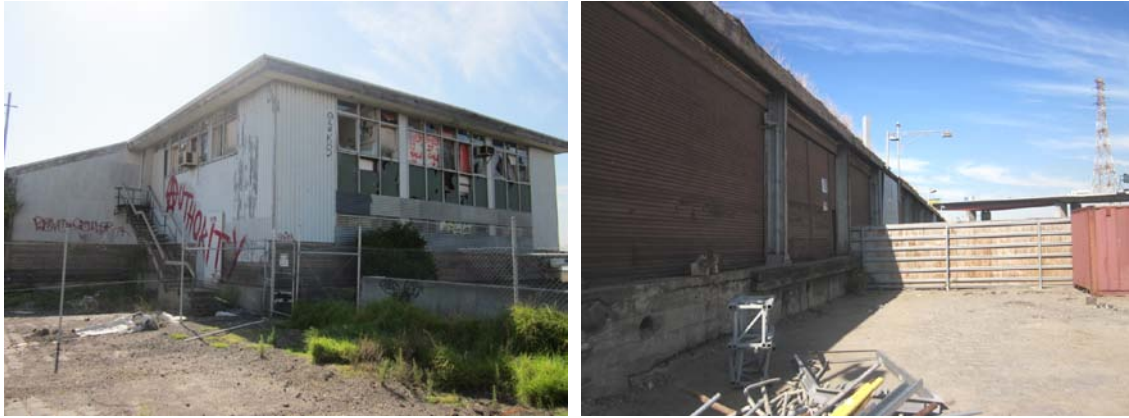
Figure 46 From left: Amenities bay constructed in 1968, to the west end of berth 21 shed; berth 20 shed, looking west. Note the deteriorated wharf structure and missing timber buffer rail at left.
