TREE REMOVAL FOR PEST & DISEASE

SAWFLY DAMAGE – RODEN STREET, WEST MELBOURNE

Prepared by Tree Dimensions, February 2023

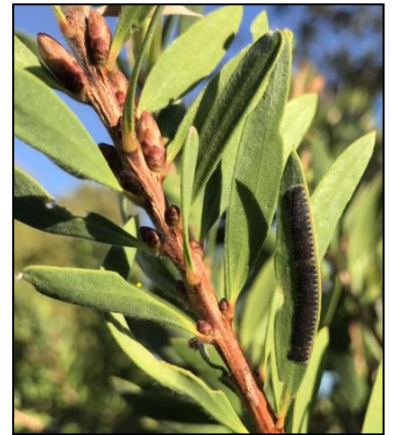
In late summer, the female sawfly uses a 'saw-like' egg-laying tube, called an ovipositor, to cut slits in leaves and stems and then lay eggs.

Image above: A row of black sawfly eggs

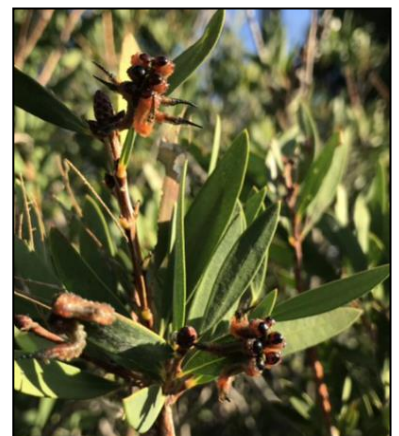
The larvae that emerge from these eggs then feed on the leaves by stripping, or 'skeletonising', them. This intensive feeding stresses the trees because the leaves produce the trees' 'food' in the form of sugar (glucose), by converting sunlight, oxygen and water through the chemical process called photosynthesis.

Image above: Sawfly larvae feeding on leaves

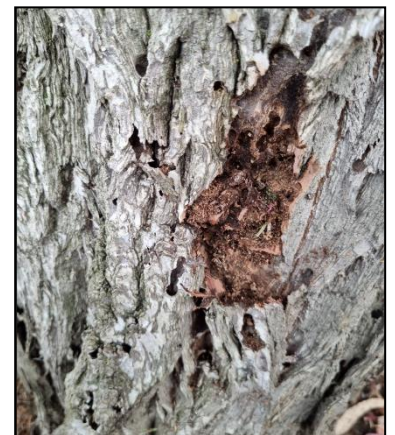
Holes created by wood-boring larvae are apparent on many of the Callistemons on Roden Street. With time, this damage weakens the tree, potentially resulting in broken branches or trunks. In extreme cases, the larvae may even ringbark the tree. The holes also allow the entry of fungal pathogens that can cause decay and further weaken the wood.

Image above: Borer holes and bark damage

As many of the trees have fair to poor structure and may no longer respond well to injuries or stress – including insect damage and pruning – the arborist concluded the trees have a short ULE and should be replaced.

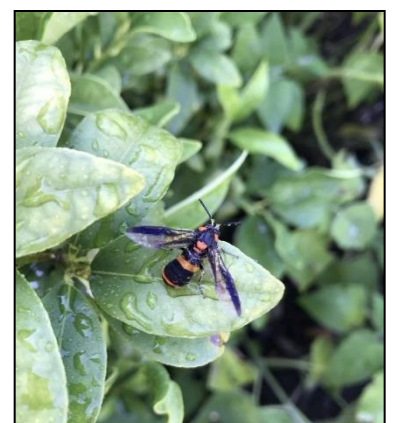
Image above: Sawfly adult
