93 - 103 CLARENDON ST SOUTHBANK

STRUCTURAL ENGINEERING EXPERT EVIDENCE REPORT

2 JULY 2020

PS119550-STR-REP-002(3)

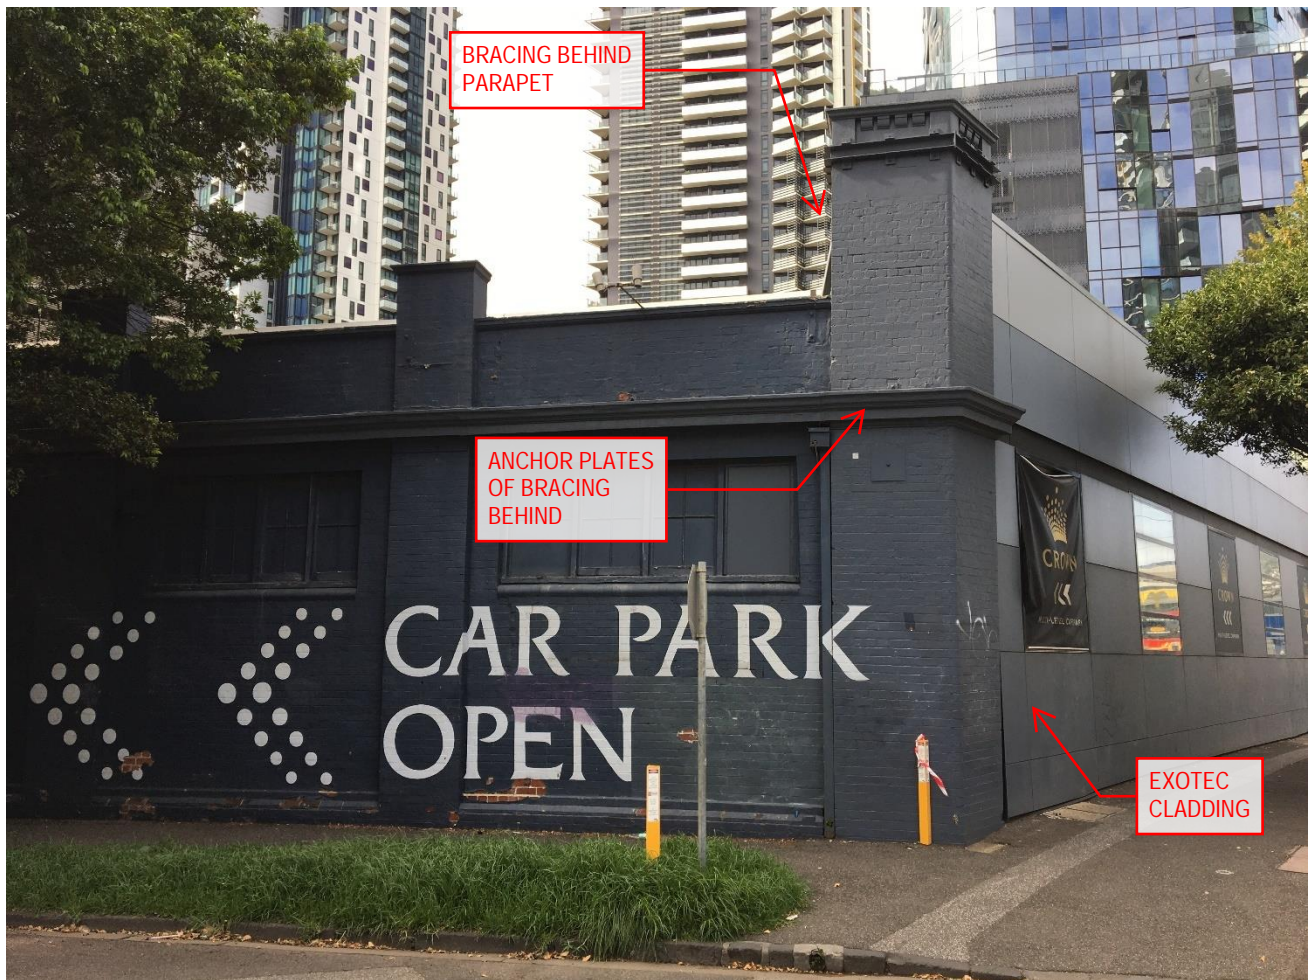
Image 1.1: Corner of Clarendon and Haig St, showing Exotec cladding on Clarendon St.

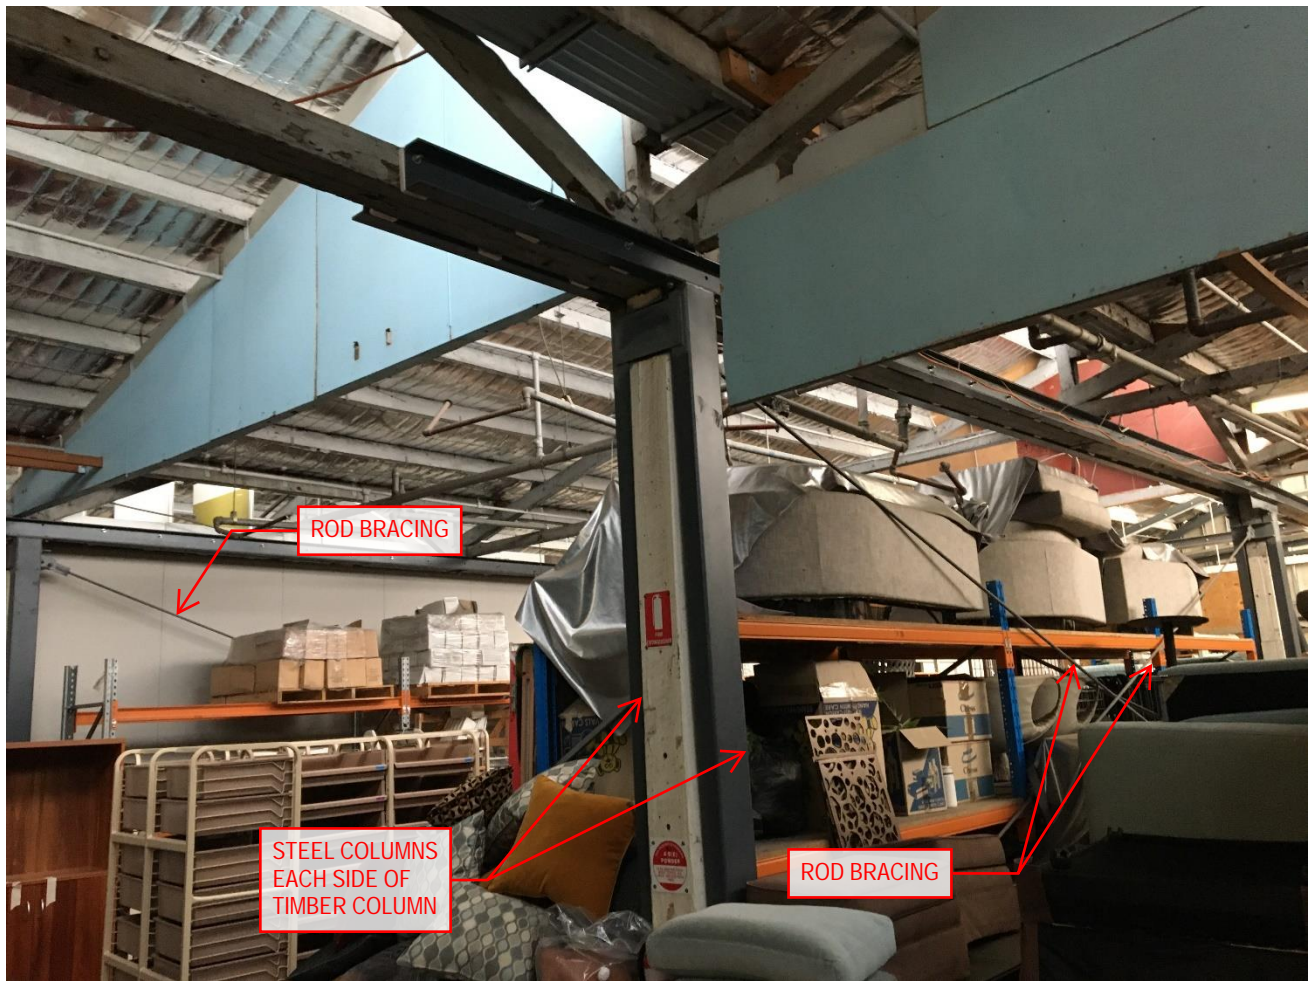
Image 1.2: Steel column strengthening of timber columns, with vertical rod bracing between columns

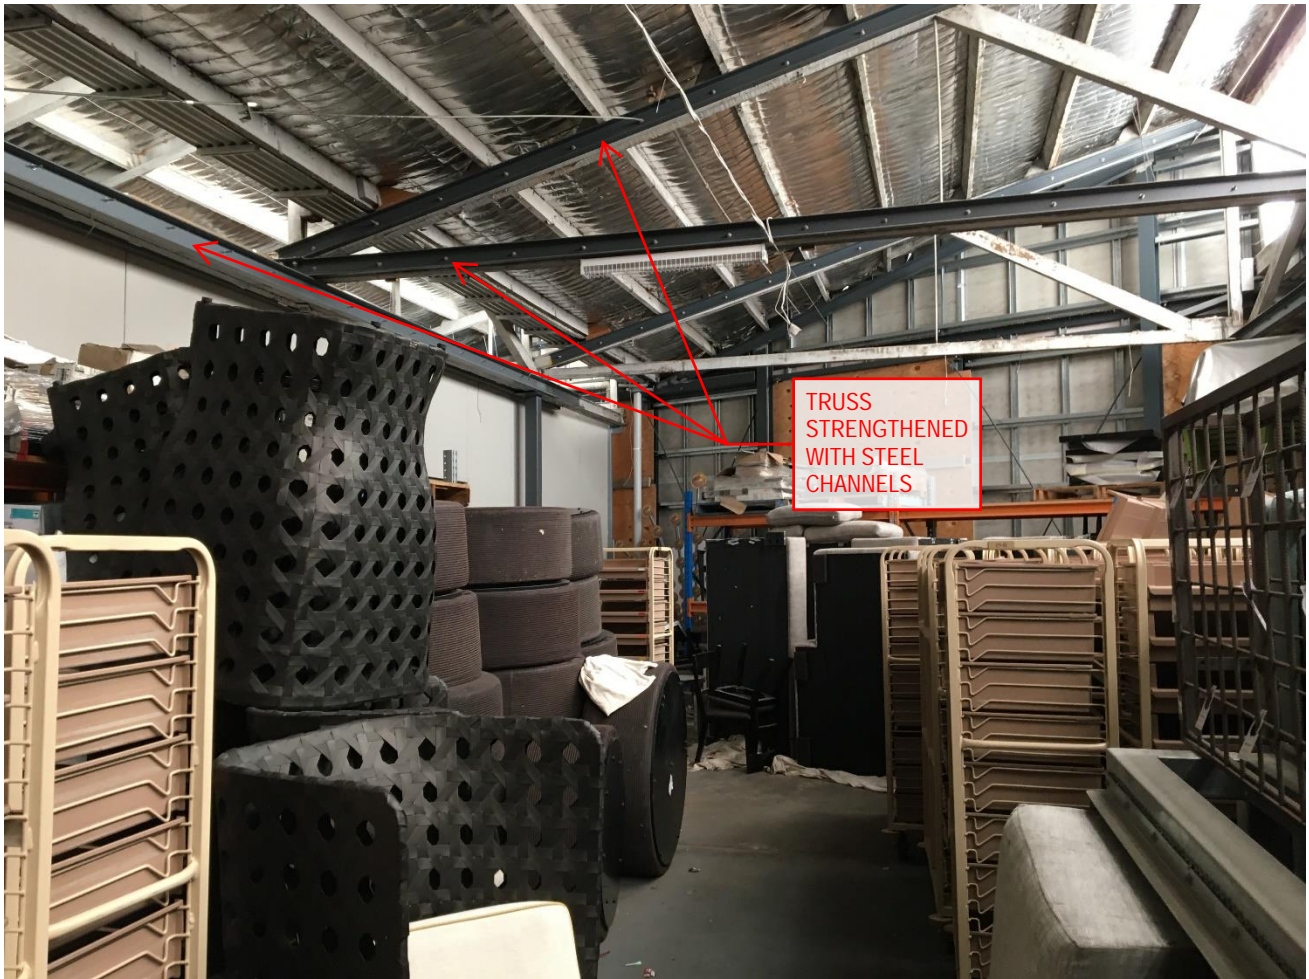
Image 1.3: Timber trusses strengthened with steel channels each side. The Clarendon St steel framed wall in the background.

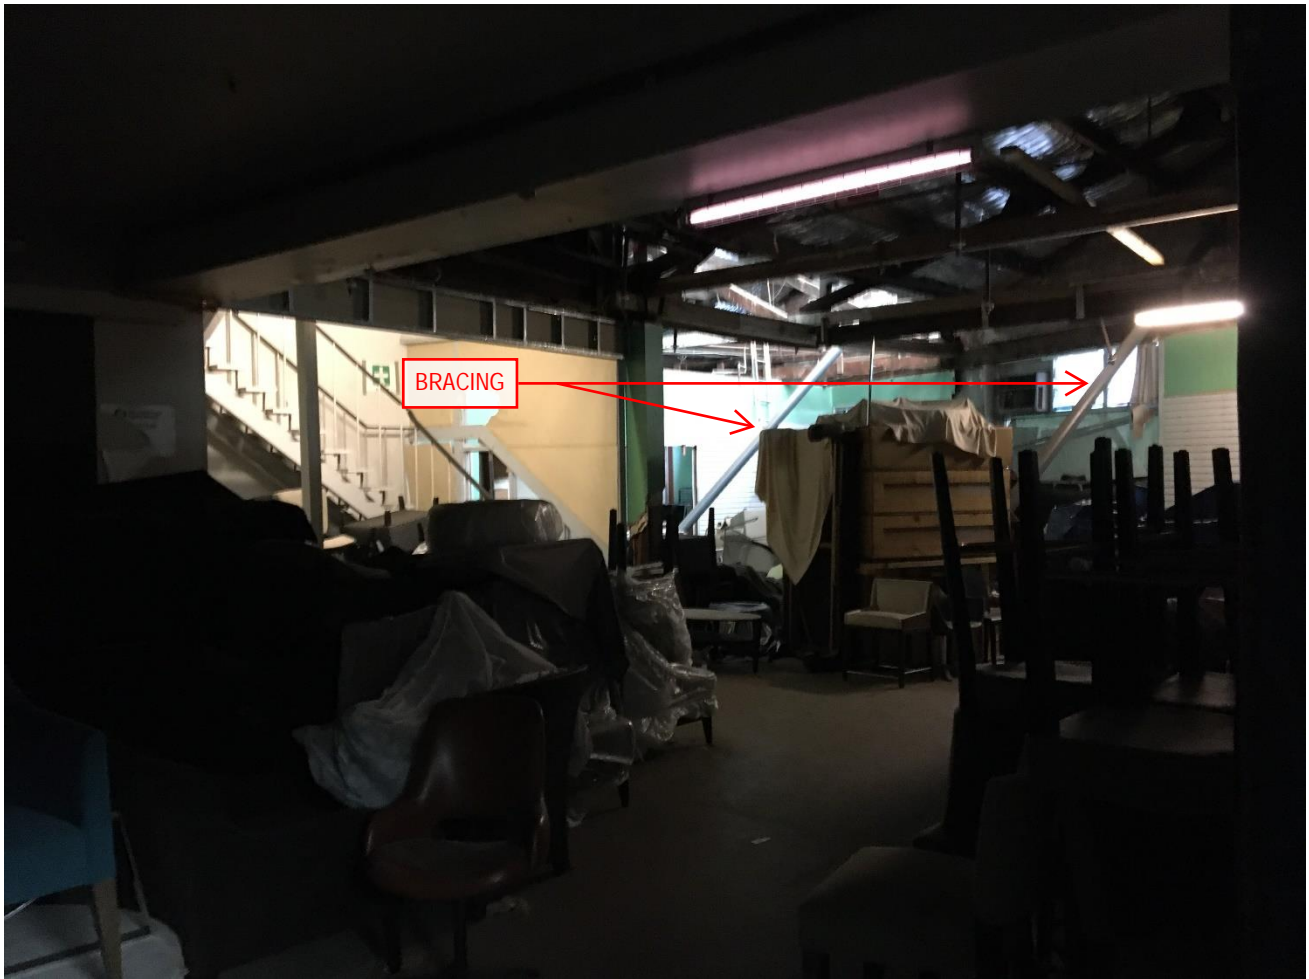
Image 1.4: Bracing of Façade at Corner of Clarendon St and Haig Lane

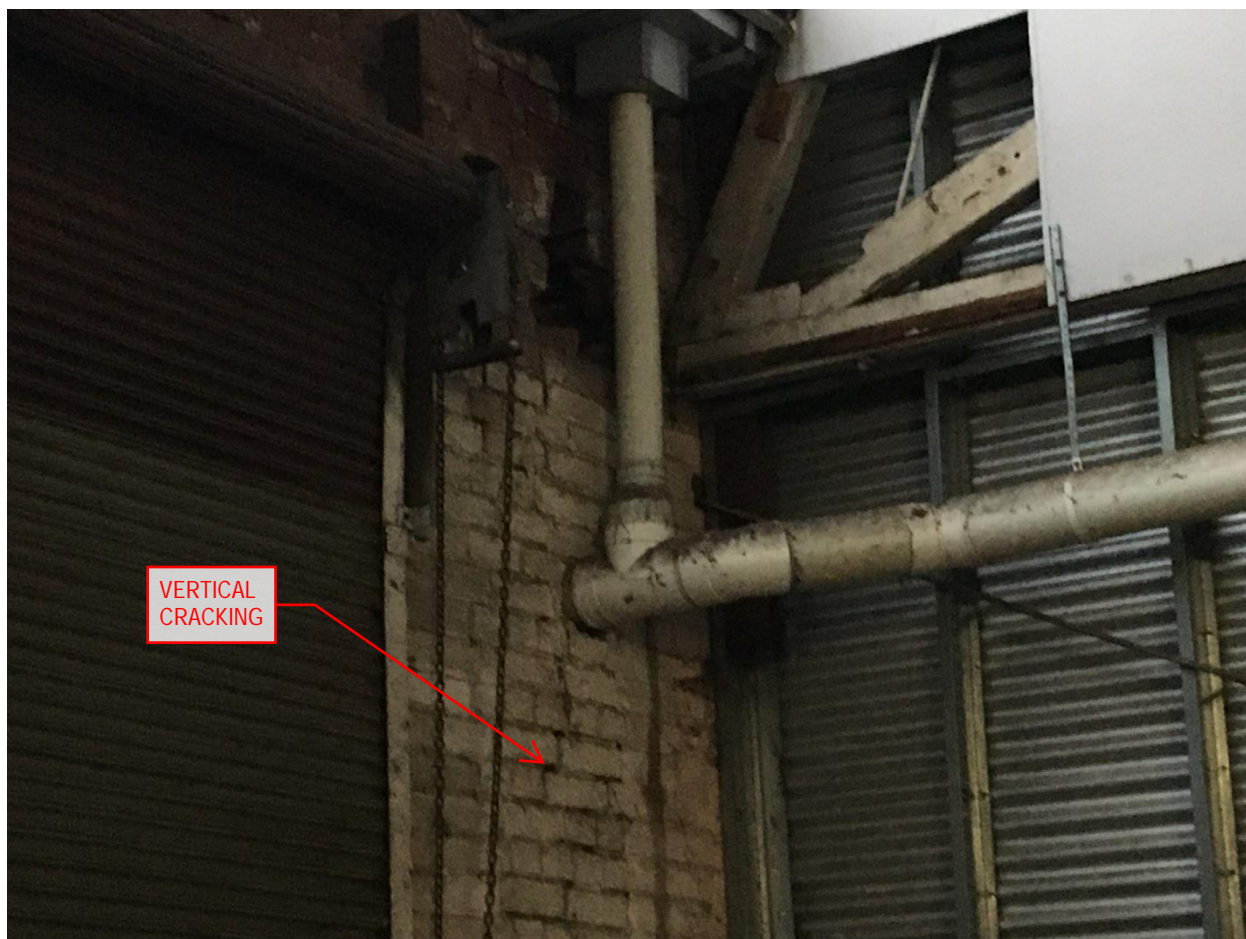
ITEM 1 -VERTICAL CRACKING

Image 2.1: Vertical cracking observed at door lintel, intersection of roof truss and downpipe.

- At locations where masonry has cracked through (items 1,2,3 and 5 of section 2), the brick wall is required to be partially demolished and rebuilt, with new bricks. The damage appears to have occurred locally at the fixing location of the roller door. As the bricks, have cracked, rather than between mortar joints, repointing is not an option. At the time of rectification works the condition of the existing foundation should also be assessed to verify its suitability.

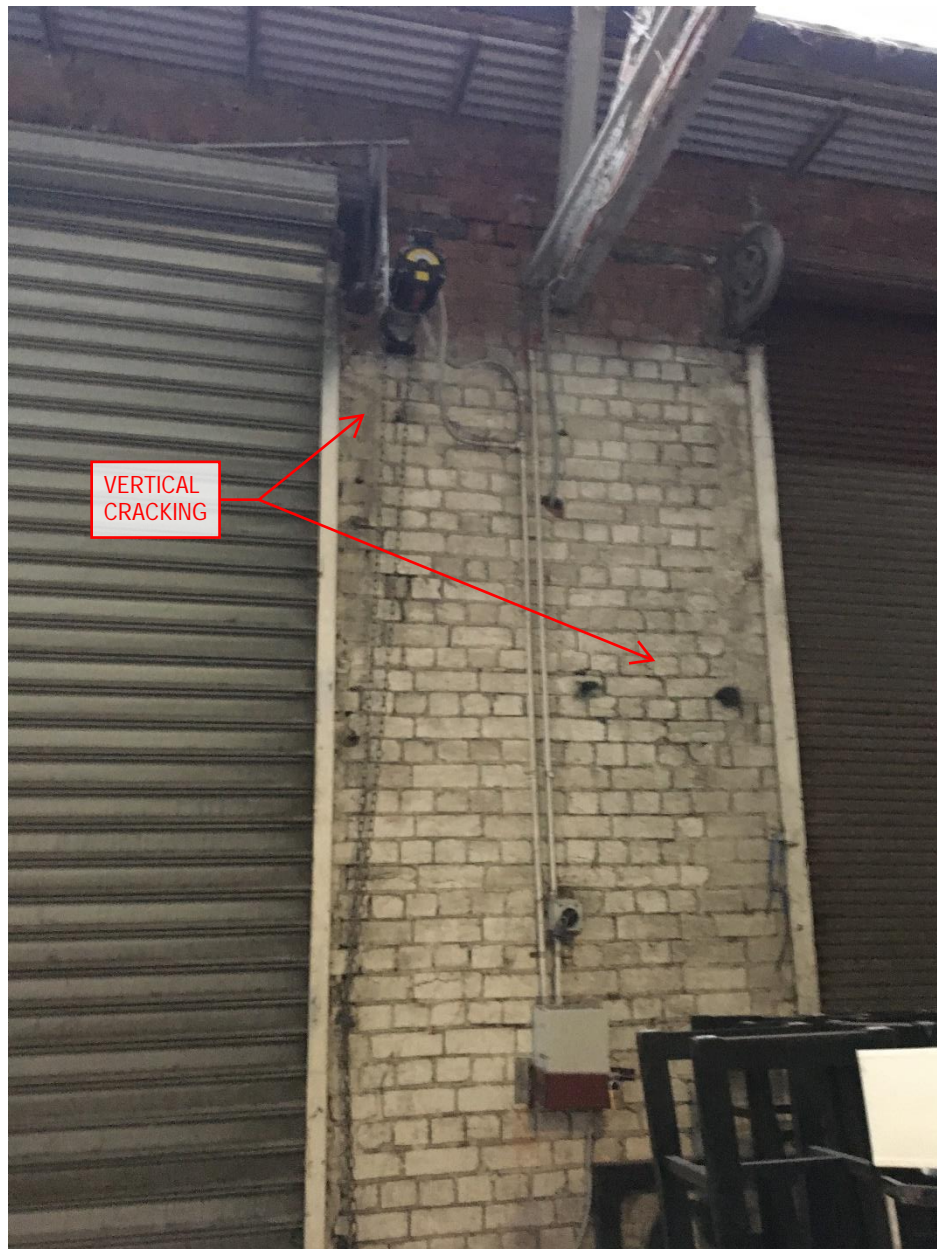
ITEM 2 - VERTICAL AND HORIZONTAL CRACKING

Image 2.2: Vertical cracking in masonry wall at connection to roller door rails. Horizontal cracking above roof truss connection.

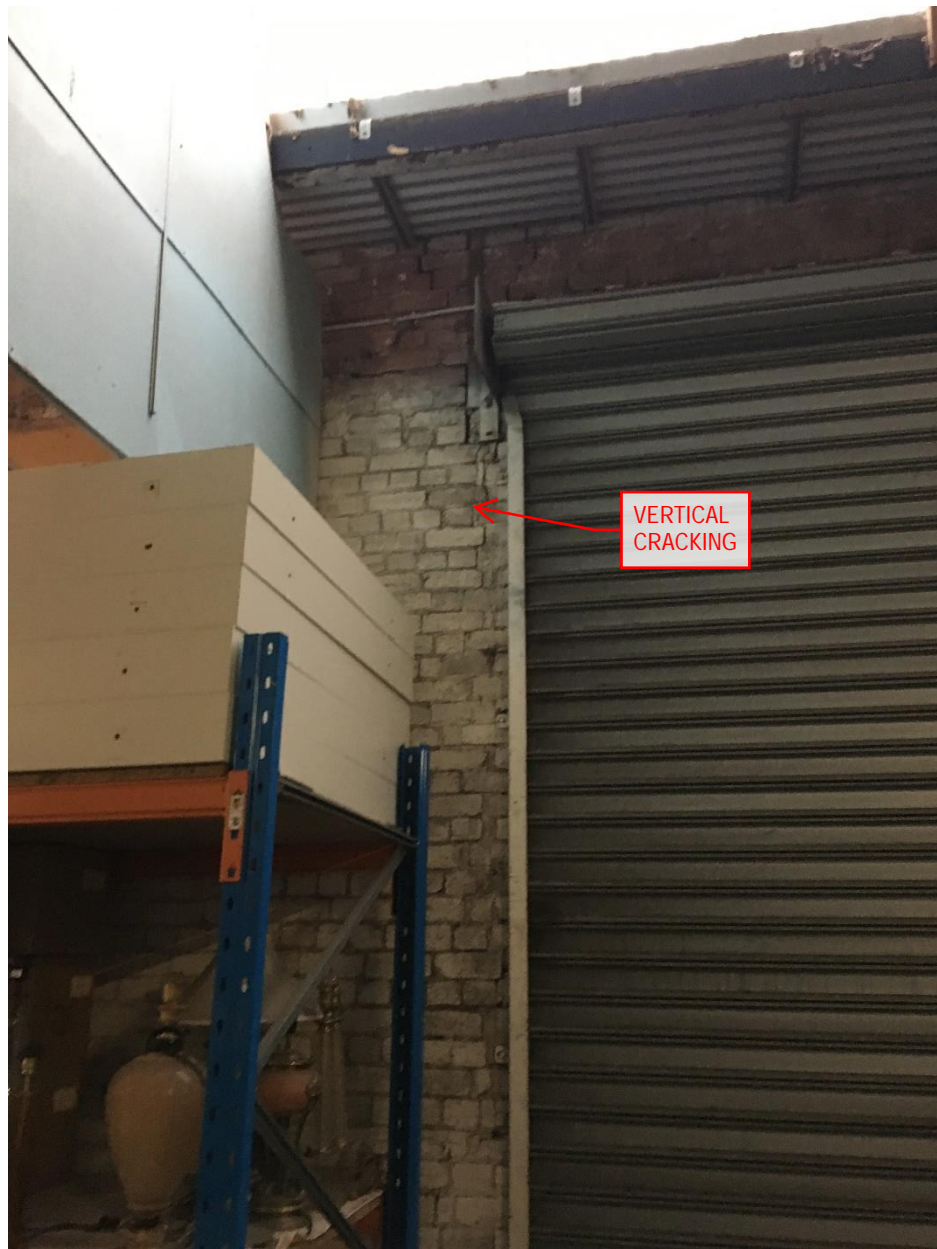
ITEM 3 – VERTICAL CRACKING

Image 2.3: Vertical cracking in masonry wall above and below connection of roller door header. Vertical cracking at connection of roller door rail.

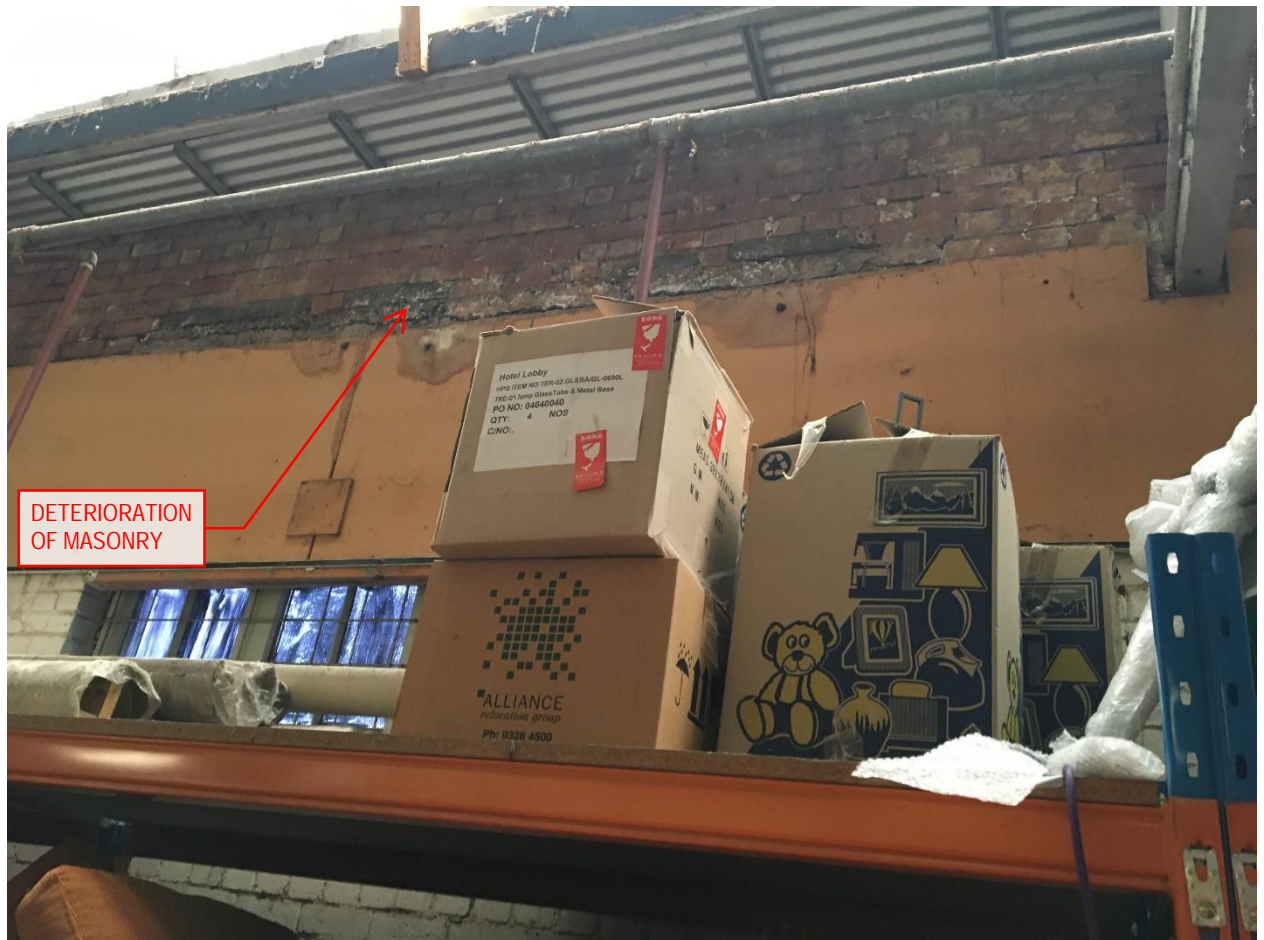
ITEM 4 - MASONRY DETERIORATION

Image 2.4 Significant deterioration of existing masonry above lintels. Horizontal cracking above connection to timber truss.

- At locations where the masonry has deteriorated (item 4 of section 2), the bricks will continue to deteriorate. The bricks require cleaning to assess their current condition. If they are found to be in adequate condition, repointing is required. If the bricks are found to be in poor condition the wall would be required to be partially demolished to approximately the top of the existing window. Satisfactory bricks may be cleaned and used in reconstructing the wall, or replaced with new bricks if the bricks are found to be beyond repair.

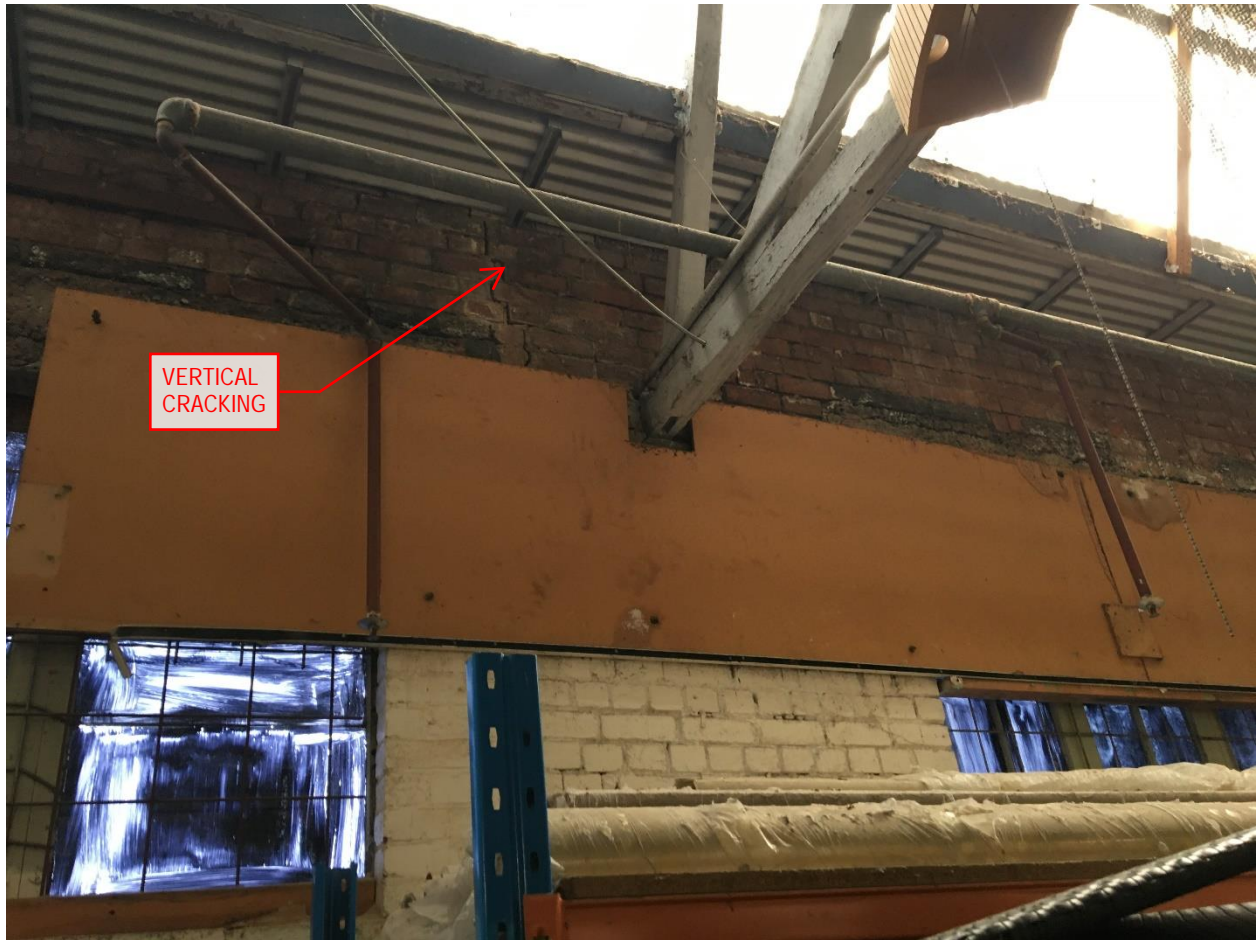
ITEM 5 – VERTICAL CRACKING

Image 2.5: Vertical cracking in masonry above lintels.

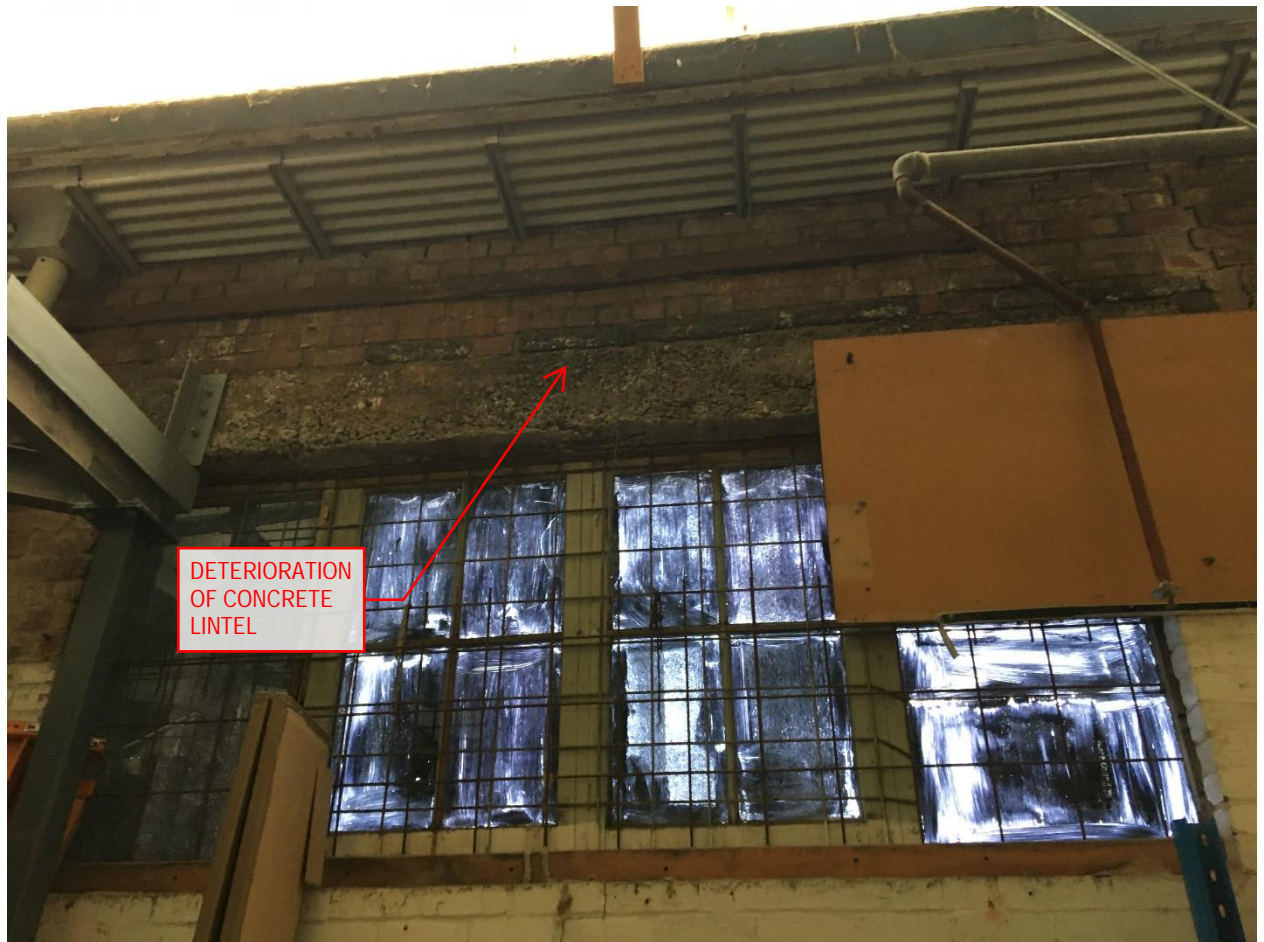
ITEM 6 – DETERIORATION OF CONCRETE LINTEL

Image 2.6: Concrete lintel deterioration

- At locations where the concrete lintel has deteriorated (item 6 of section 2), the concrete will continue to deteriorate. The lintel may be repaired if destructive investigation shows the existing steel reinforcement is in sound condition. If the reinforcement has corroded such that it is compromised the lintel is to be replaced. Destructive investigation would involve the use of a small jack hammer, or heavy duty hammer drill to break out the concrete and expose the reinforcement. The long term integrity of the lintel is uncertain.

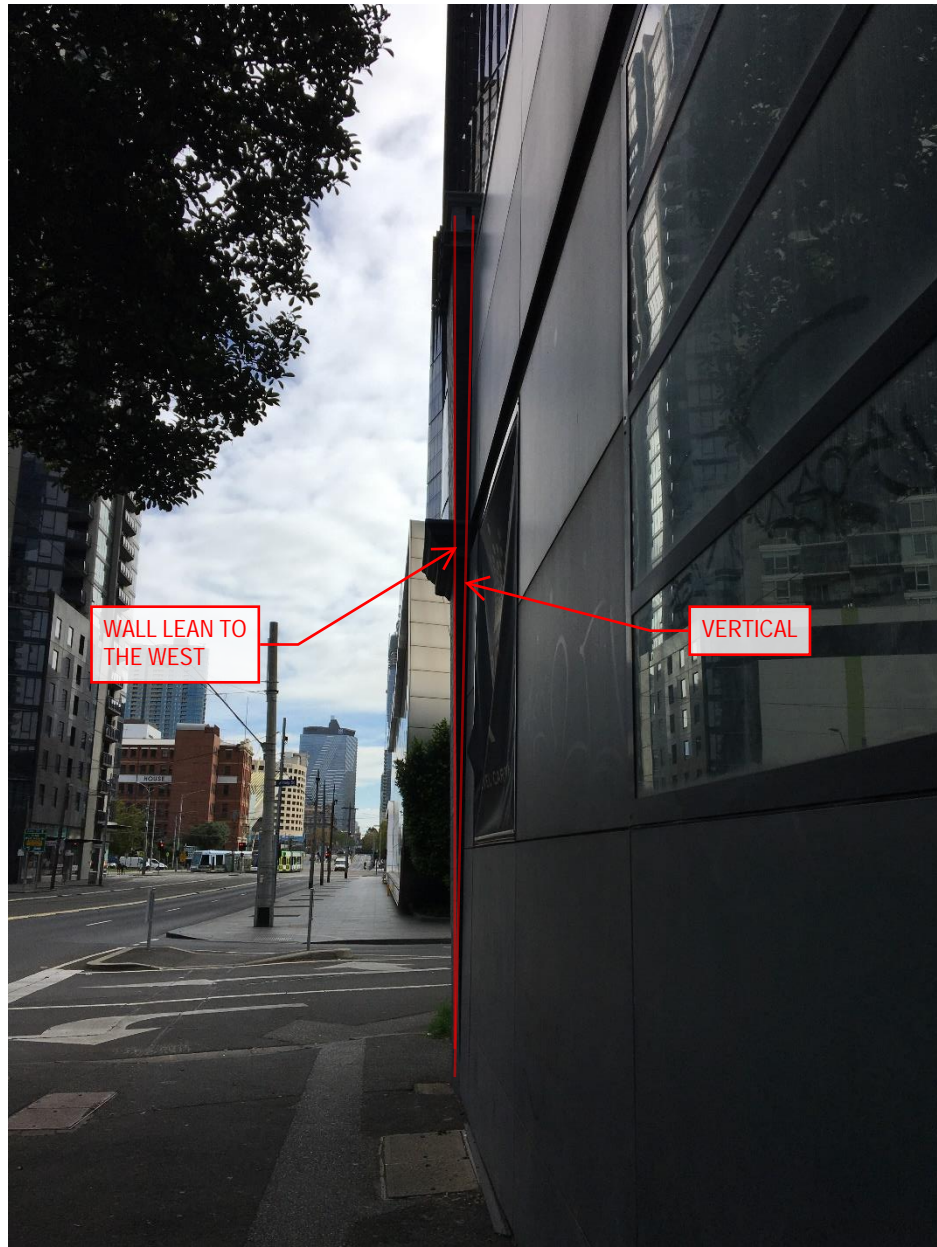
ITEM 7 MASONRY WALL SIGNIFICANTLY LEANING

Image 2.7: The masonry façade wall at the corner of Clarendon and Haig Street leans approximately 2 degrees to the west.

- The eastern end of the wall is leaning significantly to the west (item 7 of section 2) and has stepped out, so that the wall is not vertical (item 17 of section 2). It is likely this is due to settlement of the existing shallow foundation, and/or inadequate ties to the permanent structure. It is currently braced internally to resist further movement.

It may be possible to retain this section of wall with intrusive underpinning, jacking and repair works to the existing foundation. These works would likely cause significant cracking of the masonry which would then require repointing. Alternatively, the bricks at this corner appear in sound condition and may be reused if the wall was to be demolished and rebuilt.

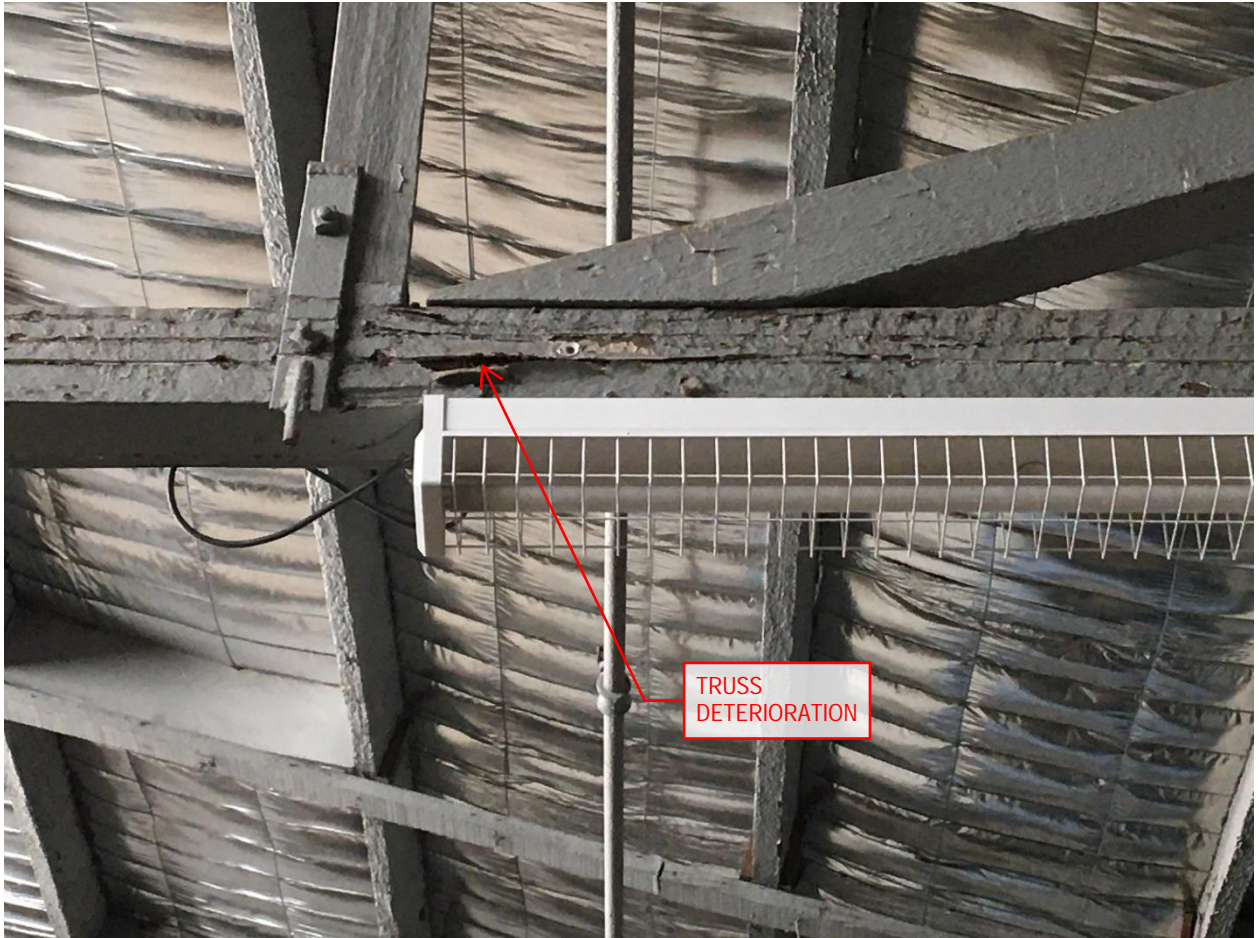
ITEM 8 - MINOR DETERIORATION OF TIMBER TRUSS

Image 2.8: Minor deterioration of timber truss within the western store room

Minor levels of deterioration of a timber truss were observed in the western store room. The deterioration is minor however, requires rectification. Refer to item 8 of section 2. The truss may be repaired by steel channels, similar steel rectification details, or the damaged section of timber may be locally replaced.

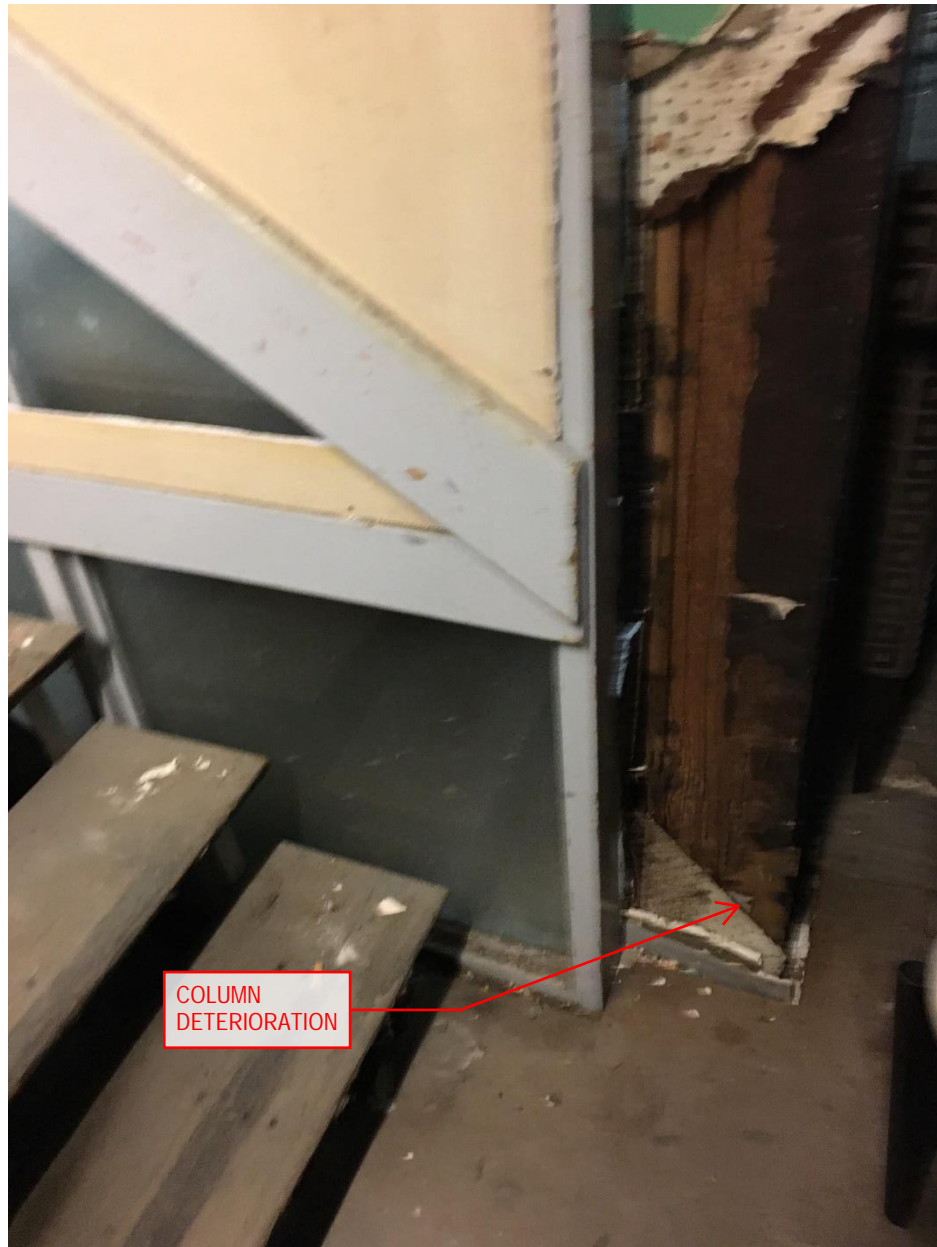
ITEM 9 - DETERIORATION OF TIMBER COLUMN.

Image 2.9: The existing timber column at the base of the stairs to the first floor has significantly deteriorated. The damage requires repair in the short term.

The timber post is significantly damaged and requires repair in the short term. Refer to item 9 of section 2. Rectification could be completed by splicing in new steel columns, similar methods used in the main store, or completely replaced.

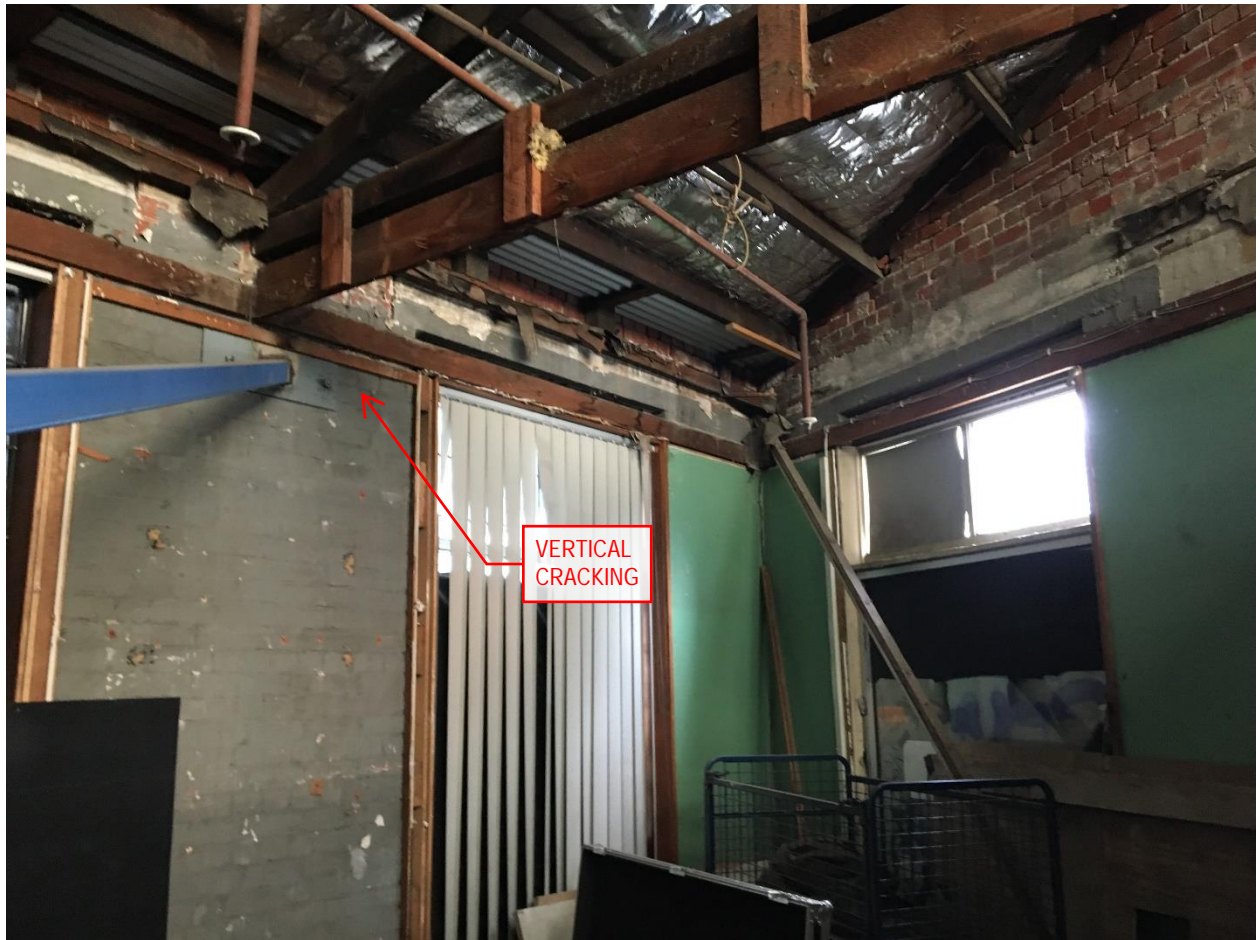
ITEM 10: VERTICAL CRACKING

Image 2.10: Minor vertical cracking adjacent to steel brace. Internal view of item 12.

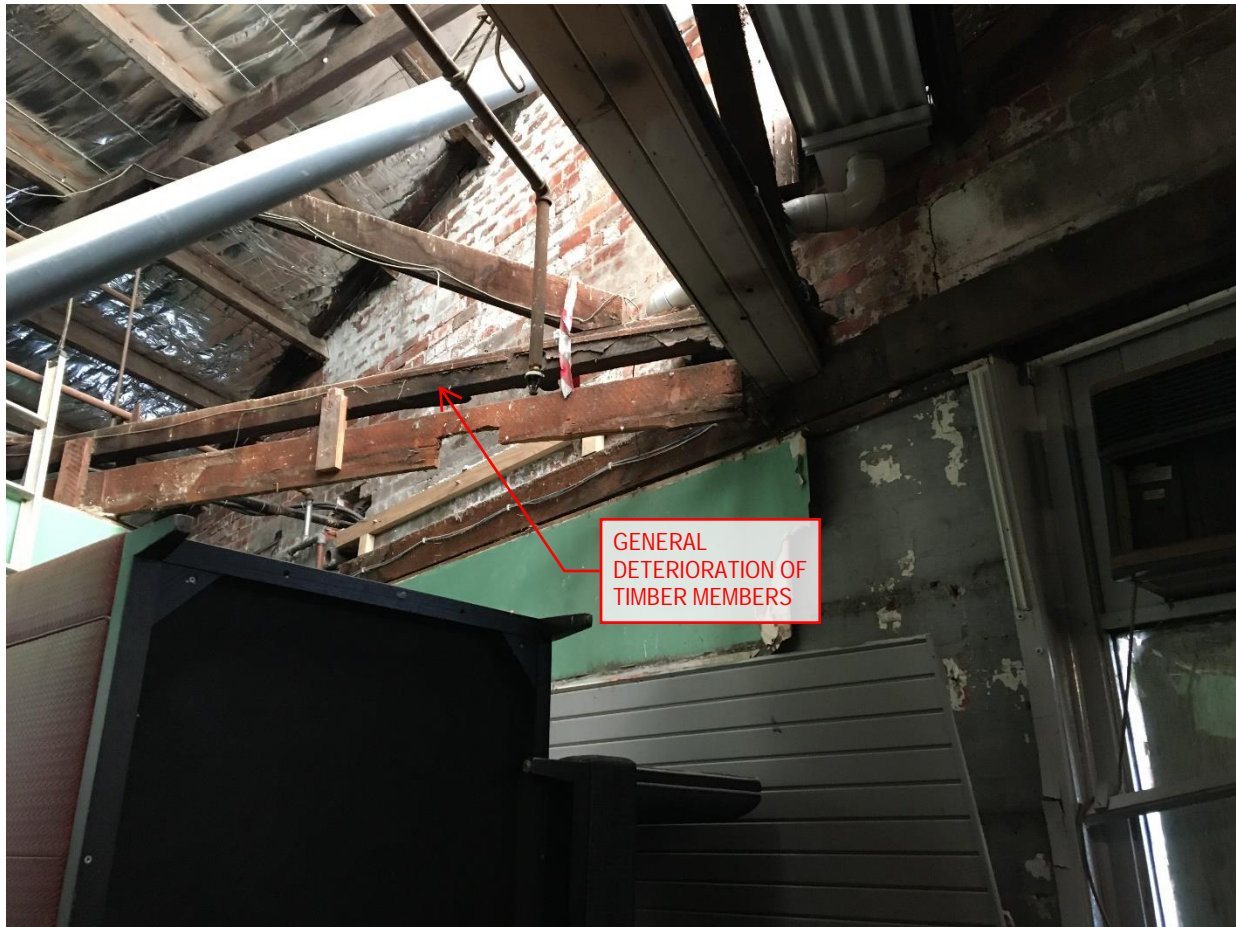
ITEM 11: SOUTHERN STORE TIMBER DETERIORATION

Image 2.11: Southern Store timber truss deterioration.

The existing timber trusses in the southern store room are in moderate condition. Some timber members appear to have been modified during previous building works. Refer to item 11 of section 2. To retain the trusses in the long term, minor investigative works would be required to expose all the timber and ensure the members have not been damaged by water or pests.

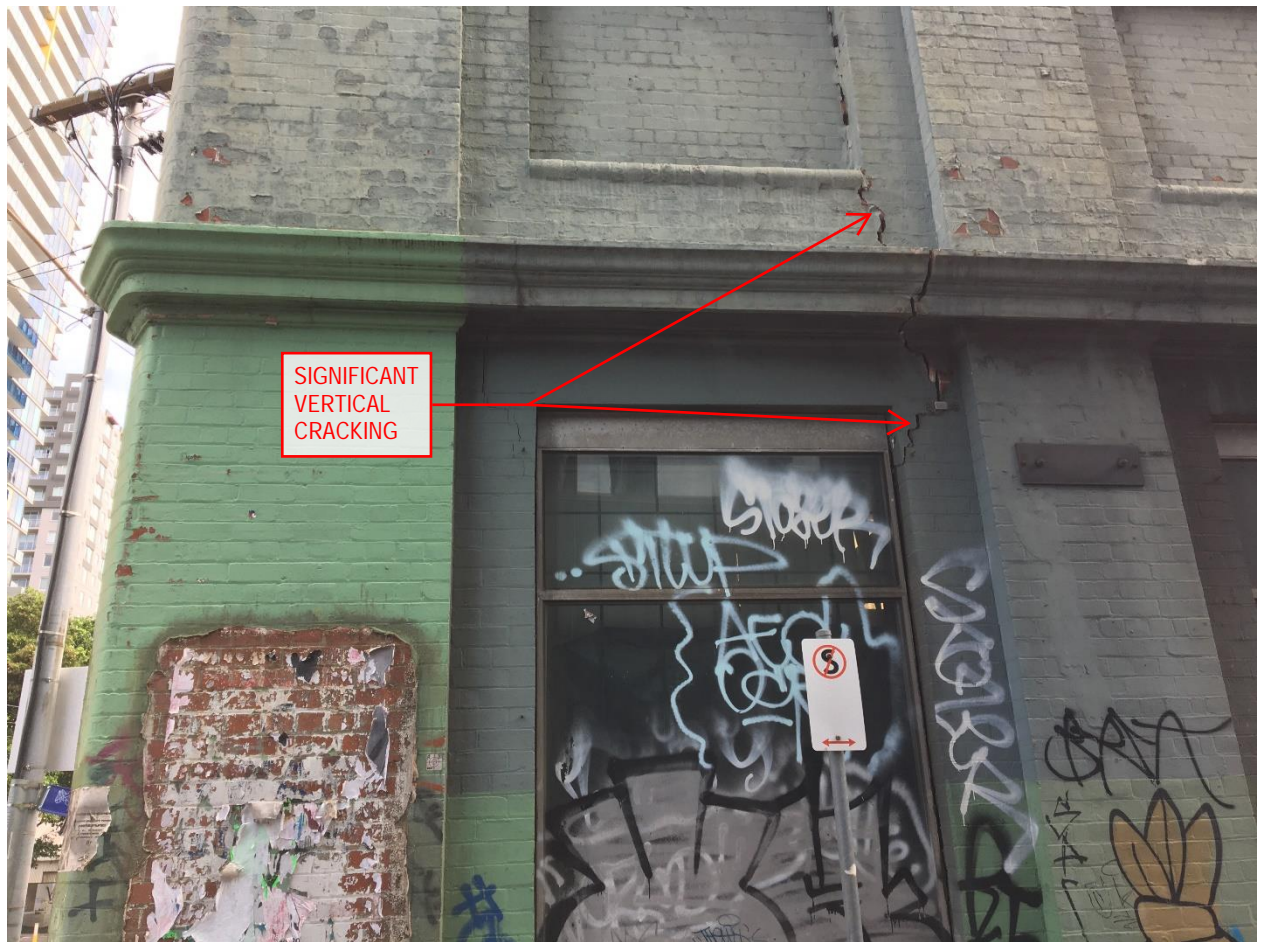
ITEM 12 – SIGNIFICANT VERTICAL CRACK

Image 2.12: Significant vertical cracking to the masonry façade. Outward lean of the wall, which is braced behind.

The Haig Ln masonry façade has suffered significant cracking, likely due to differential settlement of existing shallow foundations. Refer to item 12 of section 2. The integrity of the wall has been compromised, and repair is required in the short to medium term. The cracking is currently being monitored, as evident from the crackmeters and survey points fixed to the façade, and should continue indefinitely, until a permanent repair is completed.

This façade is significantly damaged, and beyond repair without partial demolition and rebuilding. The existing bricks generally appear to be in sound condition, and may be used in rebuilding the wall, subject to on site confirmation.

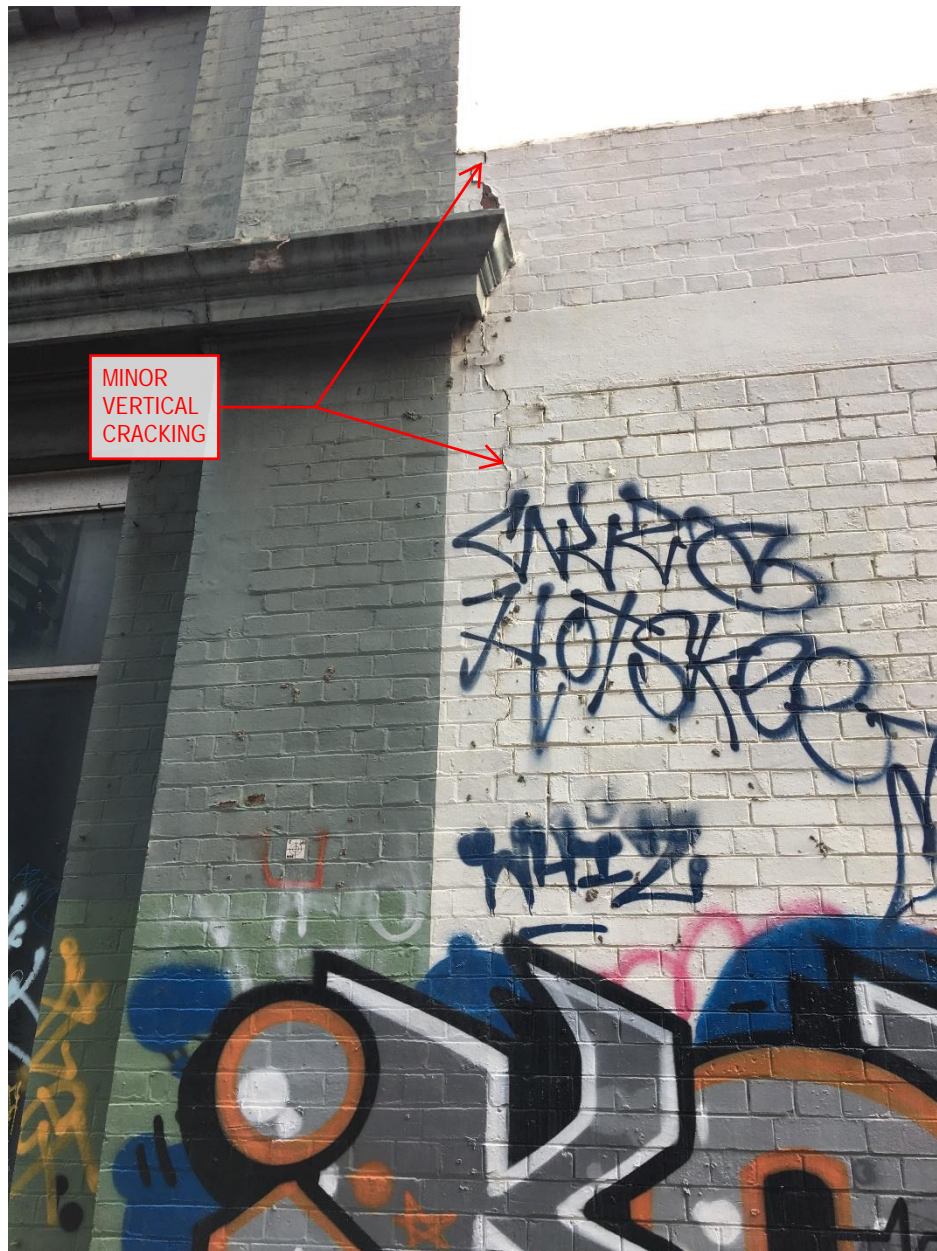
ITEM 13 – VERTICAL CRACKING

Image 2.13: Minor vertical cracking at the transition in parapet heights

Localised sections of deterioration and cracking were observed in the Haig Lane Façade. Refer to item 13 and 14 of section 2. The identified cracking requires rectification in the medium term. Rectification works would be relatively minor such as repointing, and locally replacing any damaged bricks. The wall may experience ongoing settlement typical to shallow foundations found in Coode Island silt.

The retrofit bracing is required to stay in place following any rectification works. Any modifications to the main building would be required to maintain an equivalent or better level of bracing to this façade.
