93 - 103 CLARENDON ST SOUTHBANK

STRUCTURAL ENGINEERING EXPERT EVIDENCE REPORT

2 JULY 2020

PS119550-STR-REP-002(3)

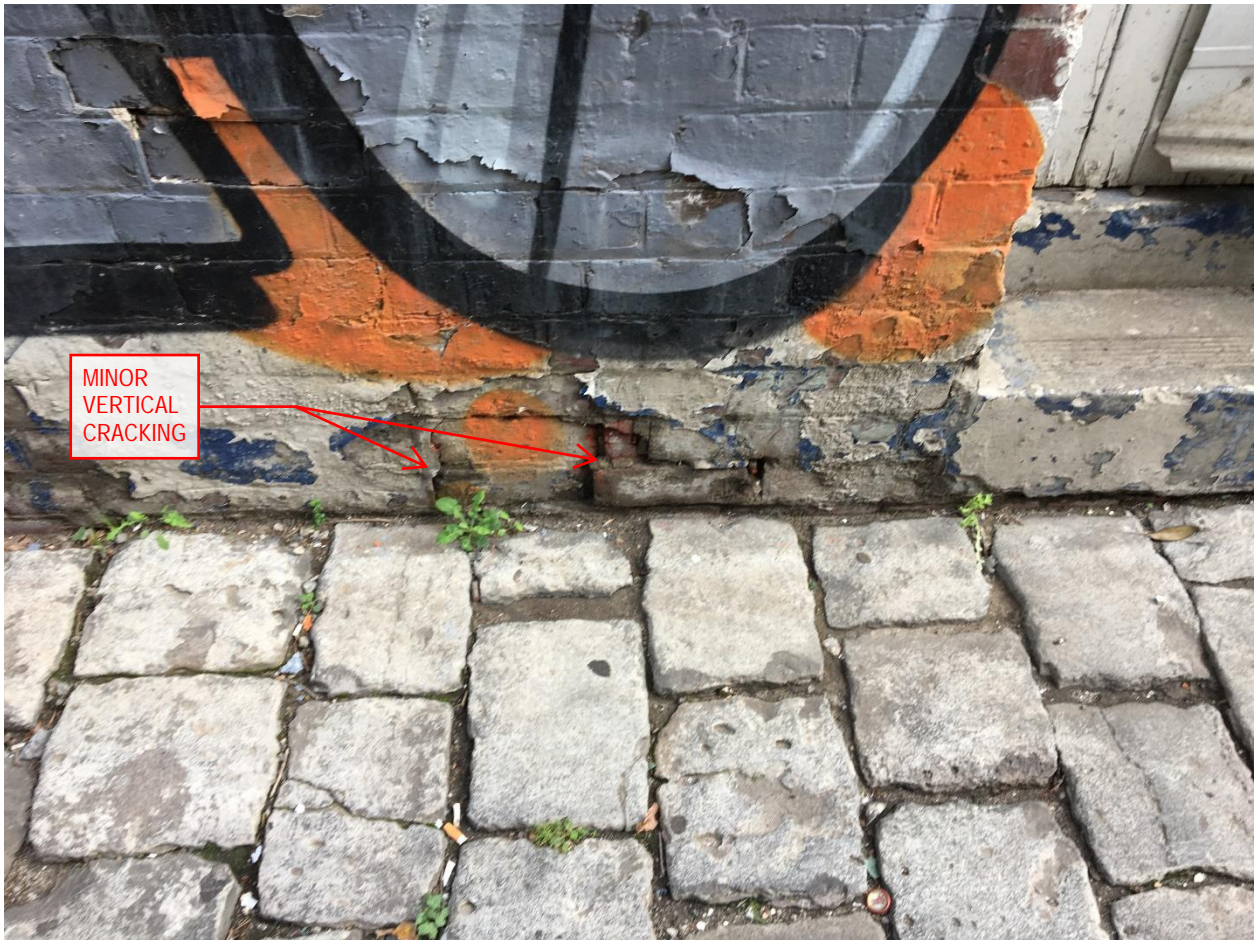
ITEM 14 – MINOR CRACKING

Image 2.14: Minor cracking in masonry mortar joints.

Localised sections of deterioration and cracking were observed in the Haig Lane Façade. Refer to item 13 and 14 of section 2. The identified cracking requires rectification in the medium term. Rectification works would be relatively minor such as repointing, and locally replacing any damaged bricks. The wall may experience ongoing settlement typical to shallow foundations found in Coode Island silt.

The retrofit bracing is required to stay in place following any rectification works. Any modifications to the main building would be required to maintain an equivalent or better level of bracing to this façade.

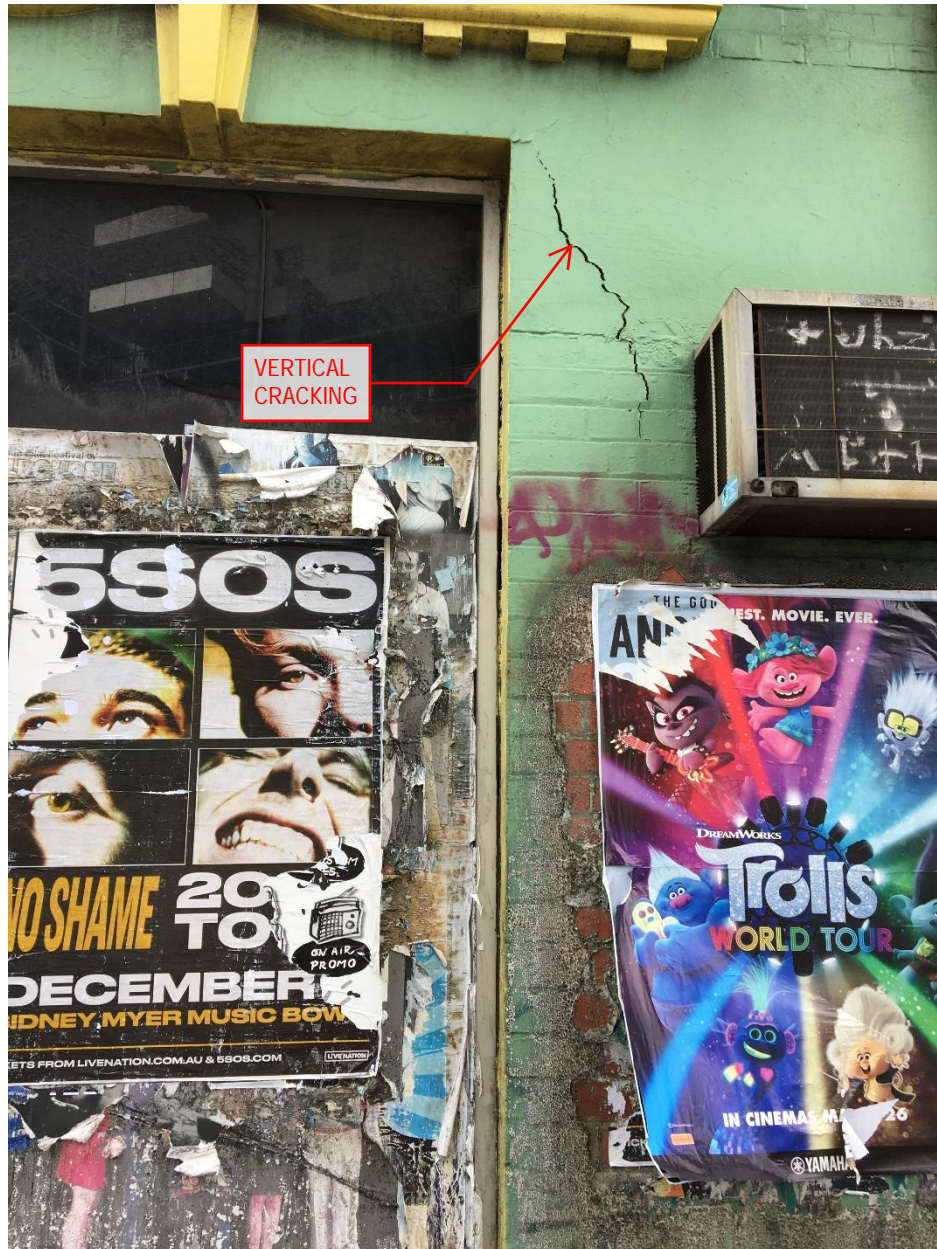
ITEM 15 - CRACKING AT LINTEL

Image 2.15: Cracking in masonry and mortar joints below a lintel.

Localised sections of deterioration and cracking were observed in the Clarendon St Façade. Refer to item 15 of section 2 item. The identified cracking requires rectification in the medium term. Rectification works would be relatively minor such as repointing. The wall may experience ongoing settlement typical to shallow foundations found in Coode Island silt.

The retrofit bracing is required to stay in place following any rectification works. Any modifications to the main building would be required to maintain an equivalent or better level of bracing to this façade.

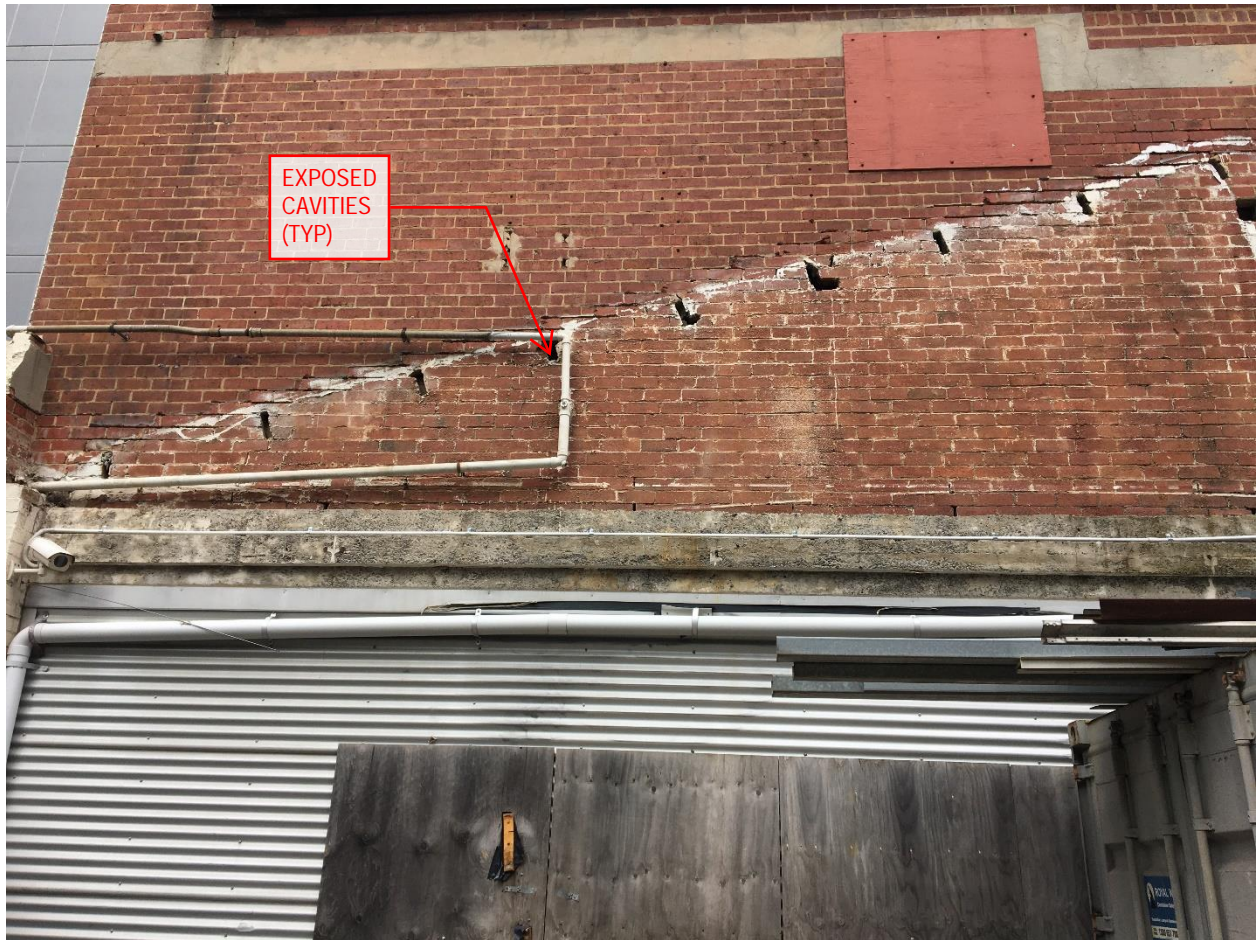
ITEM 16 – EXPOSED CAVITIES

Image 2.16: Exposed cavities in masonry due to demolition of adjacent structure

Cavities in the existing masonry façade are present. Refer to item 16 of section 2. The cavities require filling in the medium term to prevent water ingress which may lead to deterioration. The cavities could be filled with mortar, flashed over, or by keying new bricks into the existing wall.

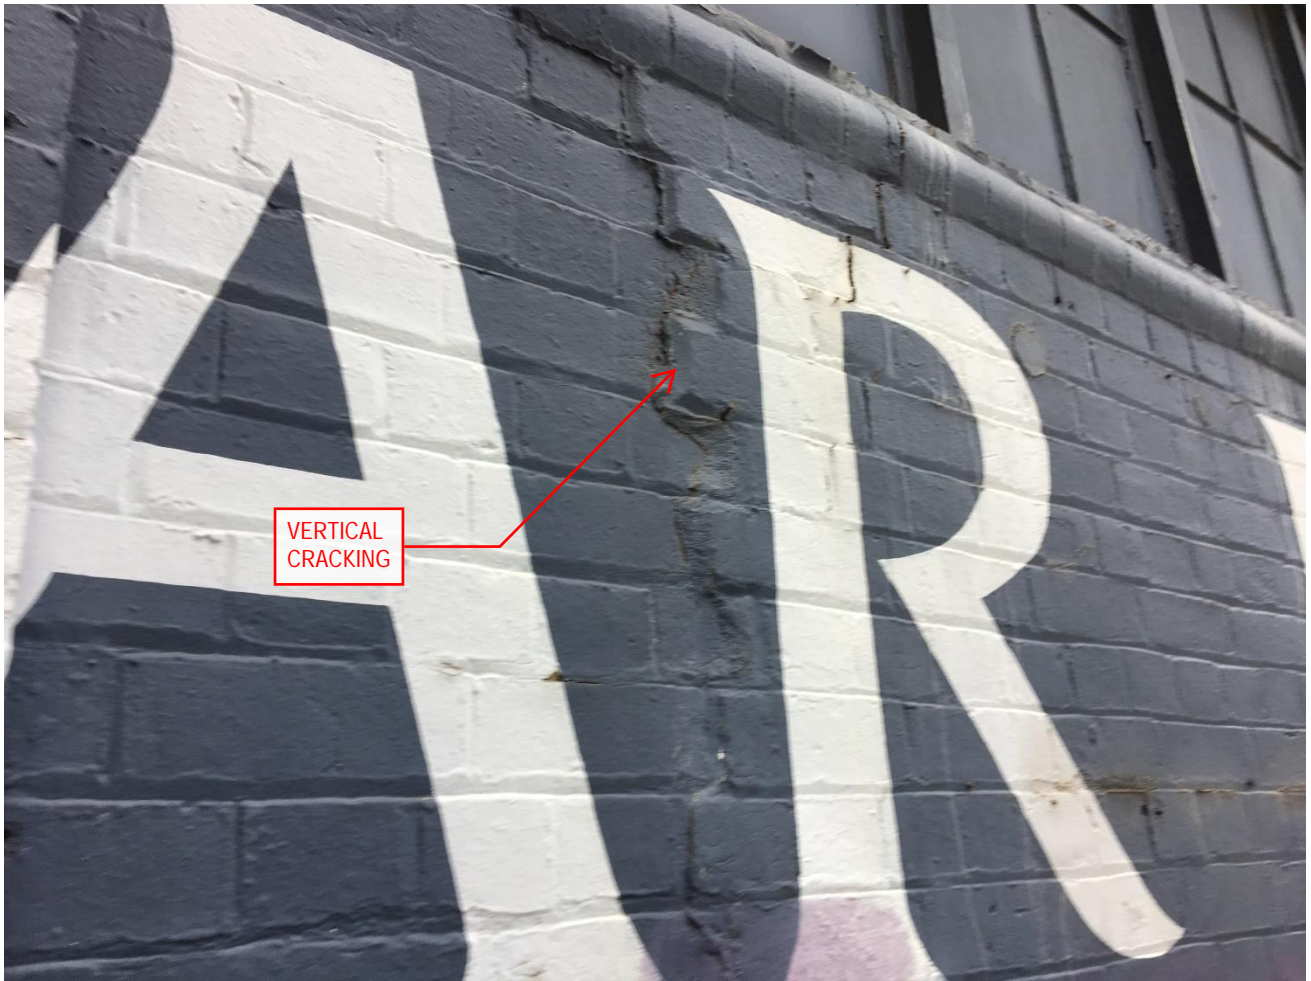
ITEM 17 – VERTICAL CRACKING

Image 2.17: Vertical cracking/step out of masonry façade.

- The eastern end of the wall is leaning significantly to the west (item 7 of section 2) and has stepped out, so that the wall is not vertical (item 17 of section 2). It is likely this is due to settlement of the existing shallow foundation, and/or inadequate ties to the permanent structure. It is currently braced internally to resist further movement.

It may be possible to retain this section of wall with intrusive underpinning, jacking and repair works to the existing foundation. These works would likely cause significant cracking of the masonry which would then require repointing. Alternatively, the bricks at this corner appear in sound condition and may be reused if the wall was to be demolished and rebuilt.

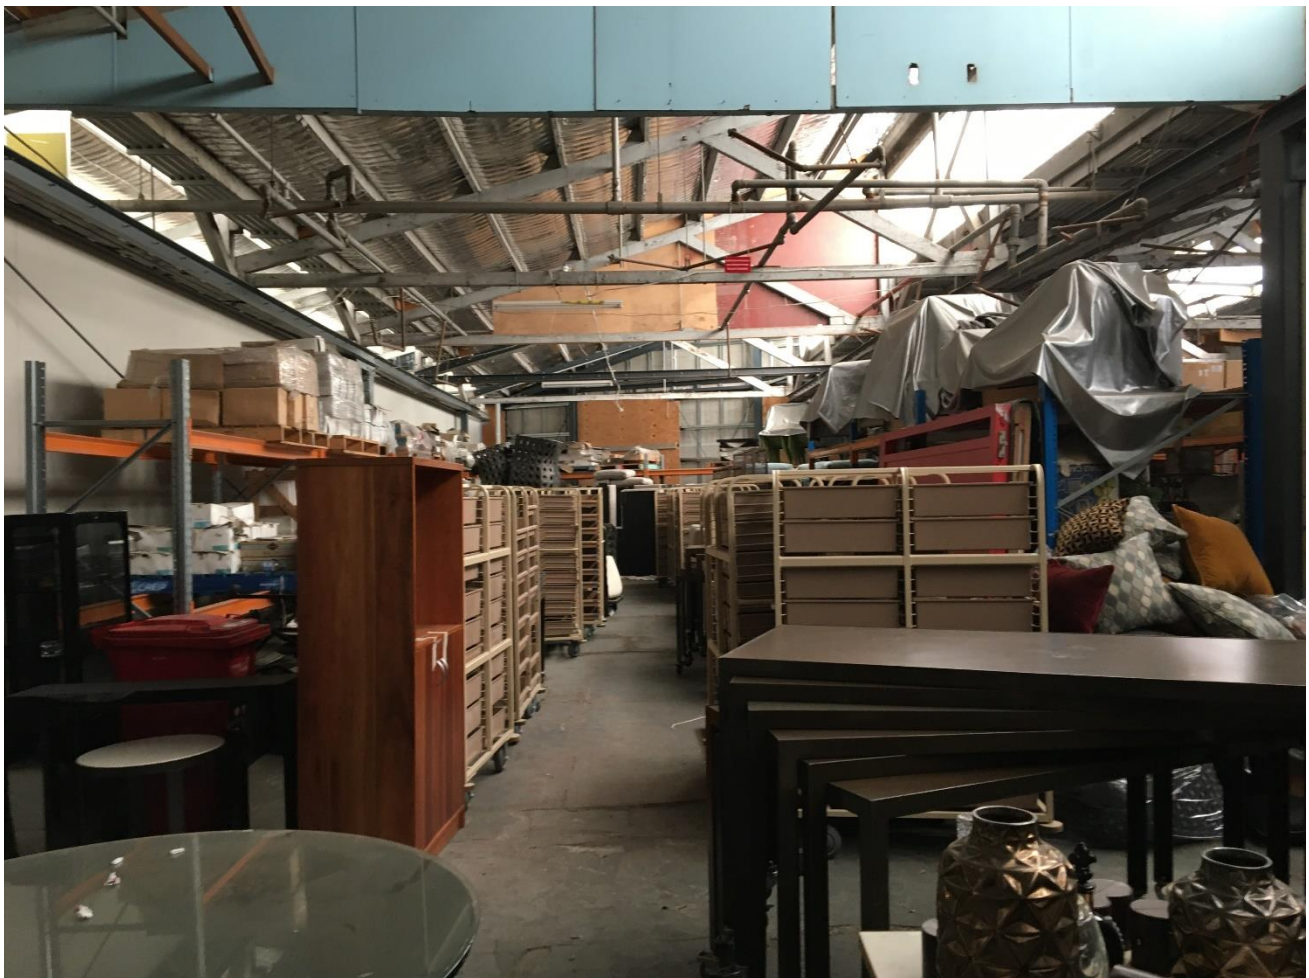
Figure 3.1: Main warehouse timber trusses

The existing saw tooth timber roof trusses in the main warehouse, excluding those already strengthened, are generally in adequate condition. The paint appears to be deteriorating but does not affect the structure.

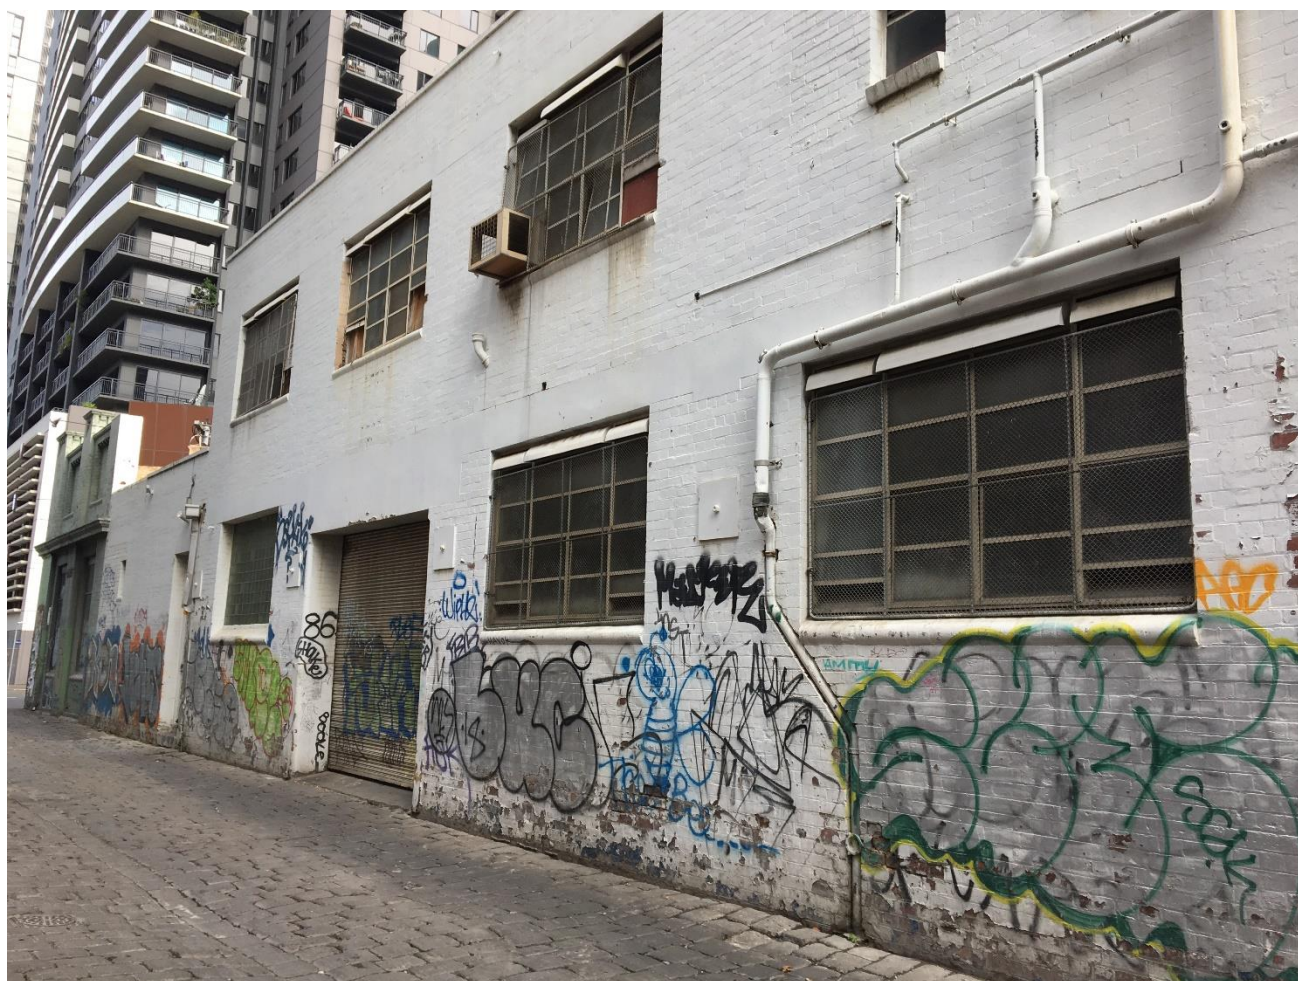
Figure 3.2: Haig Lane two story facade

The existing load bearing masonry wall is generally in adequate condition. The wall will likely experience ongoing settlement typical to shallow foundations found in Coode Island silt. This is not feasible to prevent and will likely result in increased distress over time.
