Amendment C320
160 Leicester Street, Carlton

Heritage Report

January 2018

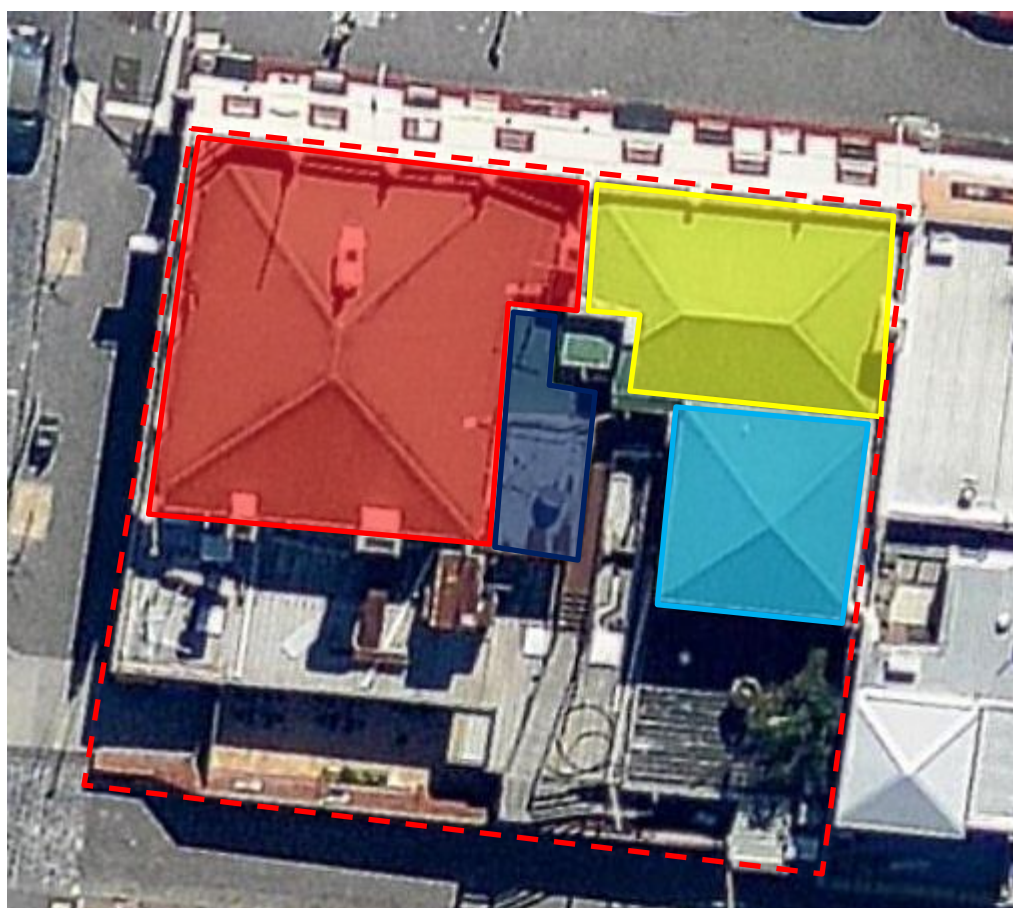
Aerial showing key phases of development (site boundary dashed)

Phase 1 – red, 1856

Phase 2 – yellow, later 19th century, possibly 1860

Phase 3 – dark blue, 1923

Phase 4 – light blue, 1936

Note rear parts, post 1954

It is known that the front part of the hotel was constructed in two principal stages during the 19th century, and so dates to the Victorian period:

- 1856/57 - the larger western corner.
- by 1895, though possibly as early as 1860¹⁴ – the smaller eastern part. The difference in the window detailing between the two parts along the northern elevation (Pelham Street) suggests that a larger time frame may have ensued than a mere 3 years.

The next major development phase was during the Interwar Period when two storey sections were built to the central and eastern part to the rear. These sections had survived prior to the demolition and there are original drawings (and so are well documented). The tiled dado to the exterior, which survived but had been overpainted, was likely introduced at this stage. A section of this dado has survived intact on the eastern party wall.

- 1923 – small central section, kitchen and bathroom. Internal alterations to the earlier parts also undertaken. It is likely that the entry at the western end of the north elevation was introduced at this time.
- 1936 – larger eastern section, kitchen and bedrooms. Some internal changes to the original sections. The eastern party wall survives *in situ*.

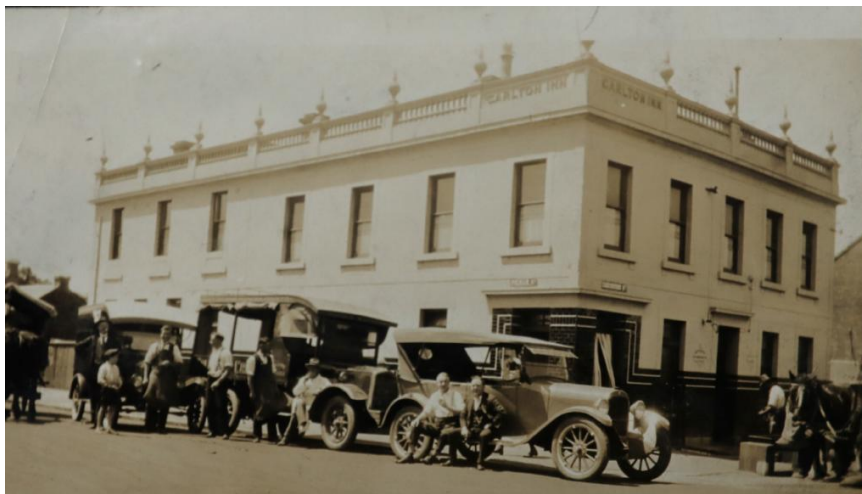
Earliest photograph of Carlton Inn, circa 1940s
(Source: *Herald Sun*, 23 October 2016, np)

Externally, the front part of the building had remained largely intact prior to its substantial demolition. The primary changes had been some modifications to the pattern of openings and the introduction of the tiled dado (during the Interwar period, a common alteration to hotels at that time).

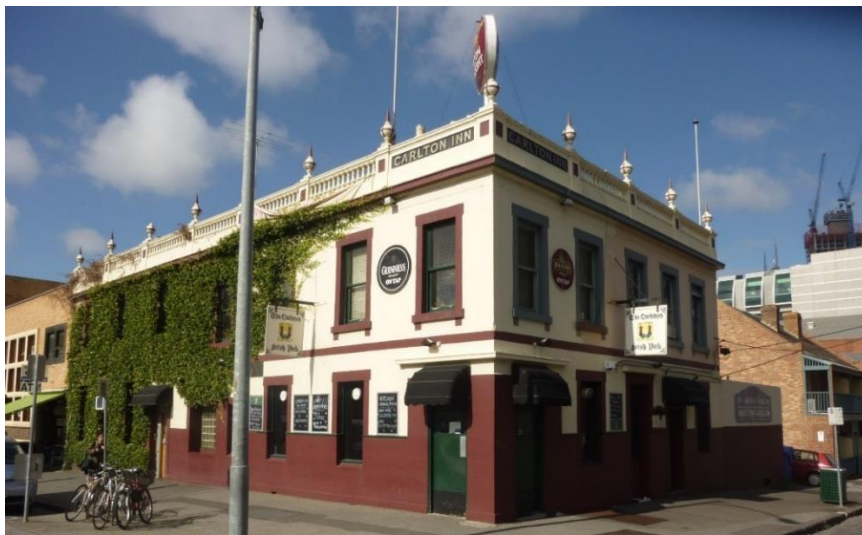
Carlton Inn, mid-2011
Comparison with the earlier photograph shows that it was largely intact to its earlier 20th century appearance
NB the tiled dado had been painted over
(Source: RBA)

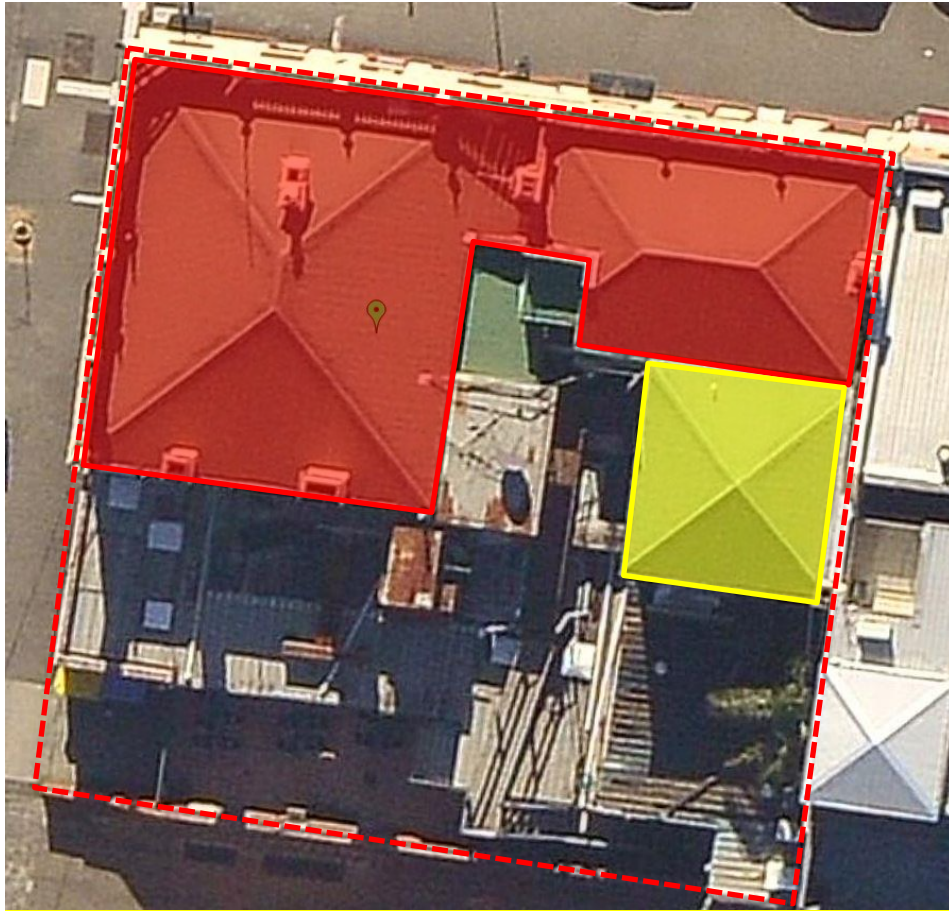
Subject site dashed
19th century section – should be reconstructed
1936 section – could be reconstructed
(Source: Nearmap, 13 September 2015)

In order to best reclaim the significance of the site as an early example of a relatively intact 19th century hotel, the first phase of which was constructed in about 1856, the fabric that primarily relates to the significance should be reinstated. The significant fabric related to the front 19th century/Victorian period two storey sections of the building. The key elements of the external fabric that should be reinstated includes the following:

In addition, consideration could be given to reinstating the form of the 1936 section constructed during the Interwar period to the east end (the party wall of this section survives *in situ*). When built, this section included a kitchen to the ground floor and bedrooms to the first floor.

There is no heritage imperative to reinstate the smaller 1923 additions to the central rear, which were of a secondary nature and seemed to have been considerably altered. In addition, the single storey sections to the rear dated to the 1950s onwards and were not of significance.

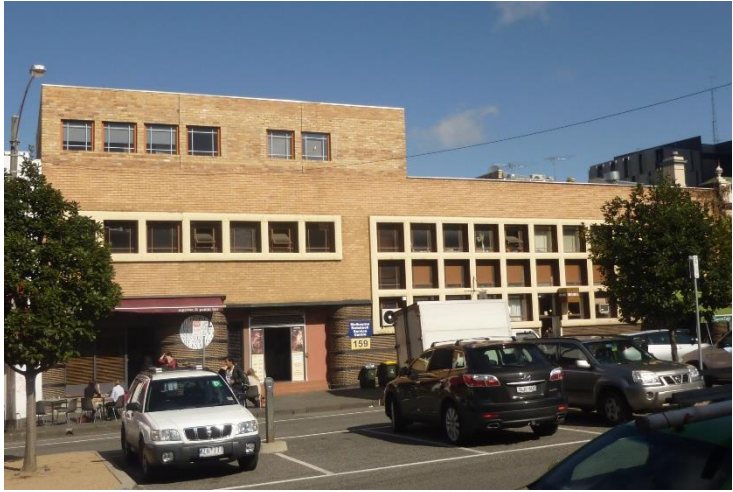
HO	Location	Details
HO84	To the east 157-163 Pelham St	<p>Former C Huppert & Co. Factory 1940s – two storey, Moderne style, brick building with part third storey additions (post-1962).</p>

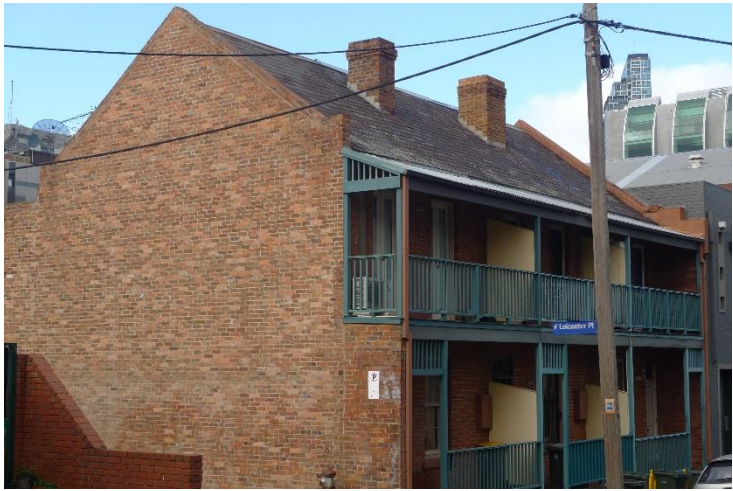
HO62	To the south, across Leicester Place 148-152 Leicester St	<p>Pattison Terrace Circa 1860, two storey terrace group of three houses with expressed pitched roof, clad in slate (to the front), face brick walls, and timber verandahs.</p>

As noted above, there is an existing heritage overlay adjacent to the subject site on both sides. Of particular importance is Pattison Terrace to the south, separated by a laneway, which was built at a commensurate time to the Carlton Inn, that is, circa 1860. Although a disparate pair in terms of building typology, they formed a distinct group in terms of being fabric from the earliest phase of development in this part of Carlton, of which there are few remnants.

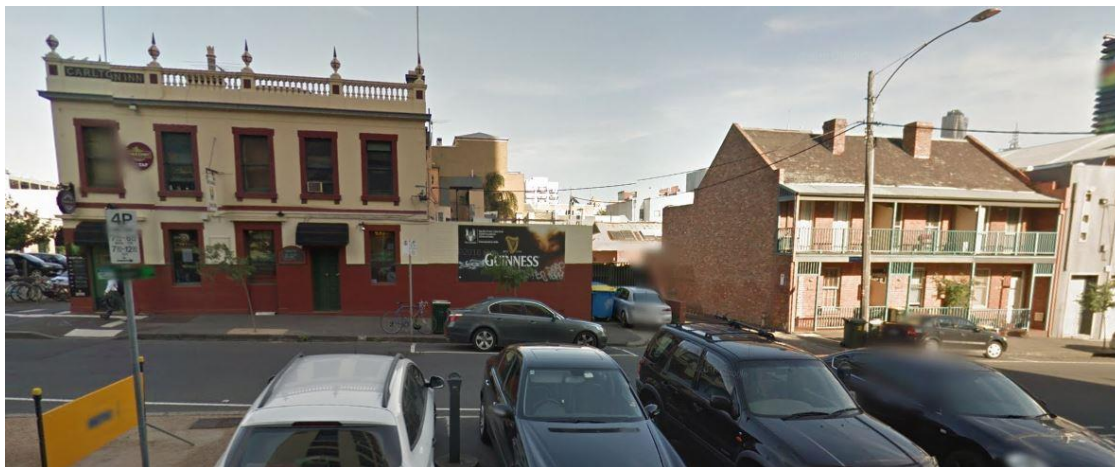
Leicester Street, south of Pelham Street - Carlton Inn (left) and Pattison Terrace (right)
(Source: Googleearth, October 2016)

Other heritage considerations relate to the interface of a reconstructed original section and any additions. In this case, the rear edge of the original section, including the prominent chimneys, was widely visible along Leicester Street and the rear laneway, Leicester Place. It would be appropriate for some visibility of these chimneys (if reconstructed) to be ensured.

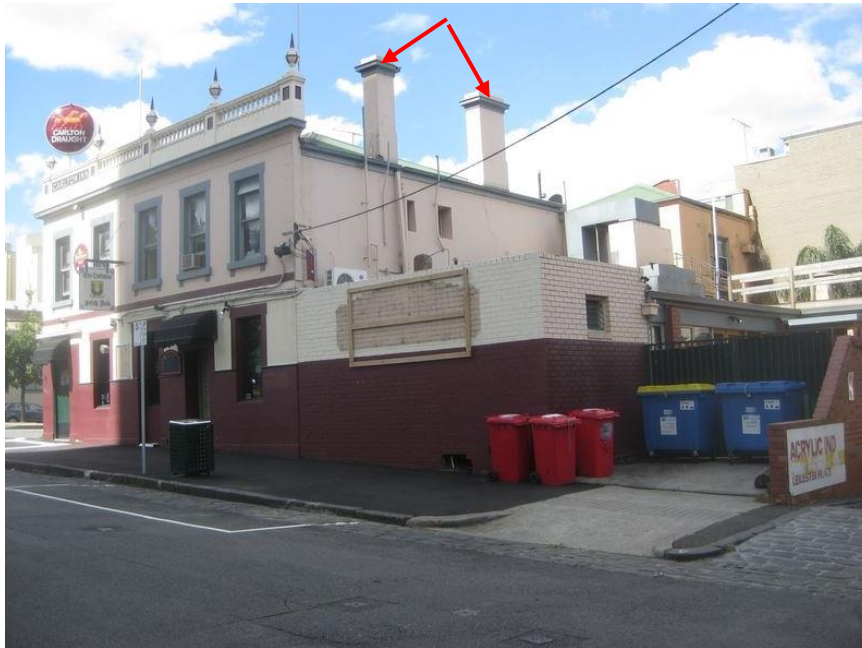
Carlton Inn, rear along Leicester Street, showing visibility of original chimneys
(Source: City of Melbourne Interactive Map, circa 2015)

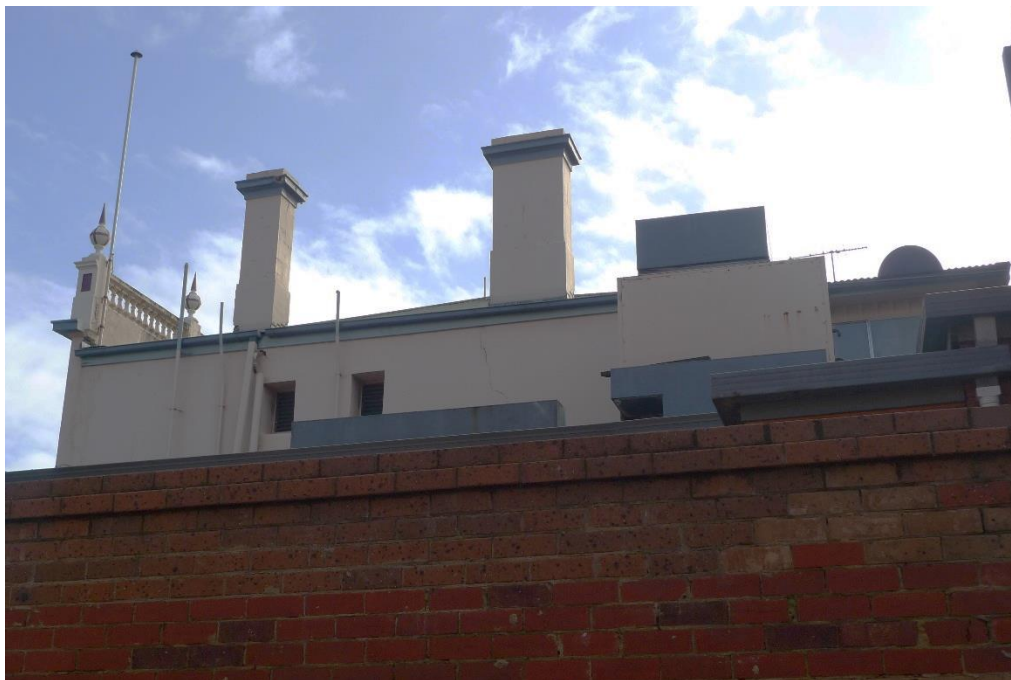
Carlton Inn, rear along Leicester Place, showing visibility of original chimneys
(Source: RBA, 2011)
