Seafarers Rest North Wharf Park, 731-739 Flinders Street,
Docklands

Cultural Heritage Management Plan 16265

Sponsor: City of Melbourne

17 May 2019

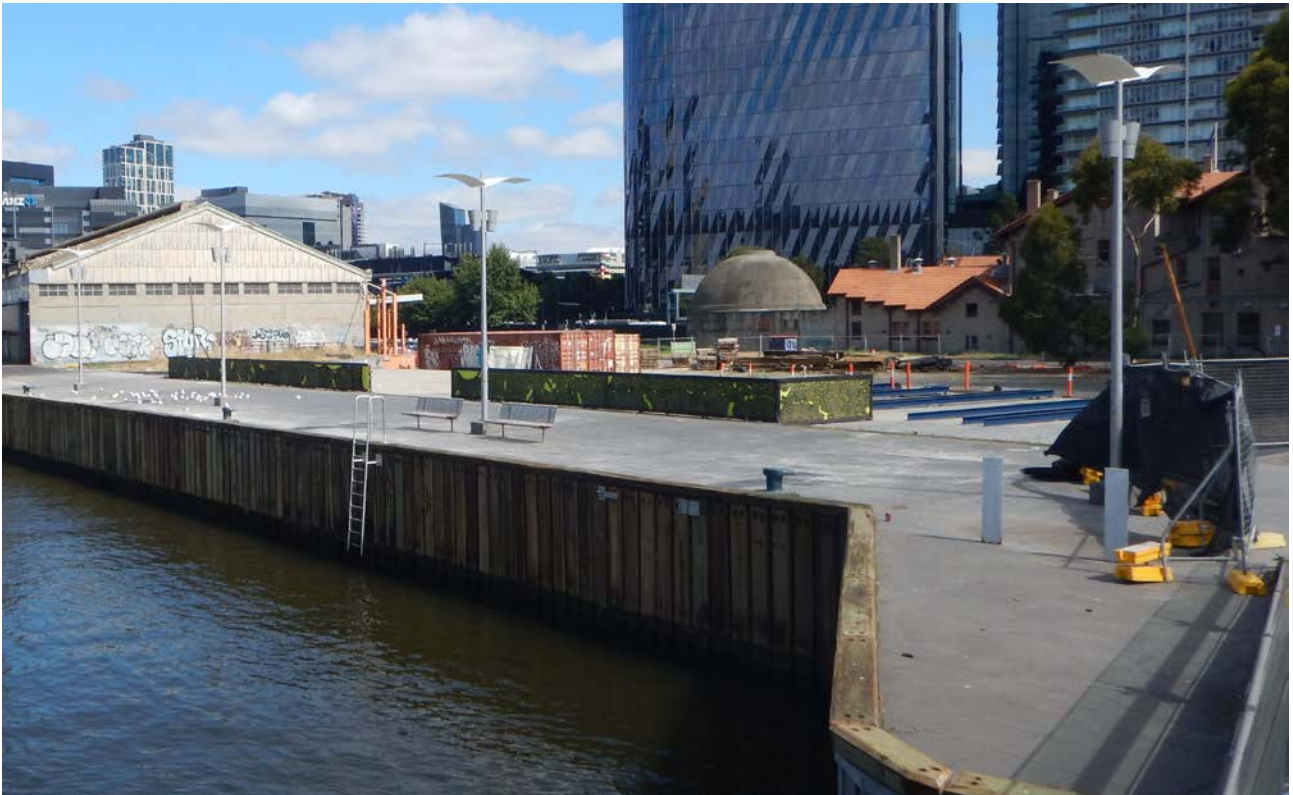
Photograph 1 Activity Area (facing north west)

Works for the activity will entail demolition of existing park furniture, lifting bluestone and concrete paving in part, excavation for new hard landscaping footings and tree planting, and construction of services including drainage, water and lighting.

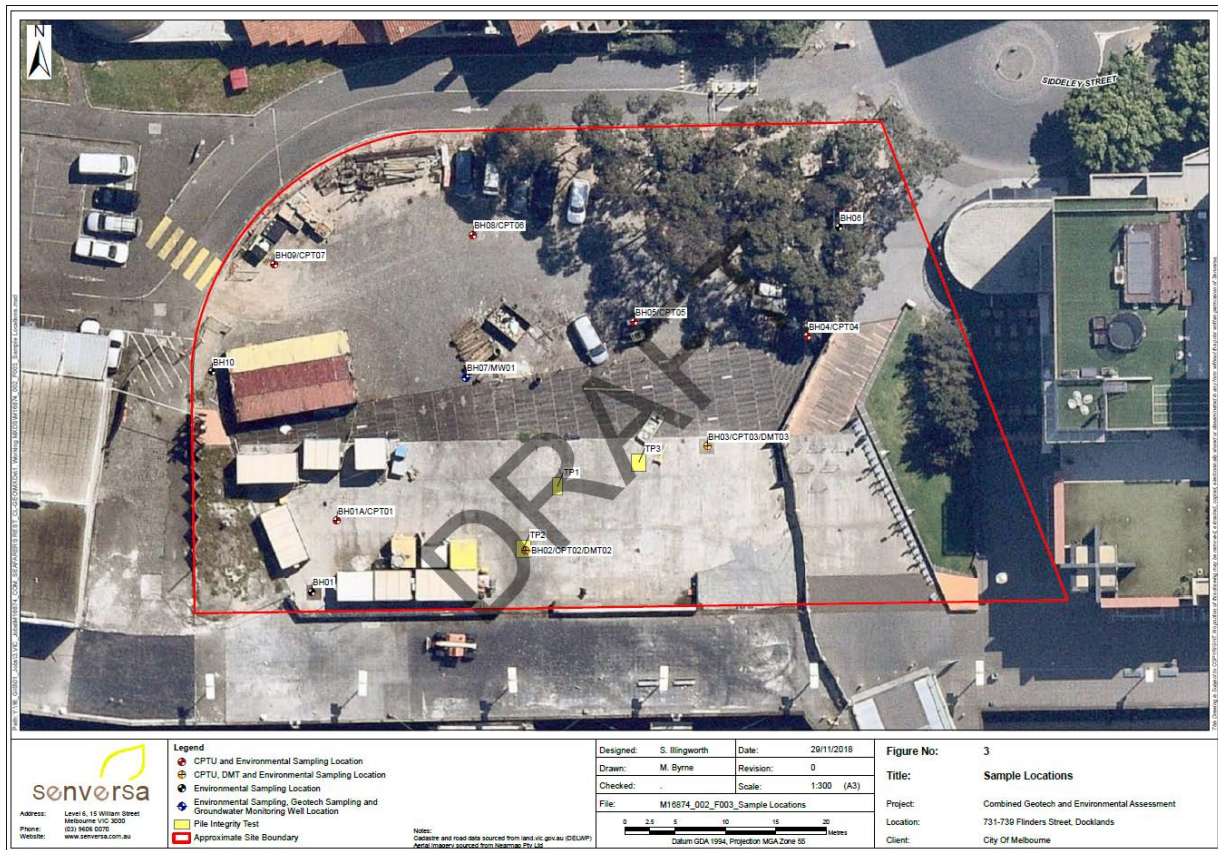
Figure 4 Location of geotech bores (Senversa, 2019)

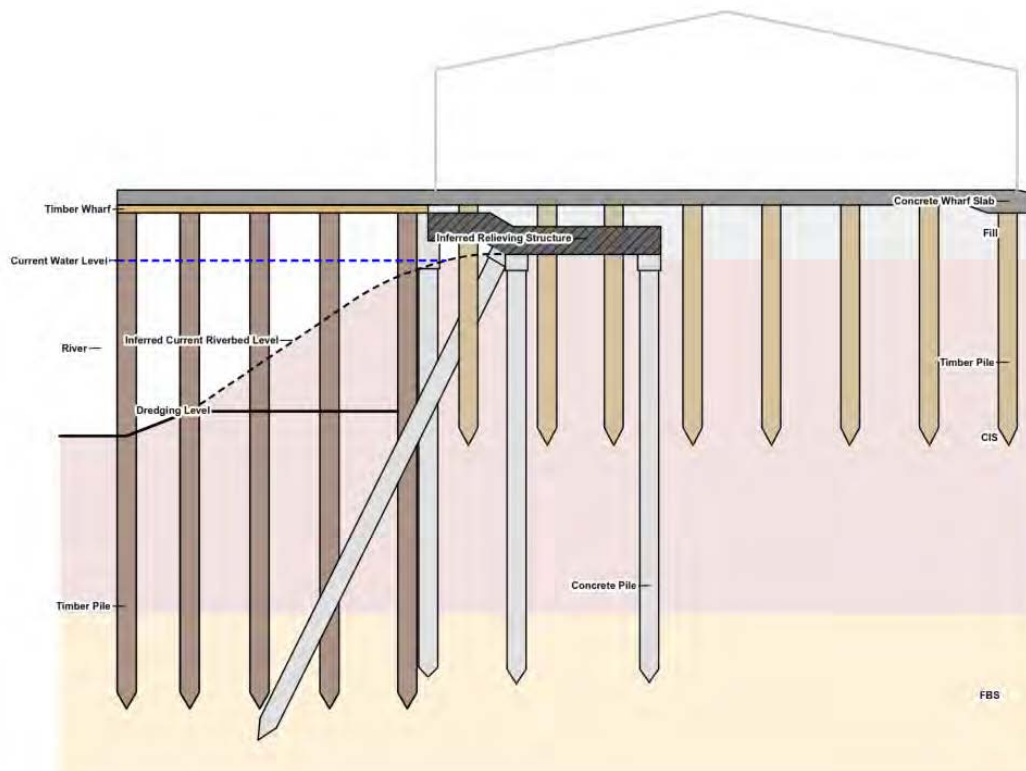
Figure 5 Inferred cross section of shed wharf and piling (Senversa, 2019)

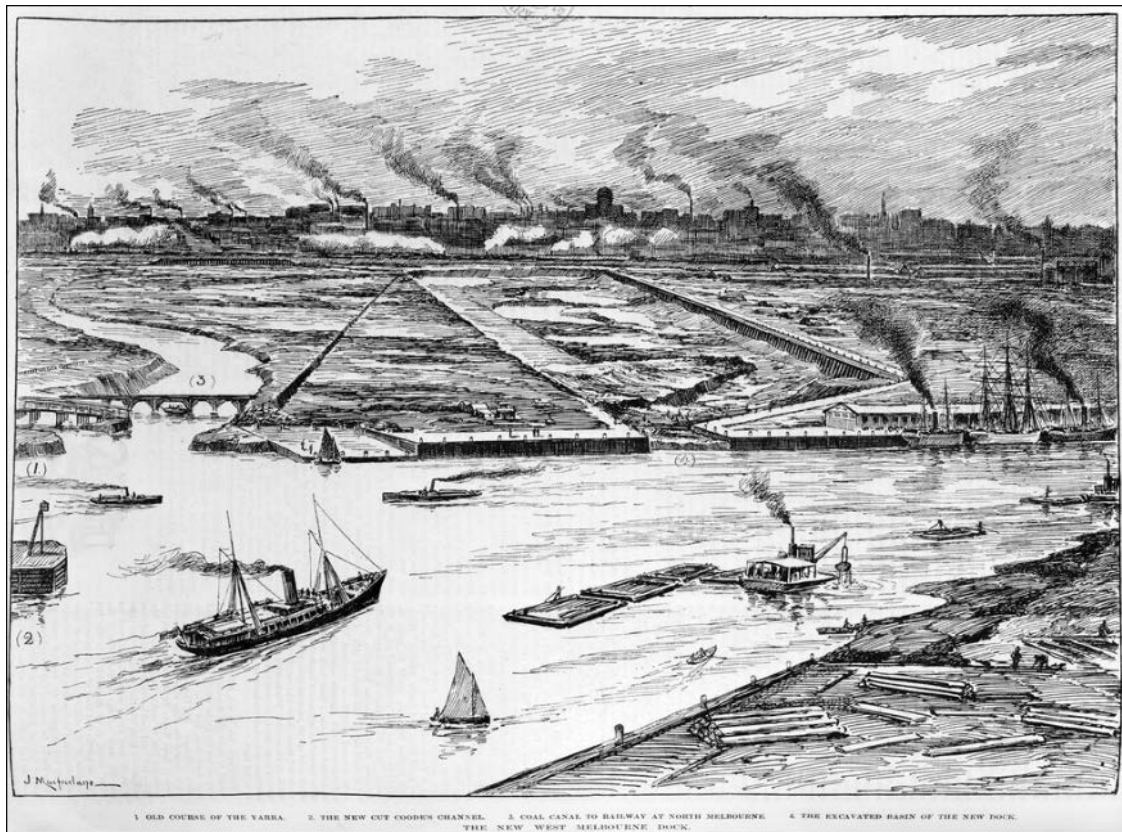
Figure 8 Widening of the Coode Canal 1892, (Macfarlane, 1892)

During the 1860s there was no coordinated management of the development of the Port of Melbourne, despite the urgent need along the Yarra River for extensive dock accommodation. Following on from this, the Melbourne Harbour Trust Act of 1876 provided for the establishment of the Melbourne Harbour Trust Commissioners. The Trust commissioned John Coode, an eminent British Harbour engineer, to prepare a plan for improvements to Melbourne's Port in 1878. His plan included widening and straightening the river entrance, excavating the Victoria Dock, and cutting a new canal from to take out the long and difficult passage around Fishermen's Bend. This commenced just to the west of where the Bolte Bridge now crosses the River, east of the current Activity Area. The work was undertaken in the 1880s and 1890s (Figure 8).

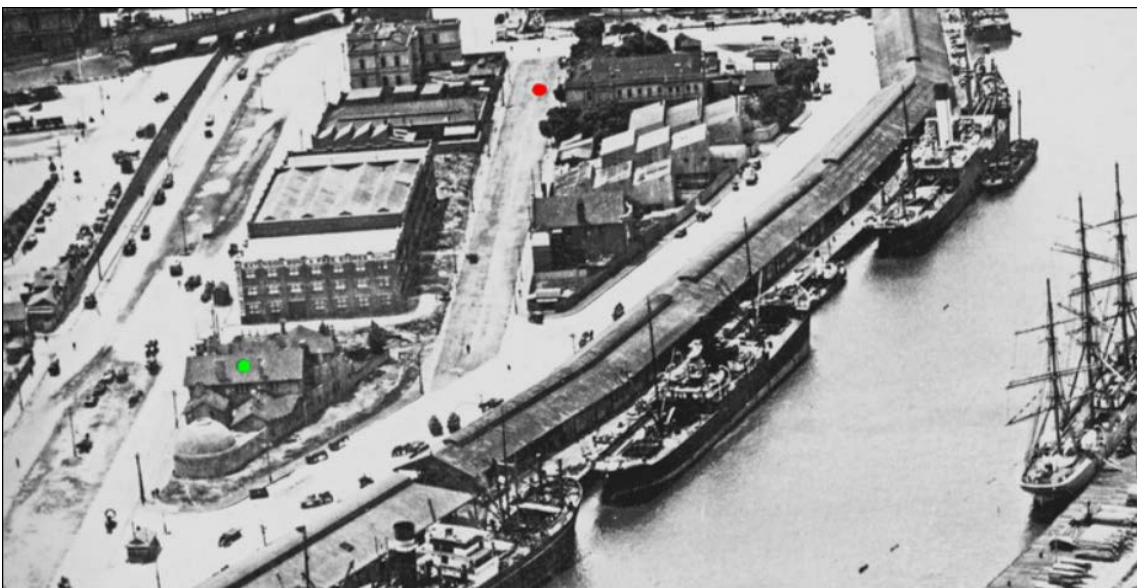
Figure 11 Australia Wharf c 1920 showing Seamen's Mission (green dot) and Siddeley Street (red dot), (unknown source)

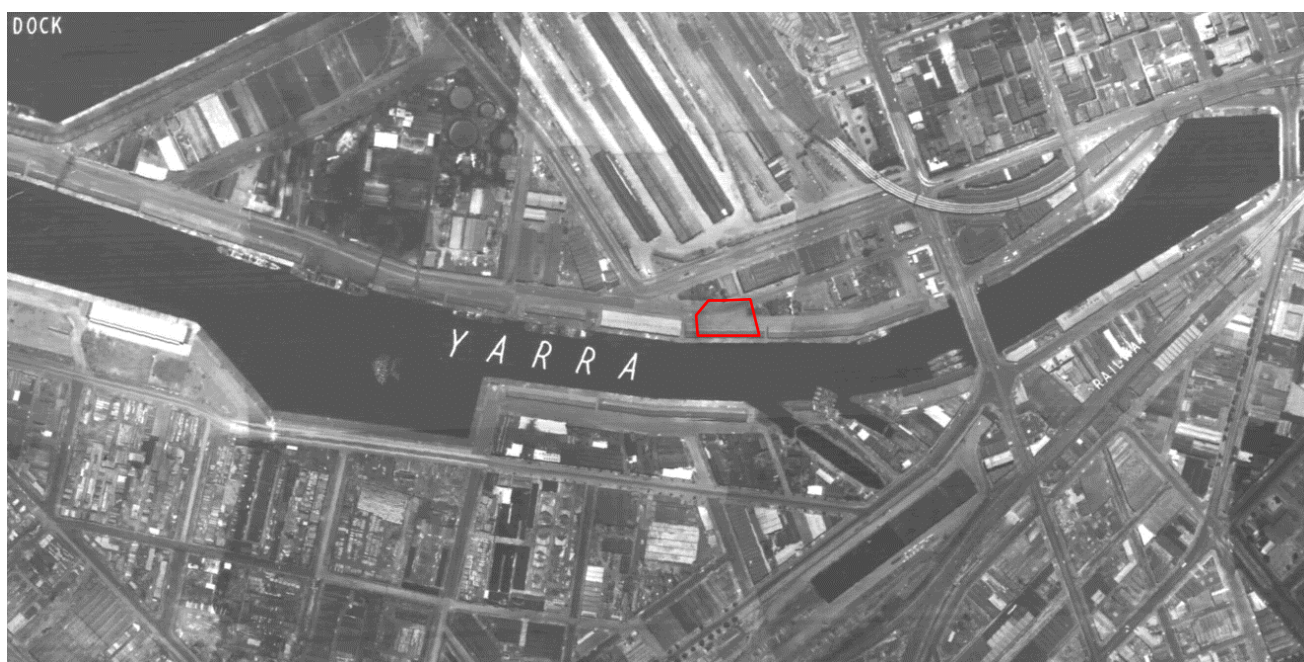
Figure 14 Aerial photography of Melbourne, 1945, approximate Activity Area outlined in red, (Department of Lands and Survey , 2018)

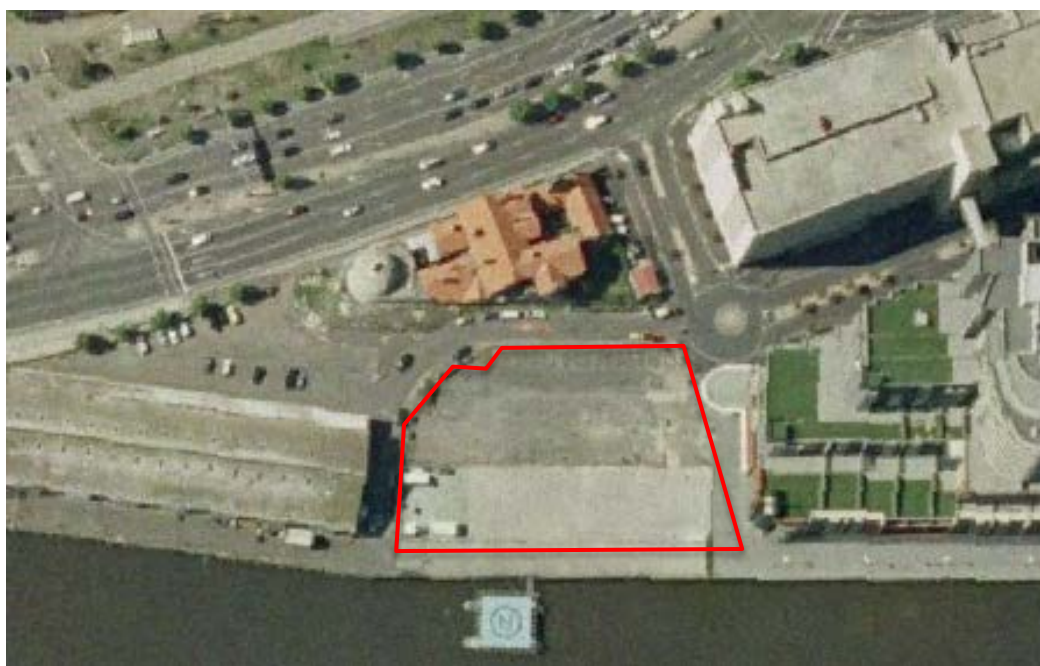
Figure 15 Aerial photography of Port Melbourne, 2004, approximate Activity Area outlined in red, (State Government of Victoria, 2018)

The area remained in use as a wharf up until the construction of the Charles Grimes Bridge in 1975. Aerial imagery from 2004 (Figure 15) shows the Activity Area is a vacant lot, which has been sealed. The Activity Area was officially opened as 'Seafarers Rest Park' in 2005, and imagery shows that several trees have been planted in the northern extent (Figure 16).

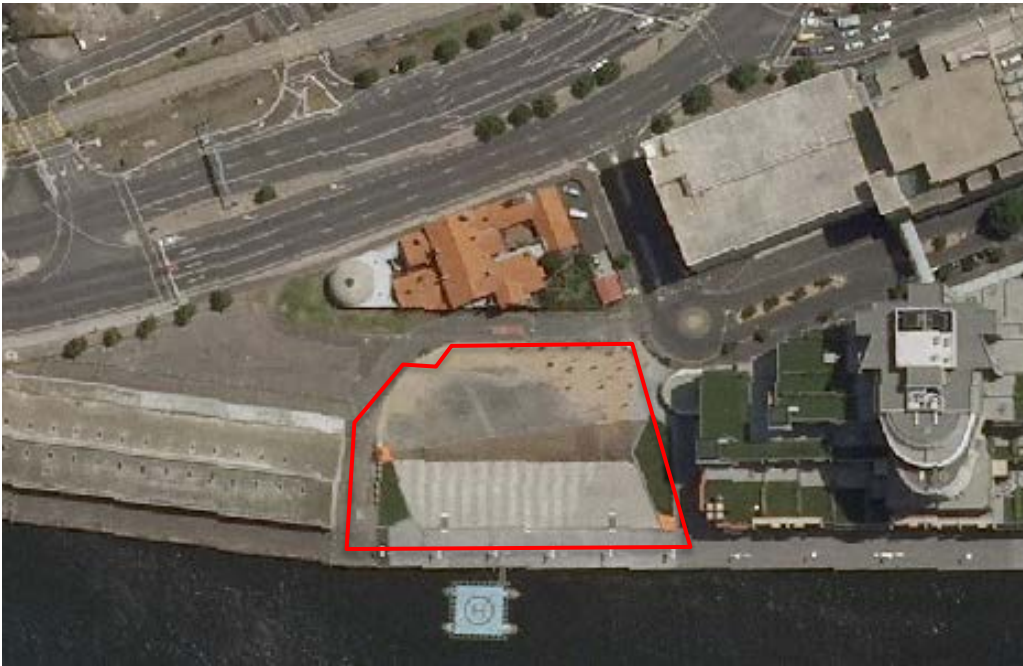
Figure 16 Aerial photograph of Port Melbourne, 2005, approximate Activity Area outlined in red, (State Government of Victoria, 2018)

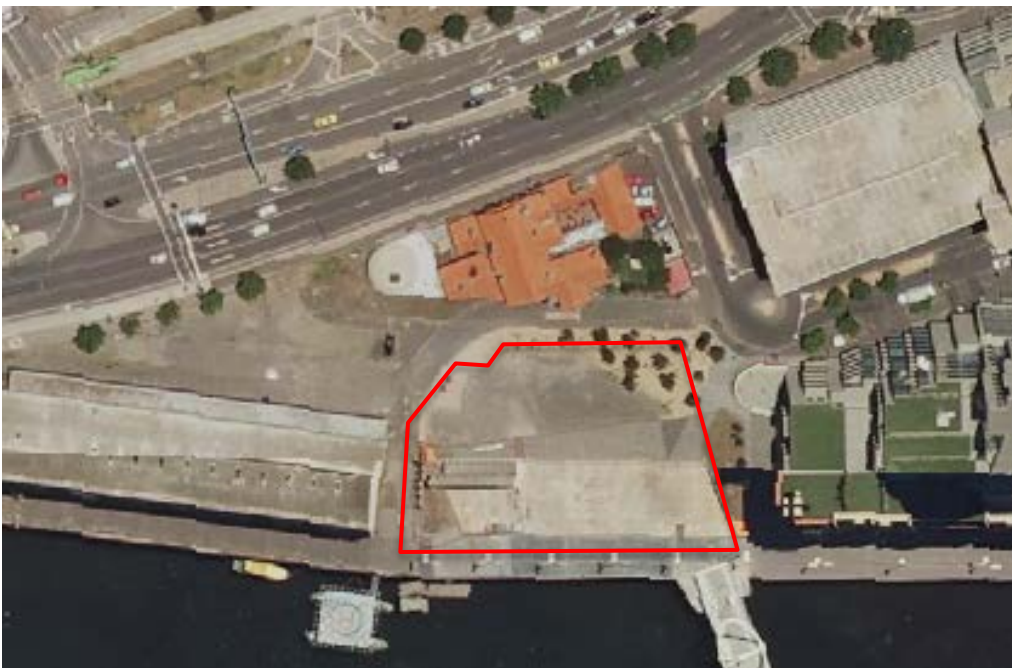
Figure 17 Aerial photograph of Port Melbourne, 2009, approximate Activity Area outlined in red, (State Government of Victoria, 2018)

The Seafarers Bridge, constructed in 2009, is a footbridge over the Yarra River connecting the Docklands and South Wharf. The northern termination of the bridge is connected with Seafarers Rest Park, just outside the south-eastern corner of the Activity Area (Figure 17). More recent imagery from 2016 (Figure 18) and 2018 (Figure 19) shows construction of a building in the western extent of the Activity Area.

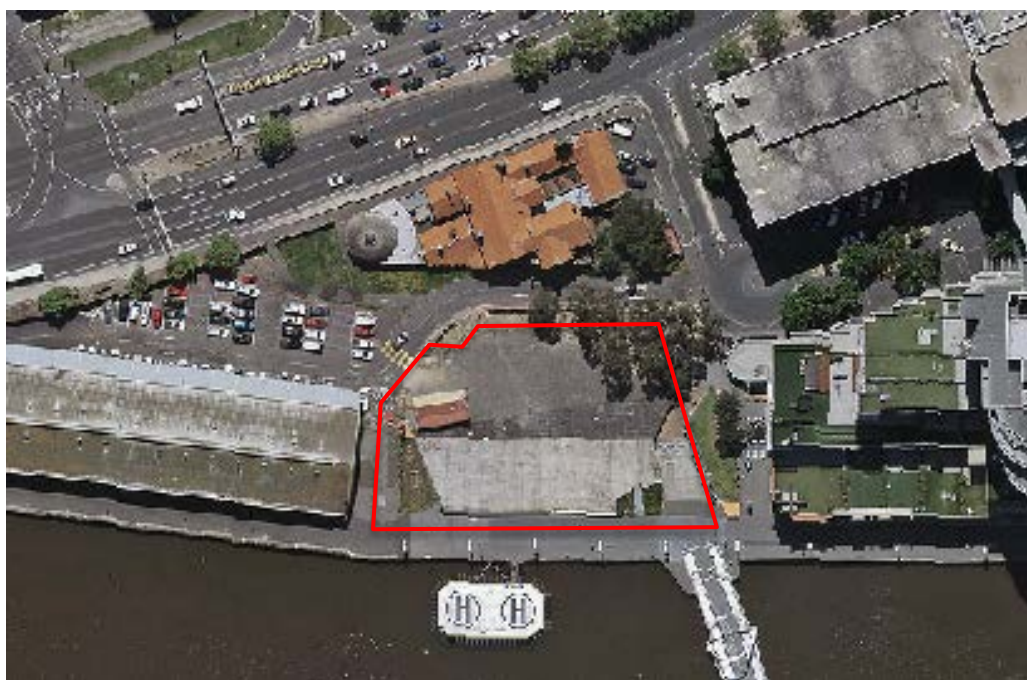
Figure 18 Aerial photograph of Port Melbourne, 2016, approximate Activity Area outlined in red, (State Government of Victoria, 2018)

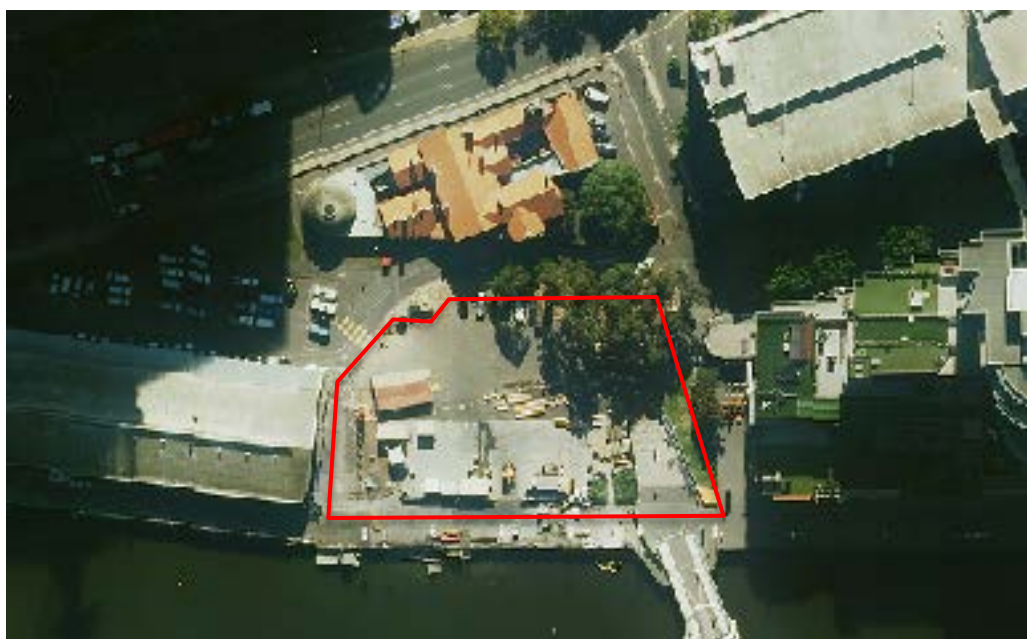
Figure 19 Aerial photograph of Port Melbourne, 2018, approximate Activity Area outlined in red, (State Government of Victoria, 2018)

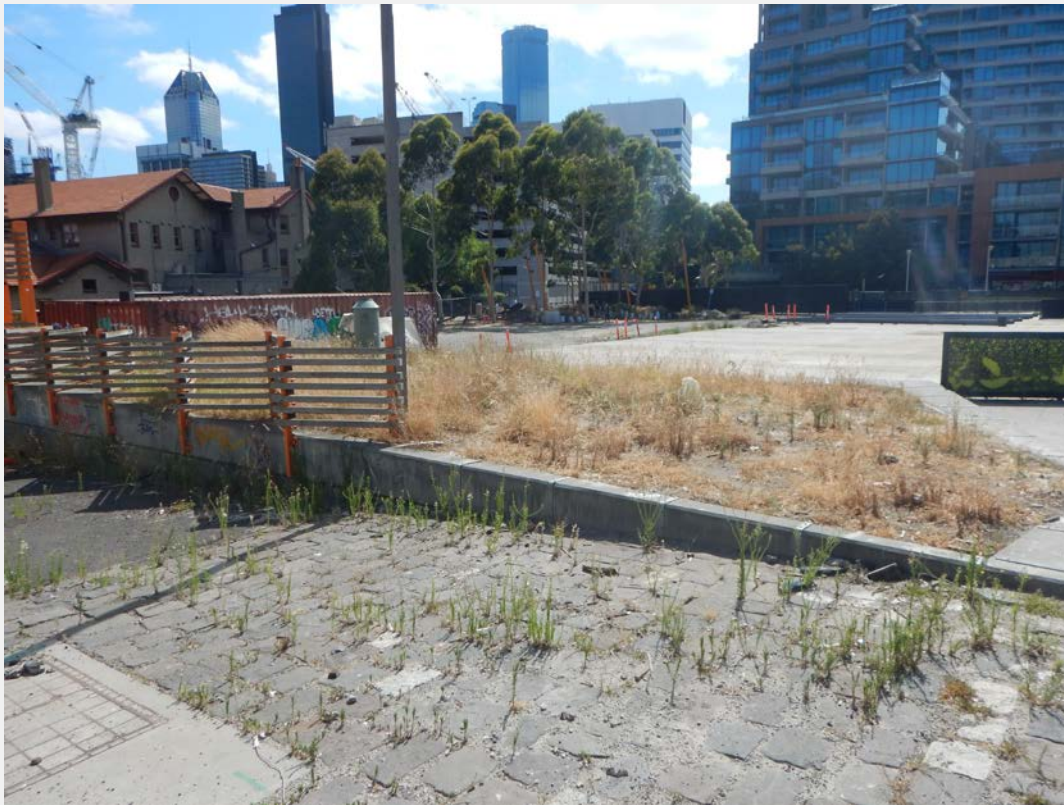
Photograph 2 Typical landforms within the Activity Area (facing north east)

Landform	The natural landform would have been alluvial sediments forming an elevated river bank, probably with mud flats at low tide and gradually rising towards the north. The current landform is a relatively flat area of artificial ground surfaces about 2.5 metres above sea level.

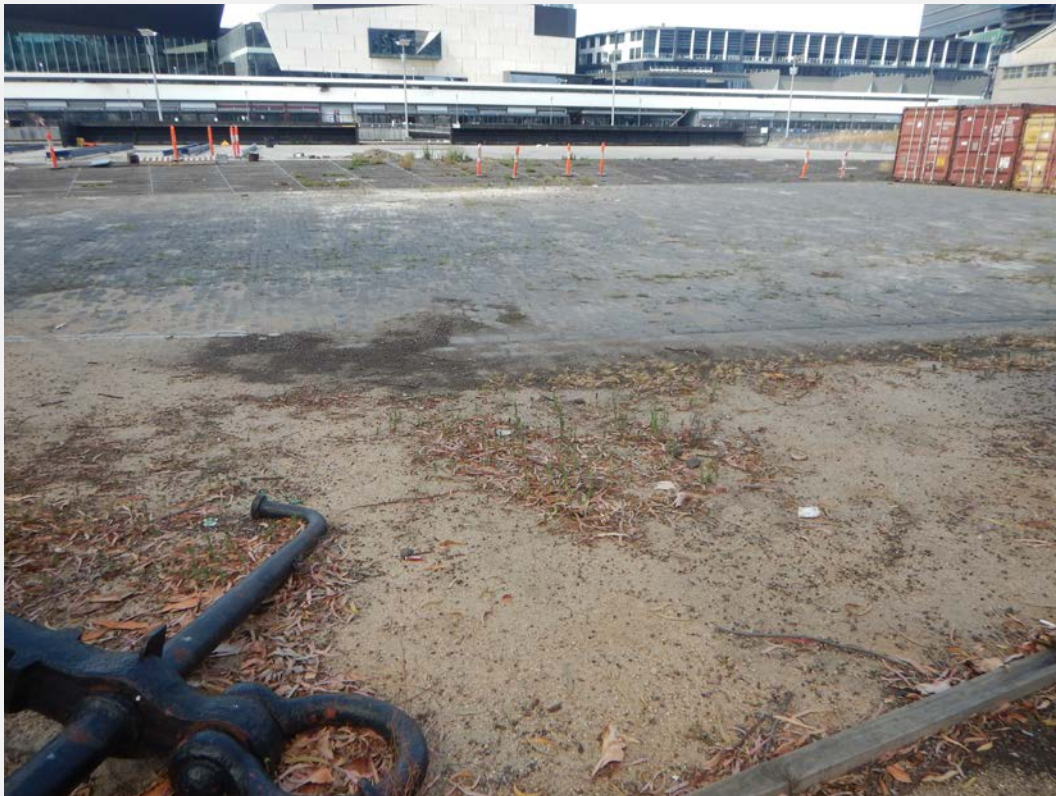
Photograph 3 Typical ground surface visibility. Concrete and bluestone paving with recent gravel overaly in foreground.

Slope	level
Soil	Not visible, but presumably if present, comprises Coode Island Silt (as demonstrated by geotechnical investigations, see Section 7.6.1)
Proximity to fresh water	Prior to removal of the Falls – 875 metres to above the falls, or 1.3 km to Elizabeth St creek
Vegetation	Planted trees and weeds
Mature trees	none
Caves or rock shelters	none
Previous and current land use	Wharf, sheds and paved roadways since 1850s, last reconstructed in 1950s. Modern development and landscaping. Use as construction compound for adjacent Riverlee development
Ground disturbance	Excavations for underground services, drains, piling, base for concrete slabs and bluestone and bitumen paving
