VICTORIA HARBOUR DOCKLANDS

CONSERVATION MANAGEMENT PLAN

Places Victoria &
City of Melbourne

June 2012

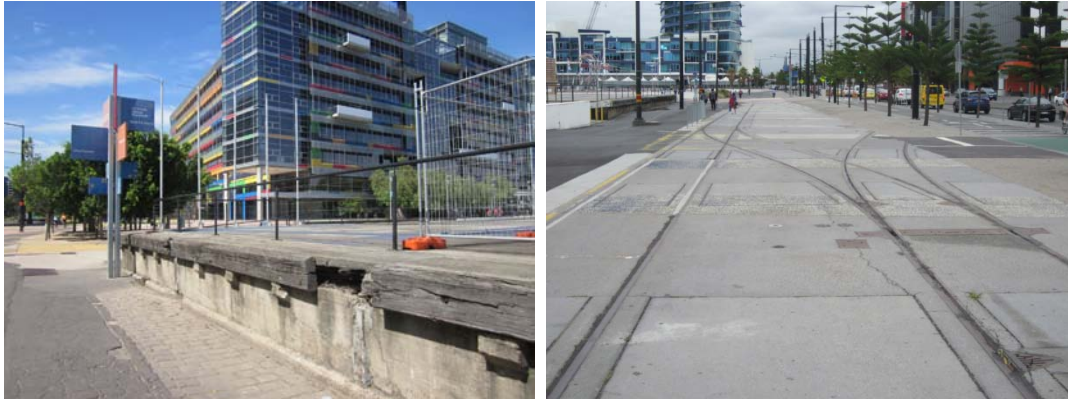
Figure 34 From left: Harbour Esplanade, showing original wharf edge and surface to the former Cowper Street alignment; rail lines embedded in the former Cowper Street road surface.

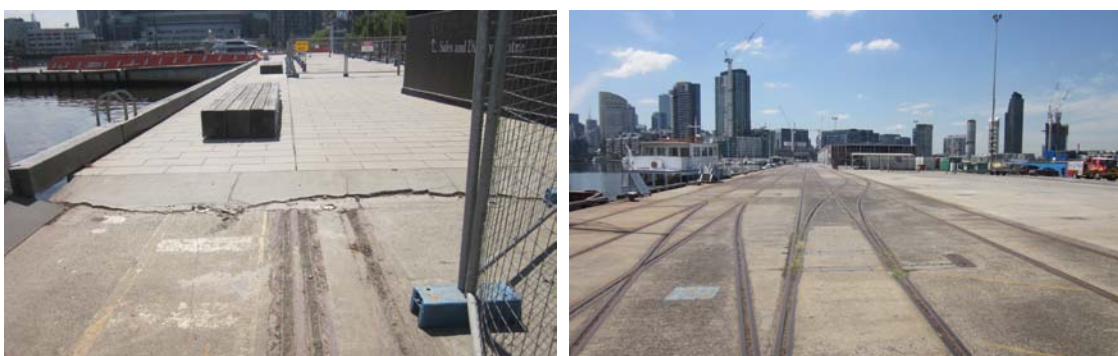
To the west of this redeveloped area, the original concrete wharf apron and inset rail lines are apparent, opposite the Concesso Concavo development (Figure 40). From this point elements of the original dock landscape – berth sheds, concrete wharf apron and in-situ rail lines – are still extant (Figure 40). This has been augmented by City of Melbourne street furniture including stainless steel litter bins and lighting, encouraging pedestrian exploration of the precinct. Cast metal bollards are set along the wharf edge and are in use for boat moorings. Lightweight metal moorings, gangways and a small marina are set off the dock

Figure 40 From left: extent of the Victoria Harbour Promenade landscape treatment, showing the progressive overlaying of the original concrete deck and rail line; South Arm looking east showing the wharf apron and rail lines. Berth 3 and 4 sheds are in the middle distance. Note the bollards and moorings at left.

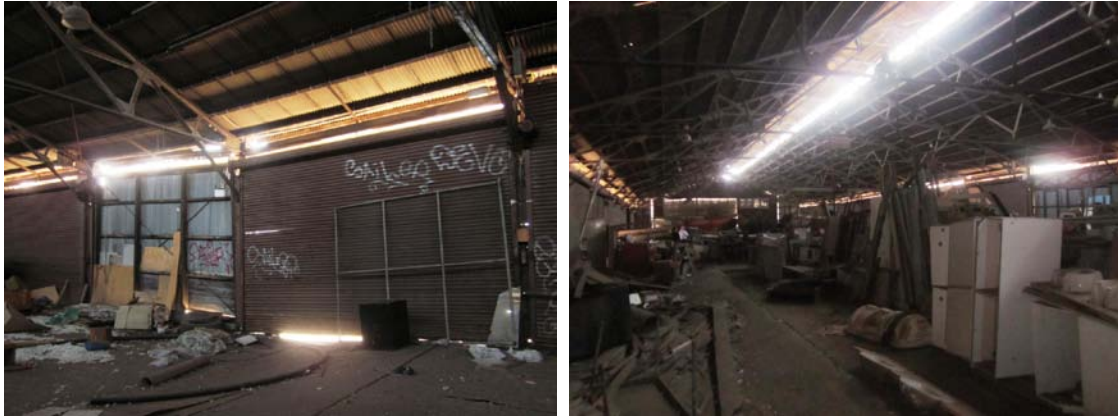
The sheds have a floor of reinforced concrete, with asphalt over, and rails set flush to its surface. Sections of this flooring are in a deteriorated condition with a large hole to the west end of berth 20 shed, and evidence of subsidence (Figure 50). To the west end of berth 21 shed there is a double-height wall of varnished timber boarding, and an open tread concrete stair which interconnects the shed proper with the 1968 bay addition. These spaces, divided by partition walls comprising plasterboard over stud, were previously offices, shower and toilet facilities.

Figure 49 From left: south elevation, berth 21 shed showing wall framing and cladding, flanked by roller doors. Note the evidence of subsidence; interior of the berth 20 shed, looking east.

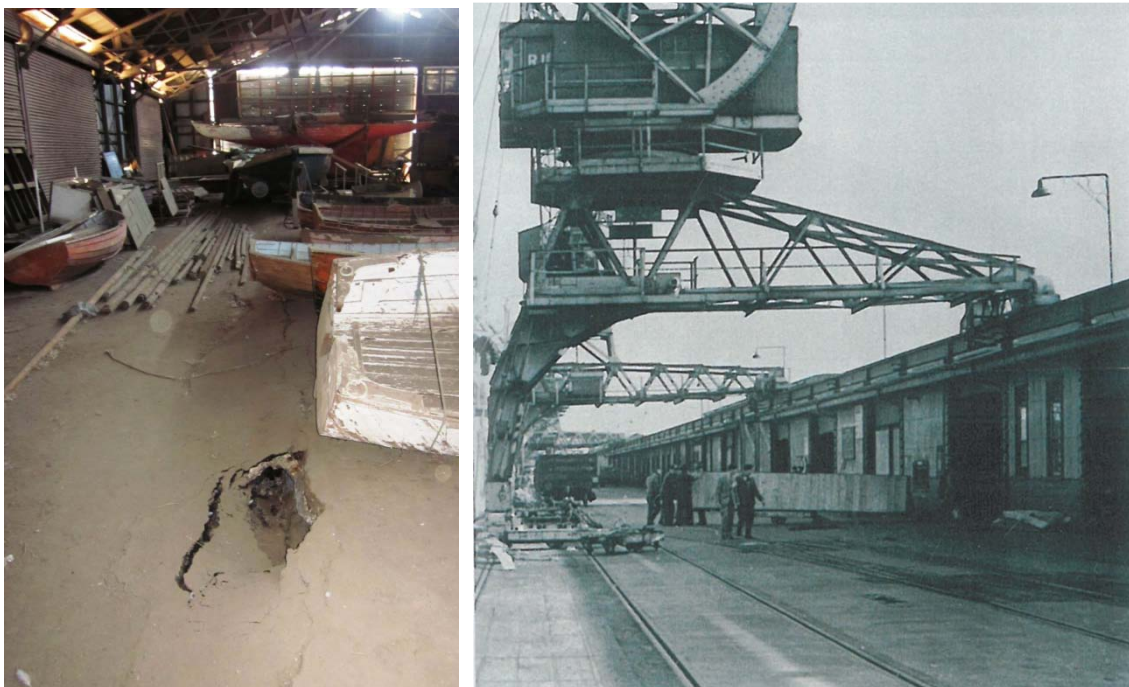
Figure 50 From left: slumped flooring to the north side of berth 20; historic view of the sheds to berths 20 and 21 showing original form of and rhythm of openings.
