Hawke Street West Melbourne Heritage Gradings

Submission prepared by: Bill Cook
for Panel Hearing Amendment 258
Melbourne Planning Scheme
14th August 2018.

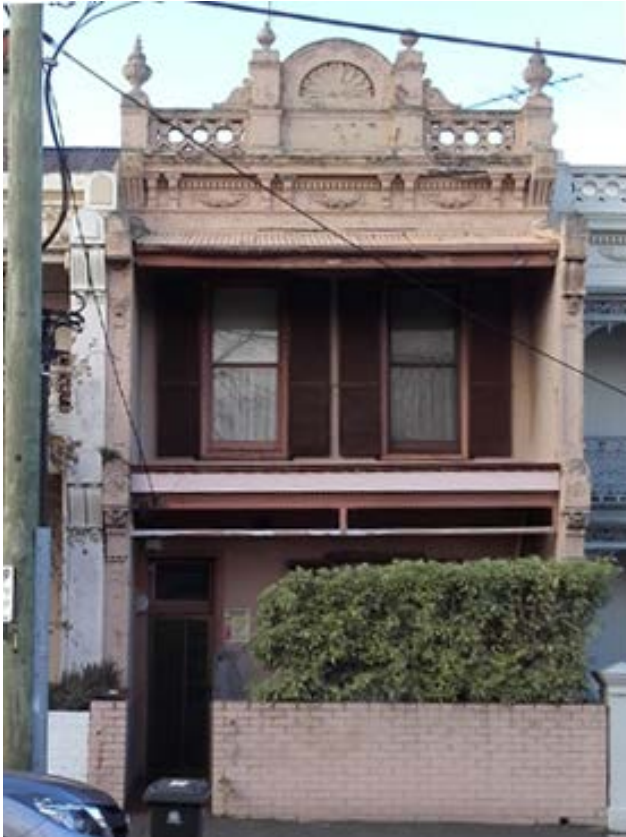
House 43 parapet including orbs in poor condition but are intact.

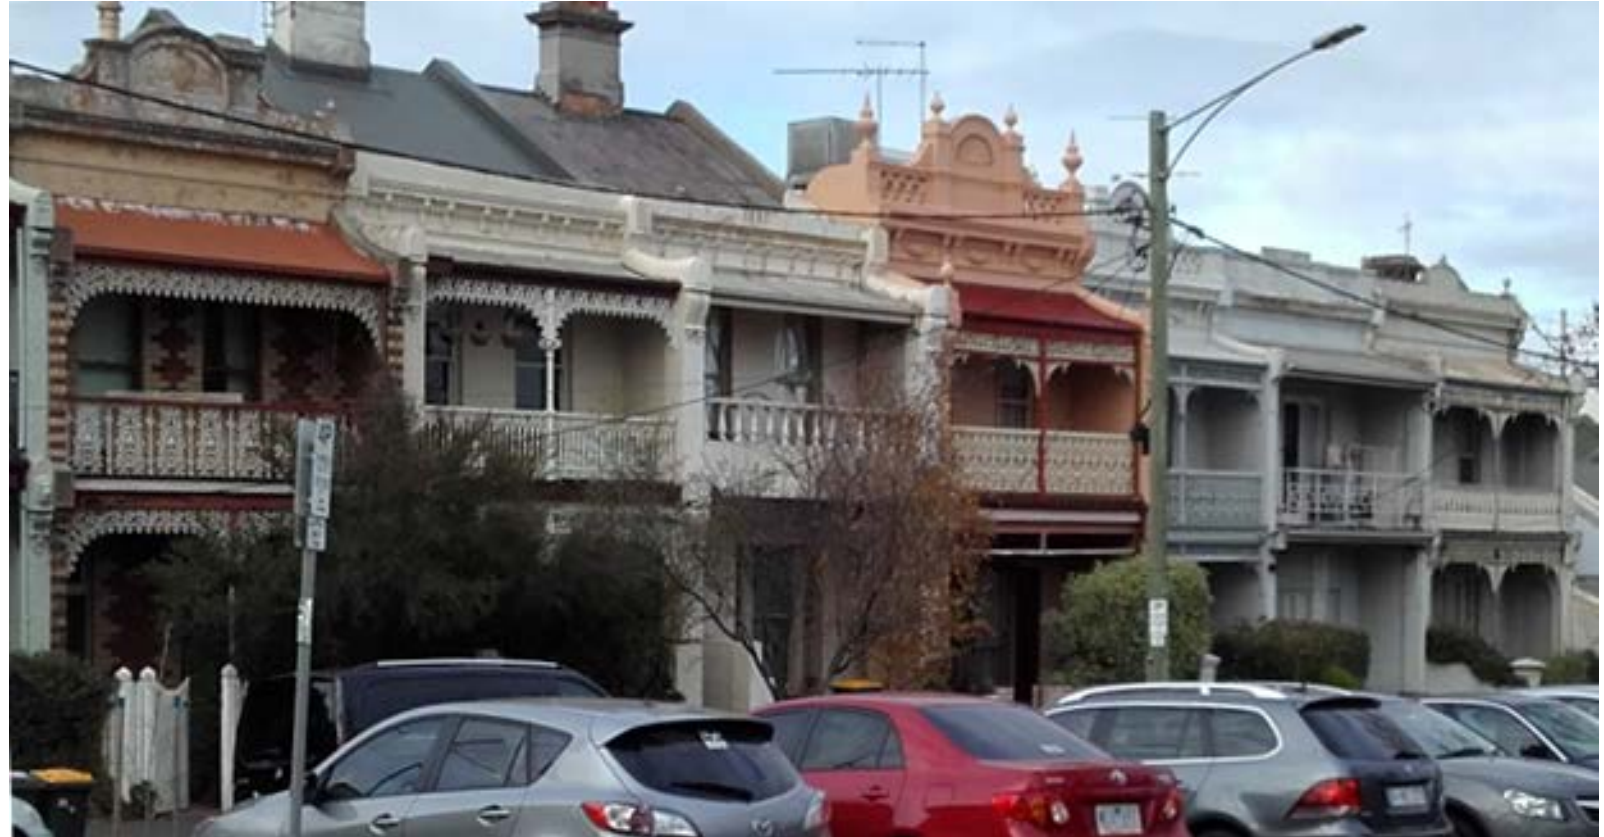
The context - only one of this group of seven 2 storey houses is graded as contributory!

House 37 and 49 are both in very original.
I will focus discussion on the pairs on either side of house 43.

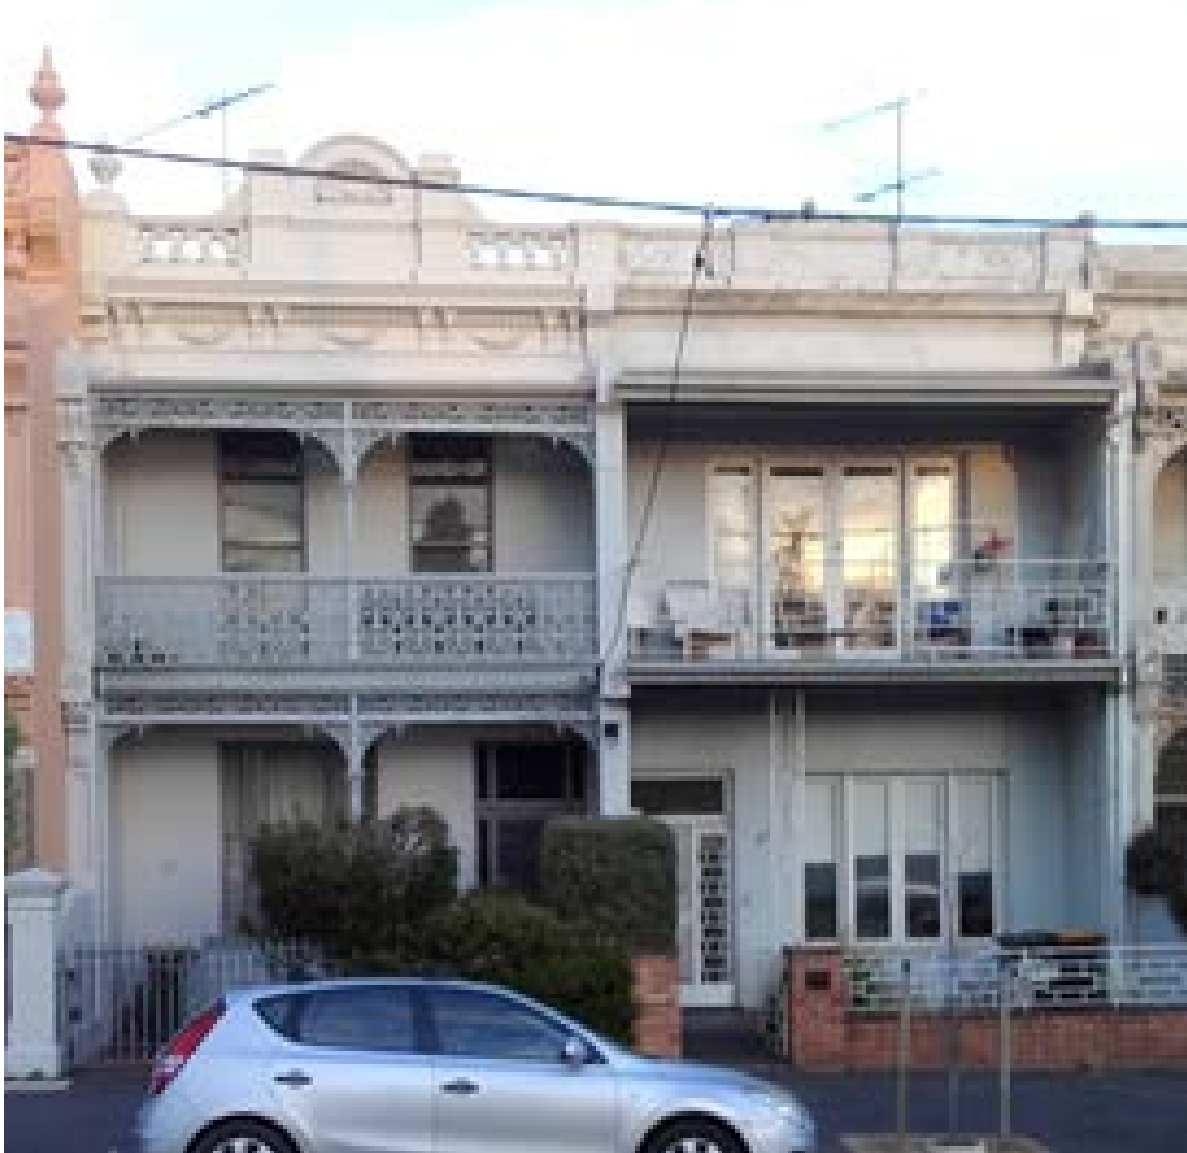
On southern side, house 45 and 47 – built as a pair

- Dated 1876
- Pairs seem to justify a rating boost.
- House 45 relatively intact. Parapet good but minus 5 of 6 orbs.
- New iron lacework on house 45 was installed in 1980s.
- House 47 significantly defaced – parapet, windows, balustrade, friezes, corners and fence.
- Negative affect on RHS of 45

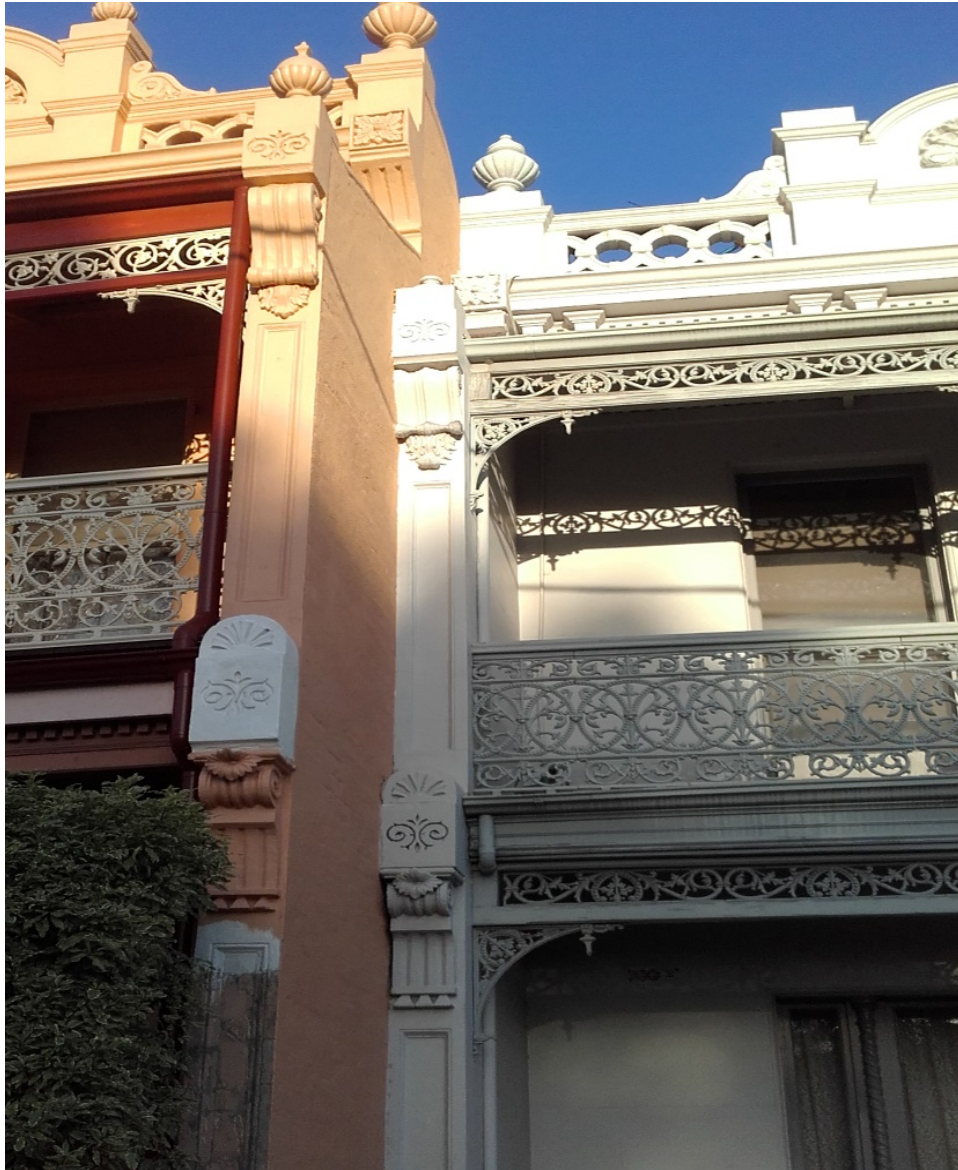
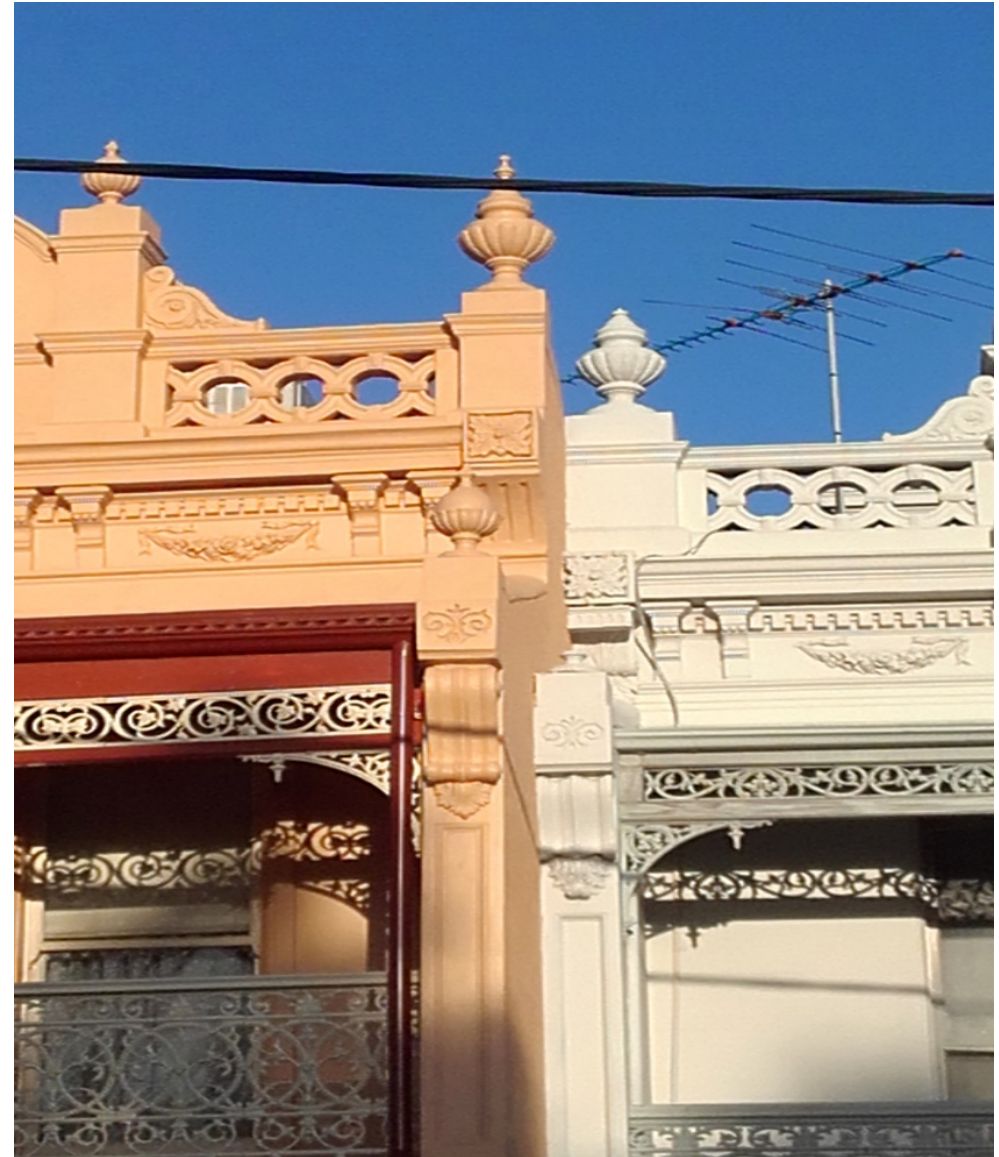
Details on house 43 and 45 are very close to identical. As 45 and 47 are a pair, 47 would once have had the same decoration.

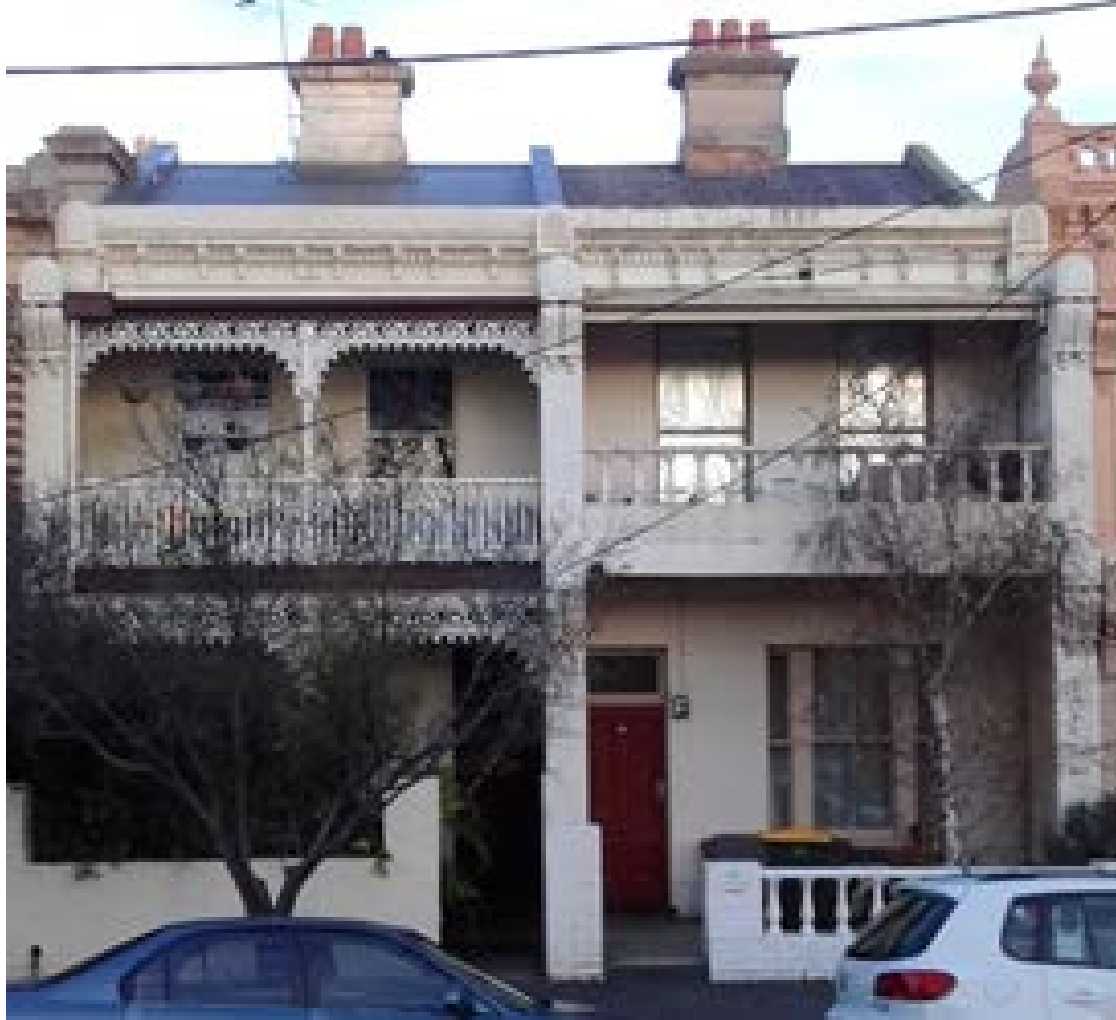
On the northern side, house 39 and 41 Hawke Street, were built as another matching pair.

- Dated 1883
- House 39 is in well-preserved condition, apart from fence and one missing chimney pot.
- House 41 has been altered – verandah balustrade and fence.
- Style is quite different to house 43 and 45.

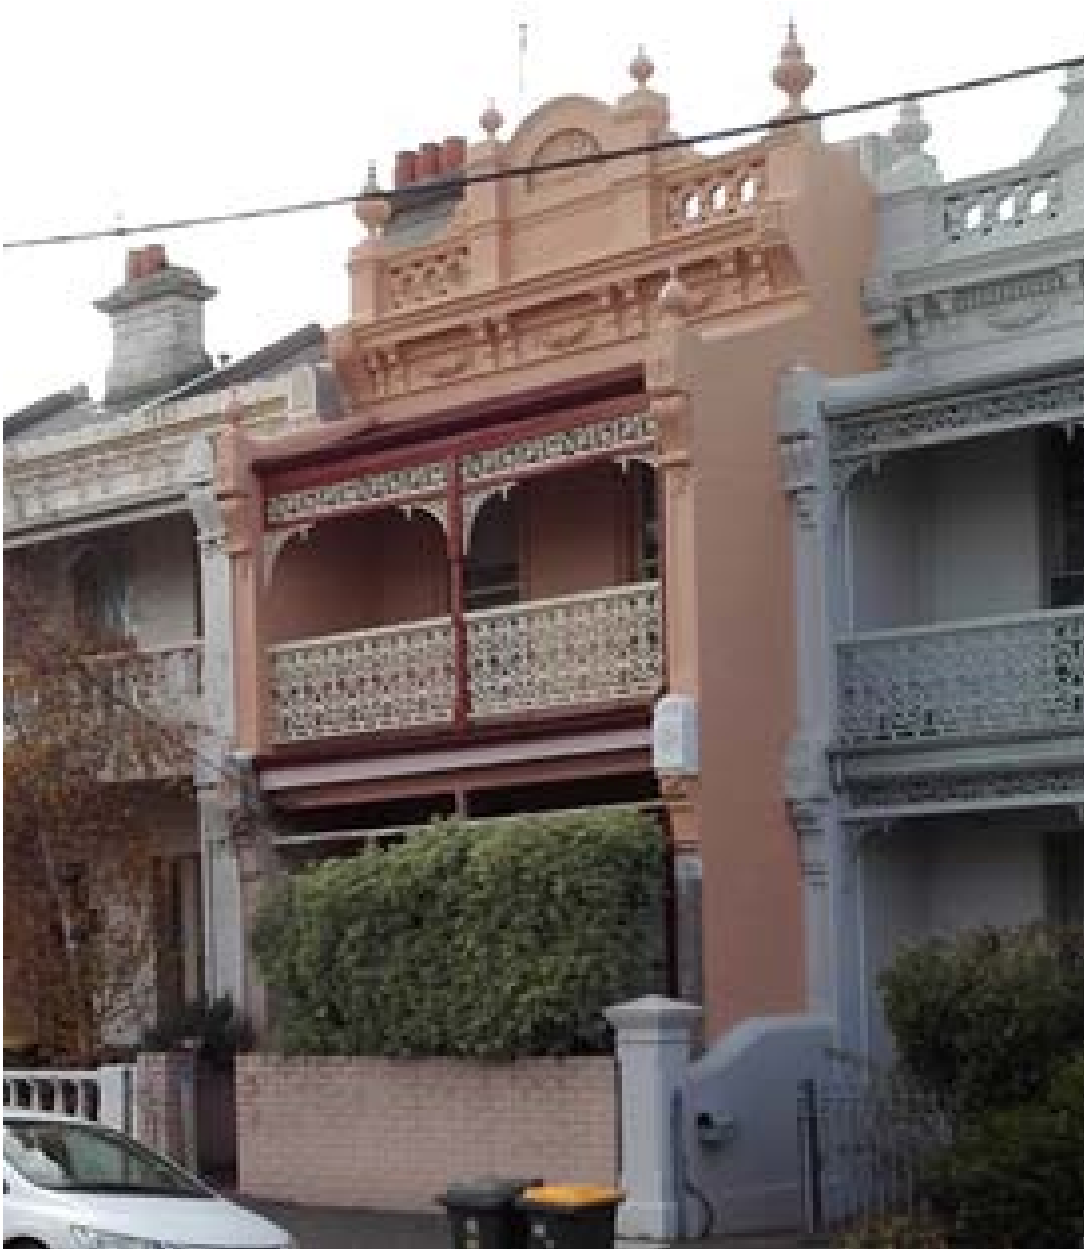
43 Hawke Street, West Melbourne

- Unique - not built as part of a pair but possibly as a non-identical twin.
- Original chimney has been removed.
- Front fence is not original.
- Façade is fully intact
- Lower verandah lacework original.

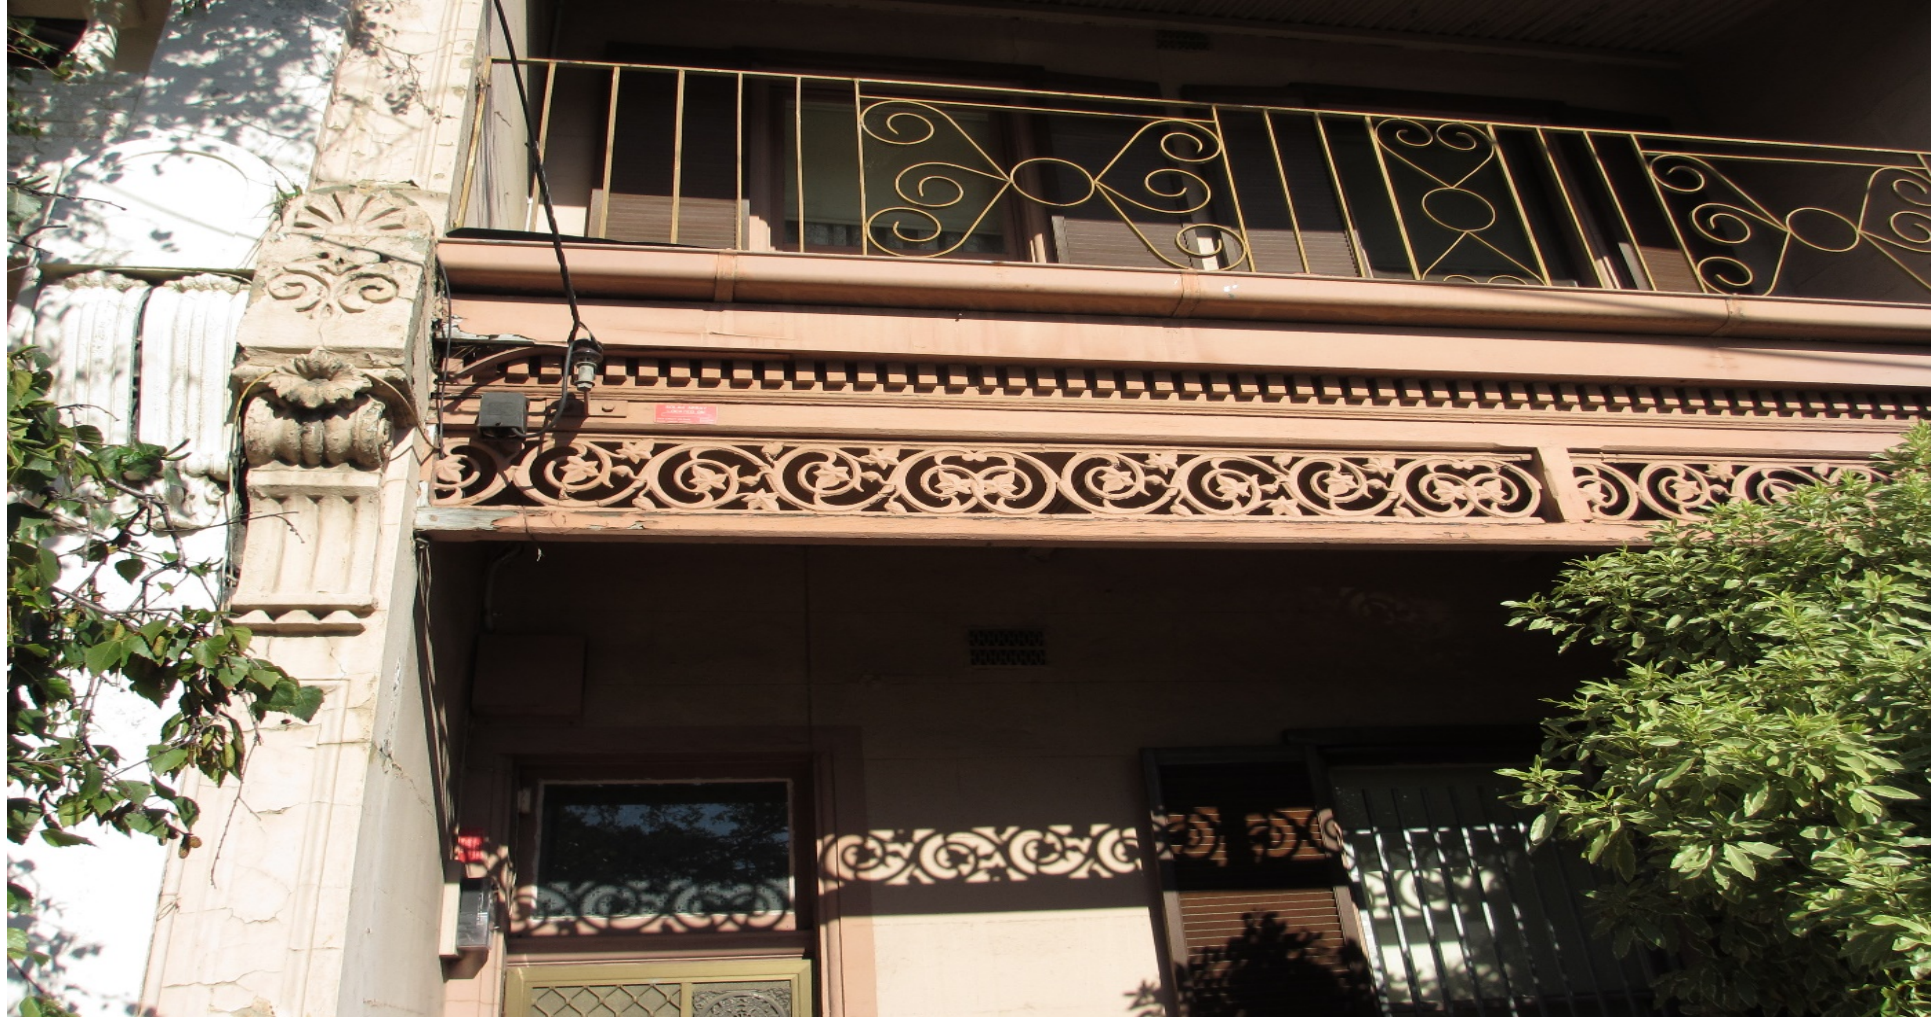
The original lacework of house 43 on the ground floor frieze is intact. It's design is unique in that it reads from right to left in each section. This lace pattern has been replicated and re-installed above in the upper verandah.

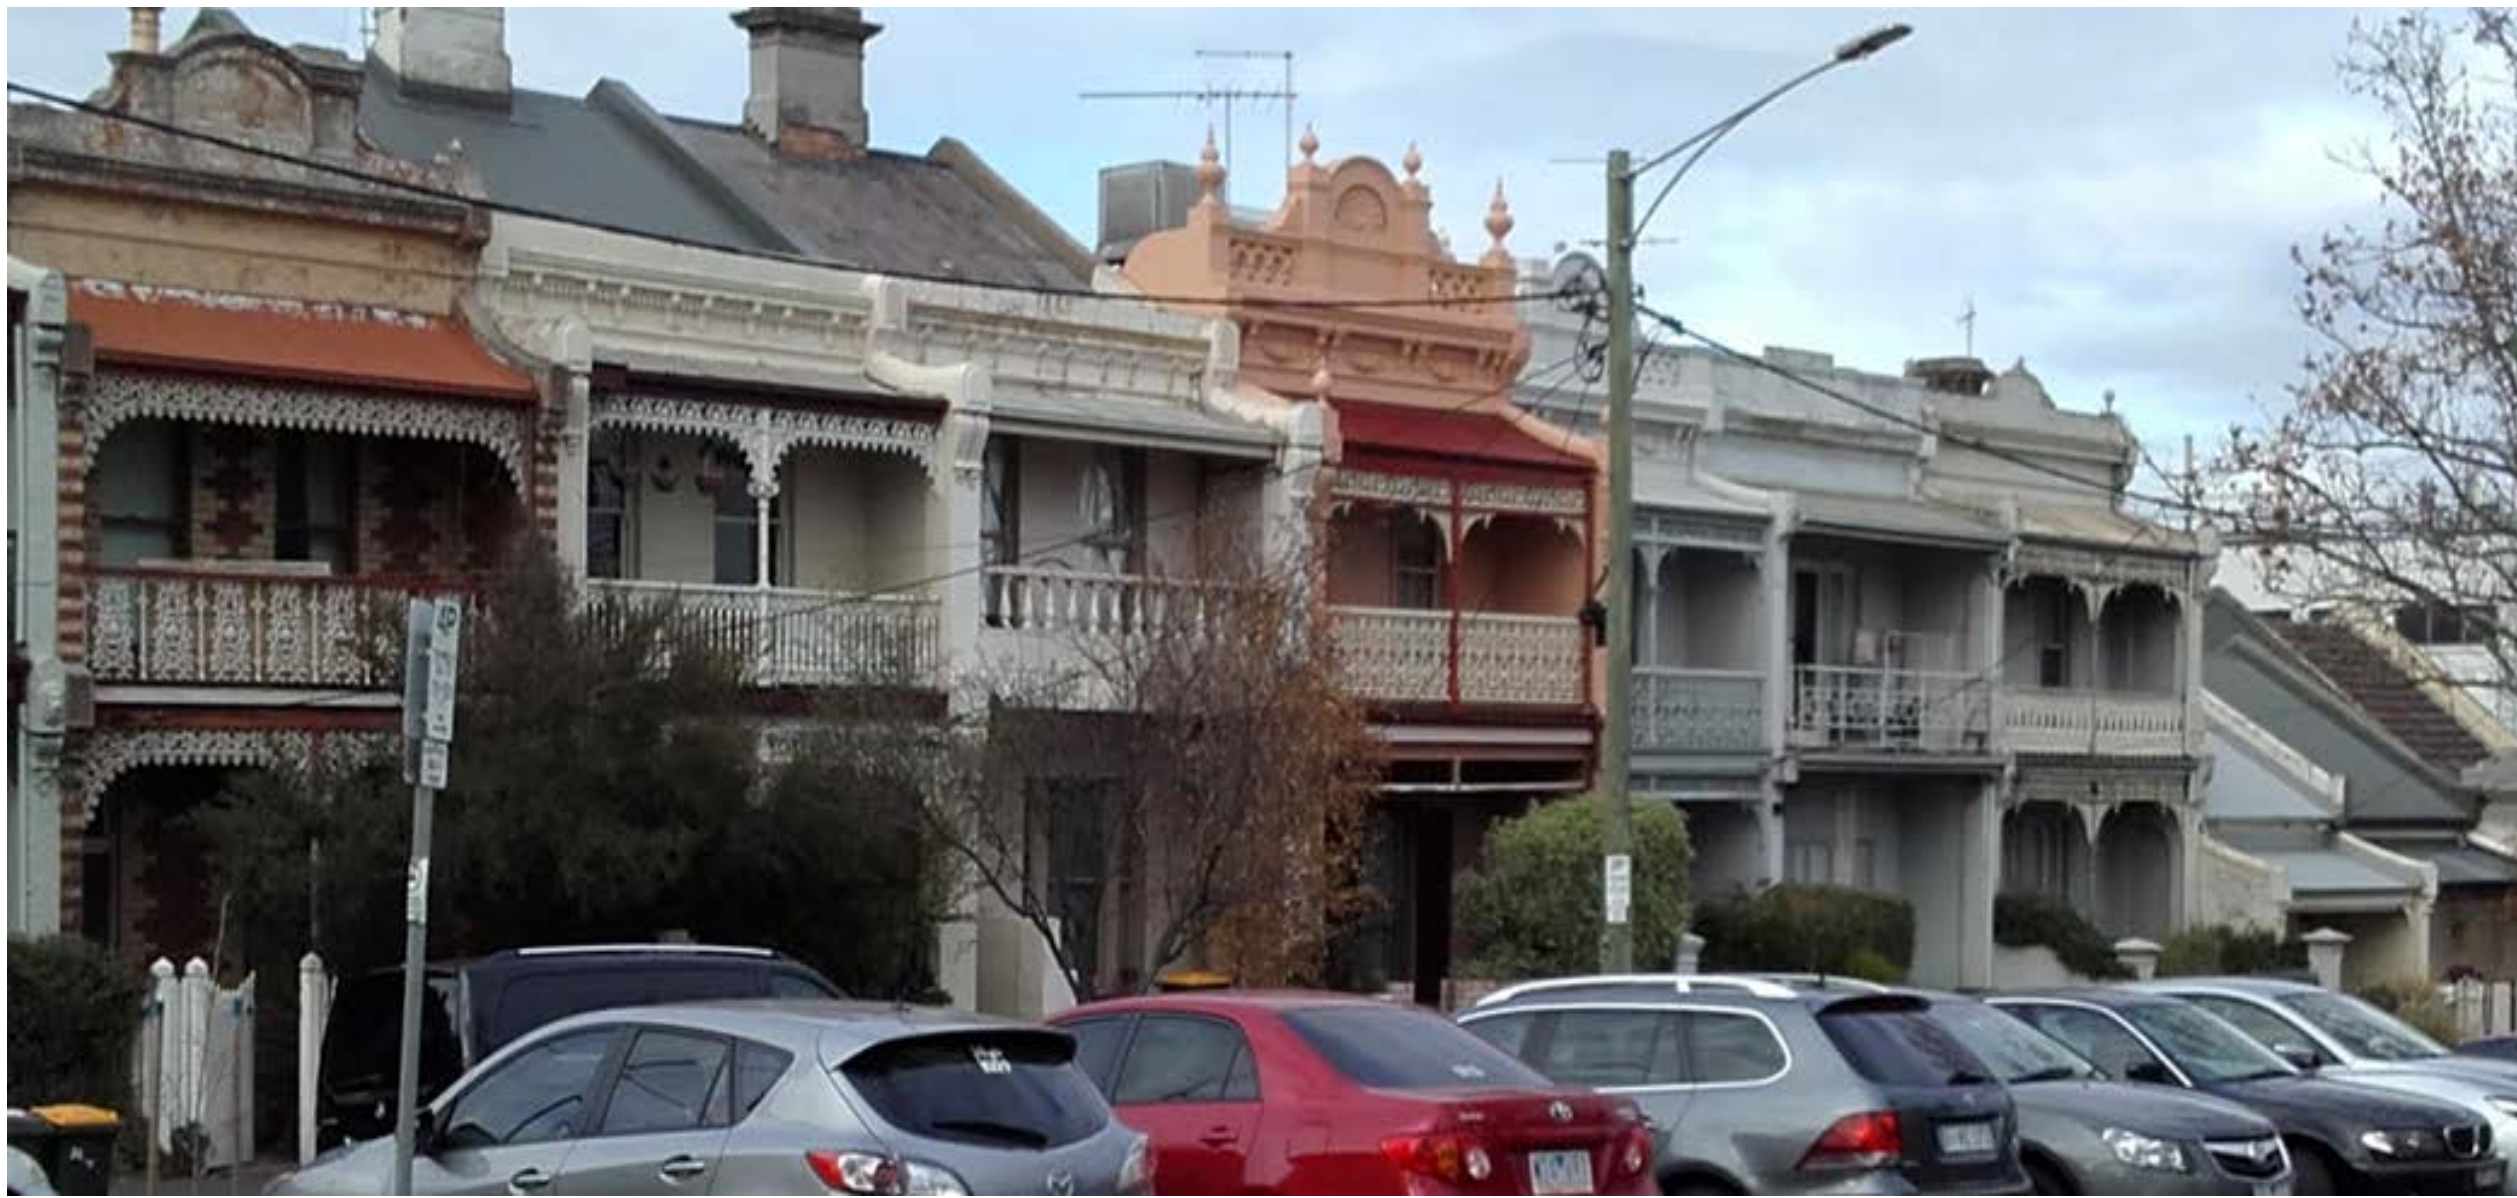
Acknowledge S of S for house 45 with some exclusion for fence , Corinthian column, pair, face brick side and rear, chimneys, three lights at ground floor. Additions applicable to house 43 are in red.

- Two story stuccoed house.
- Cemented dentilated cornice moulds, rosettes and brackets with a raised arched entablature and guilloche pattern balustrading either side.
- Pitched roof behind parapet.
- Two storey cast (iron) verandah, panelled cast (iron) frieze and brackets.
(replacements on 43 are cast aluminium)
- 4 out of 6 orbs still in place.
- Original cast iron frieze in place on lower verandah.
- The siting of house 43 on the crest and in a forward position from house 45, allows the high parapet to crown this Victorian streetscape.
- Double hung sash windows.
- Four panel entry door and toplight.
- Contribution to valuable Victorian era streetscape.

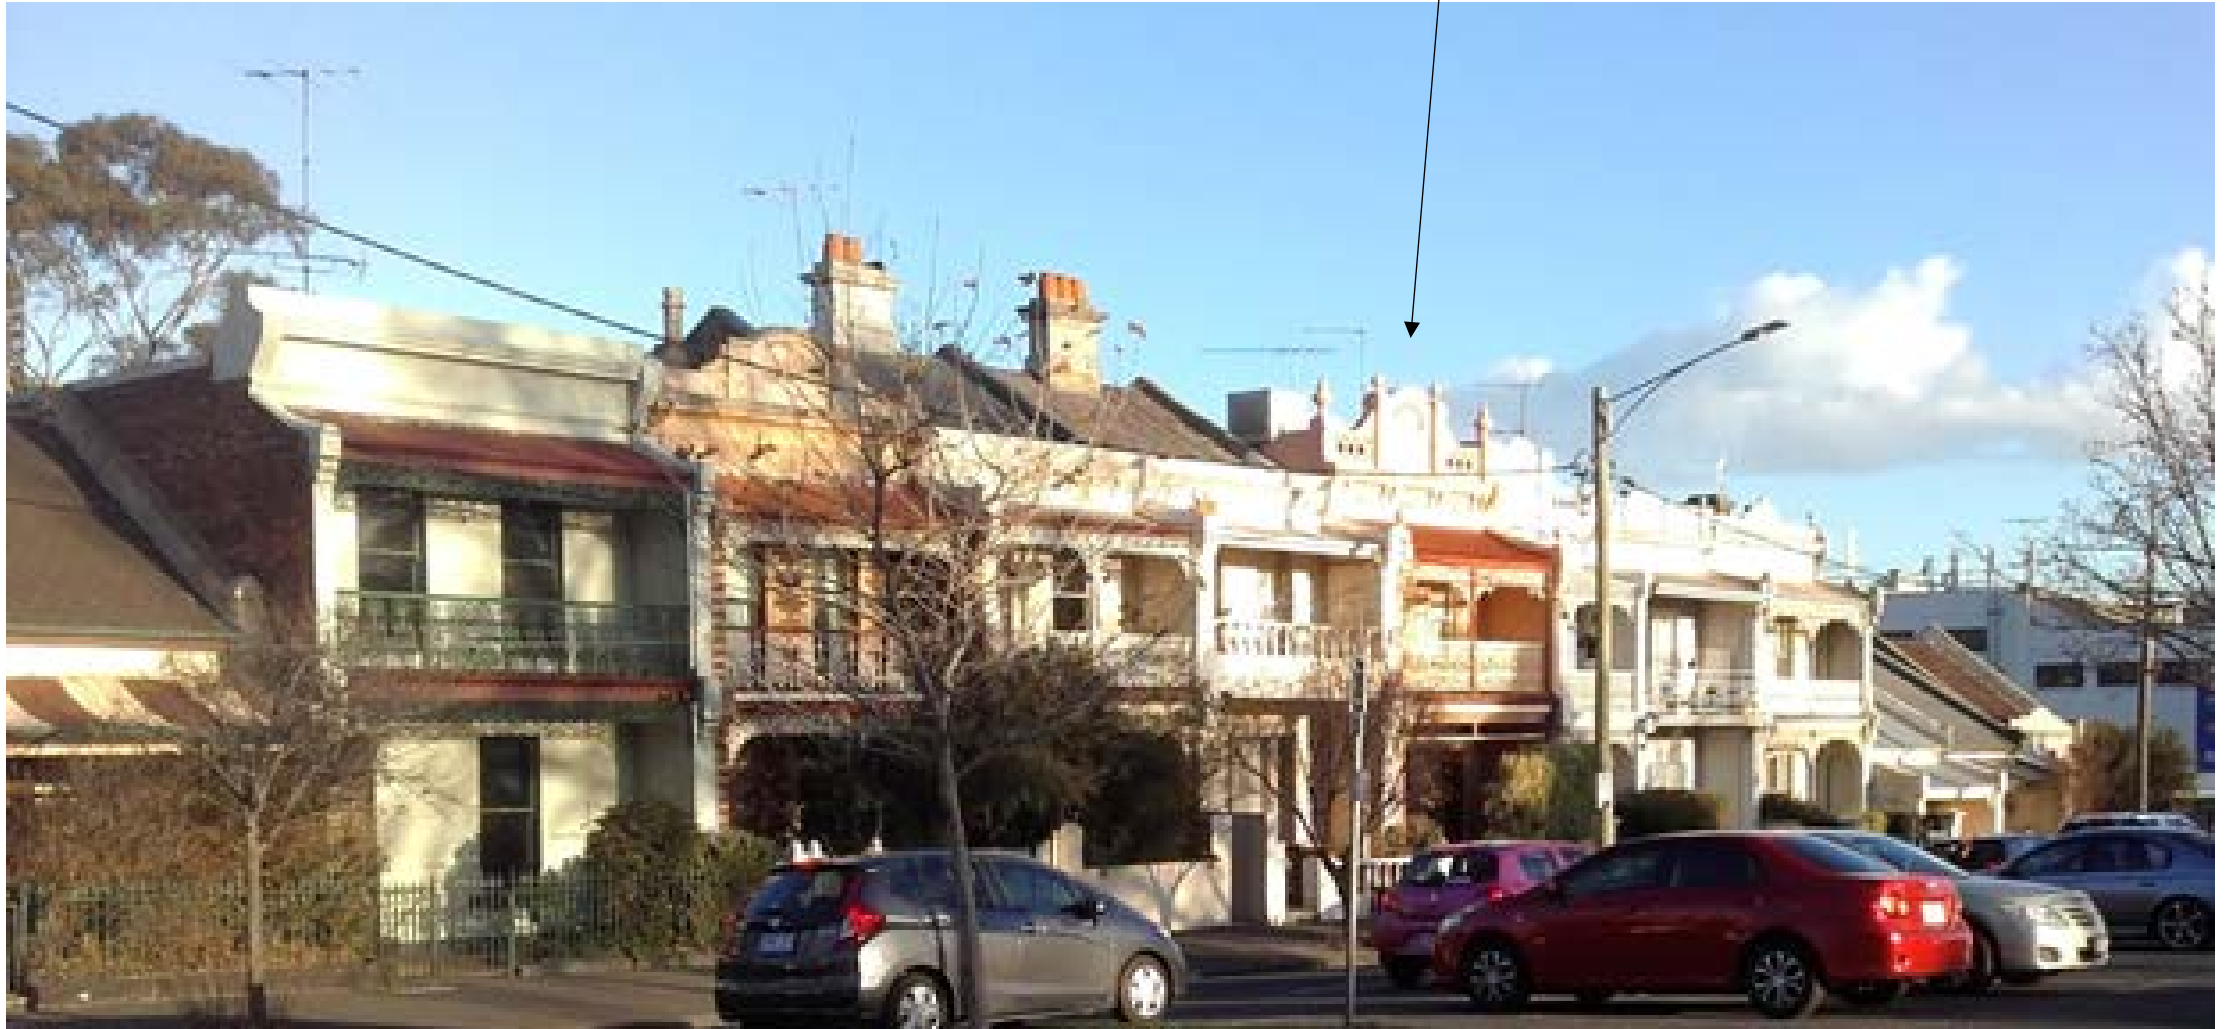
Note the crowning effect of house 43 on the streetscape from the distance.

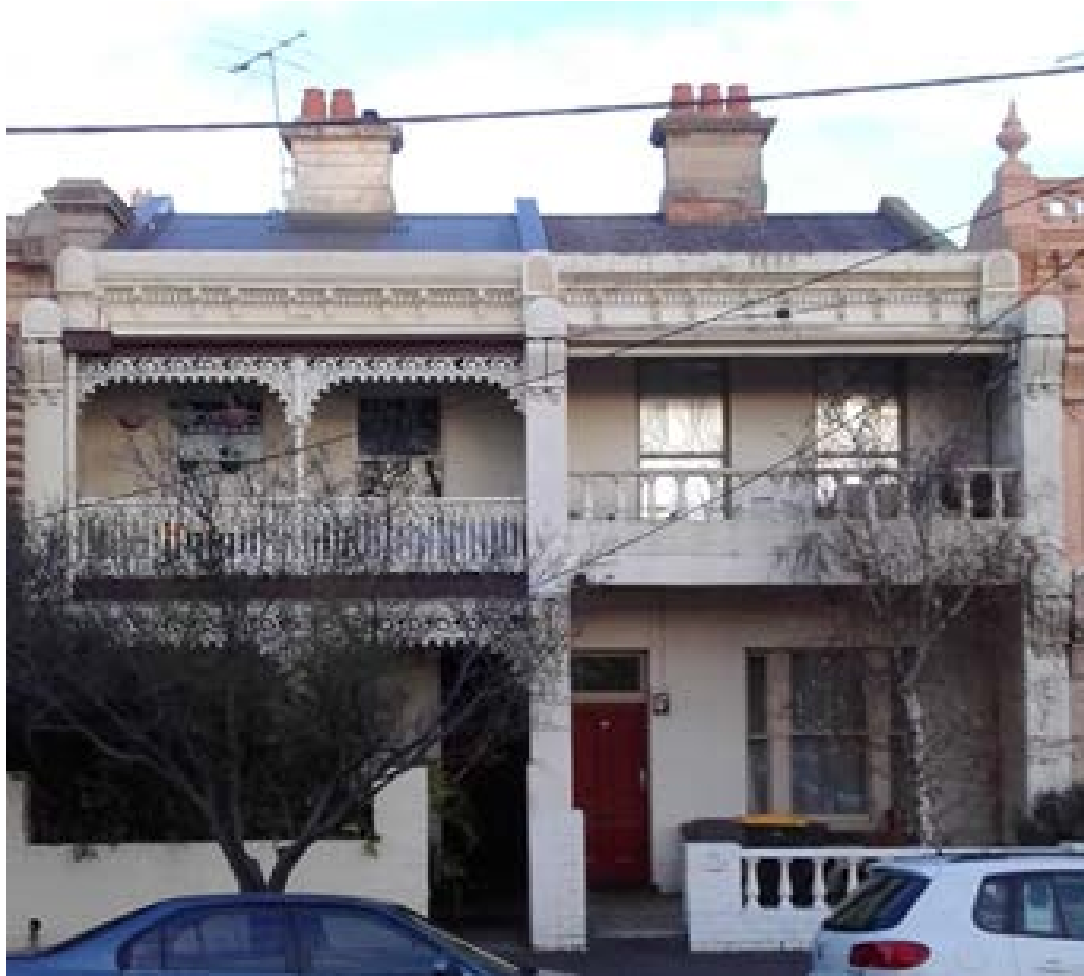
House 39 and 41

- I rely on the heritage consultant's advice on whether the notable features are broadly achieved. I fail to see why house 43 fails to achieve significance - while others, in particular, house 41 and 47 do, due to their pairing status, but discounting their defaced condition.
- Siting is not referred to, even though it is included in the definition, whereas pairing, as such, is not.
- Siting in this case of house 43, promotes diversity within this streetscape, acknowledges changes of slope and lot shapes, which adds to its unique and special quality.
- Pairing might be significant when each of the partners are in reasonably consistent condition, and their matching strengths are mutually reinforcing.
- It is my strong contention that this is not the case here. The partnering pairs are so different that it is almost impossible to tell that they are pairs.

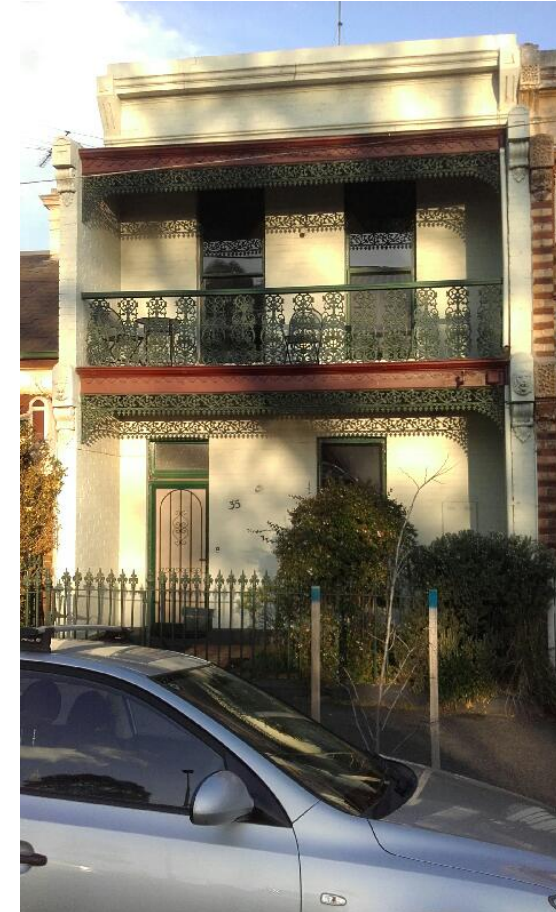
1. It would be unfortunate if the “Significant” street classification did not extend to cover the three additional contributory houses (51 to 55) to the SW of 49 Hawke Street in order to reinforce the protection of this entire Hawke Street heritage streetscape.
2. The other contributory place in this two storey row is a two storey house at 35 Hawke Street. It is the oldest of all the two storey houses and was built by the same builder who constructed the first stage of 43 Hawke Street - Crawford and Anderson. Original or modified? Samuel Woodham built the house and occupied it for more than 30 years.
